TROUT UNLIMITED

Alaska Salmonid Biodiversity Program

Ref: Fisheries Committee Testimony of February 5, 2001

Tongass Road Condition Survey Report

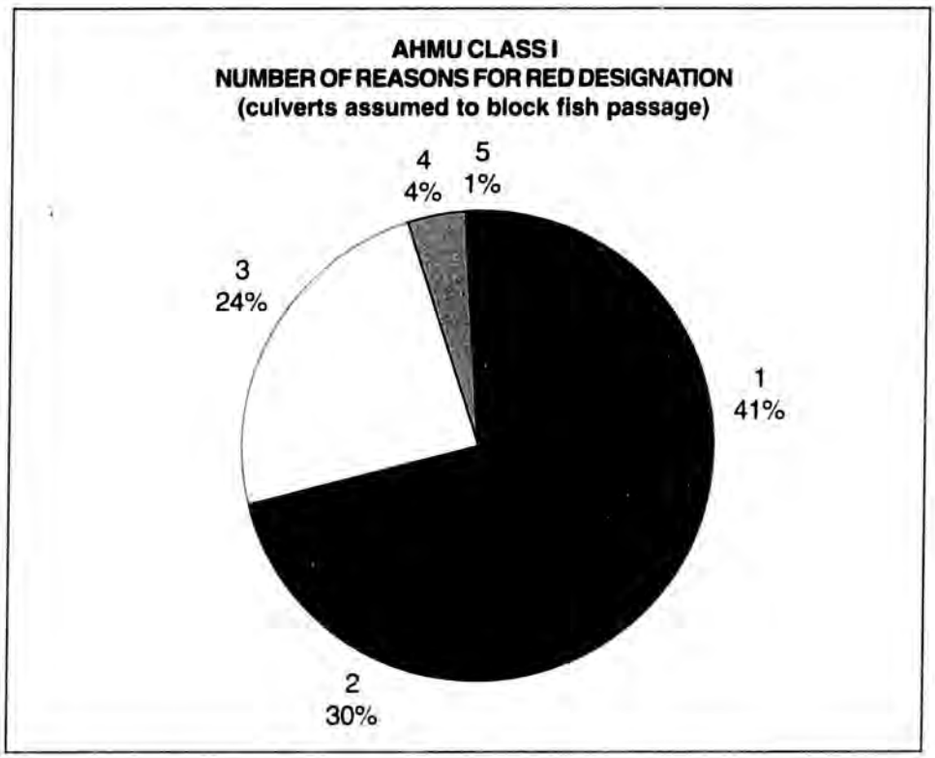
Figure 2. Anadromous fish streams: number of reasons for RED designation

The following graphs display the frequency and reasons for culverts being assumed to block salmonid fish passage for a single reason. It is assumed that adult salmon can negotiate higher velocity water through a culvert and greater culvert perch heights as long as there is adequate water depth.

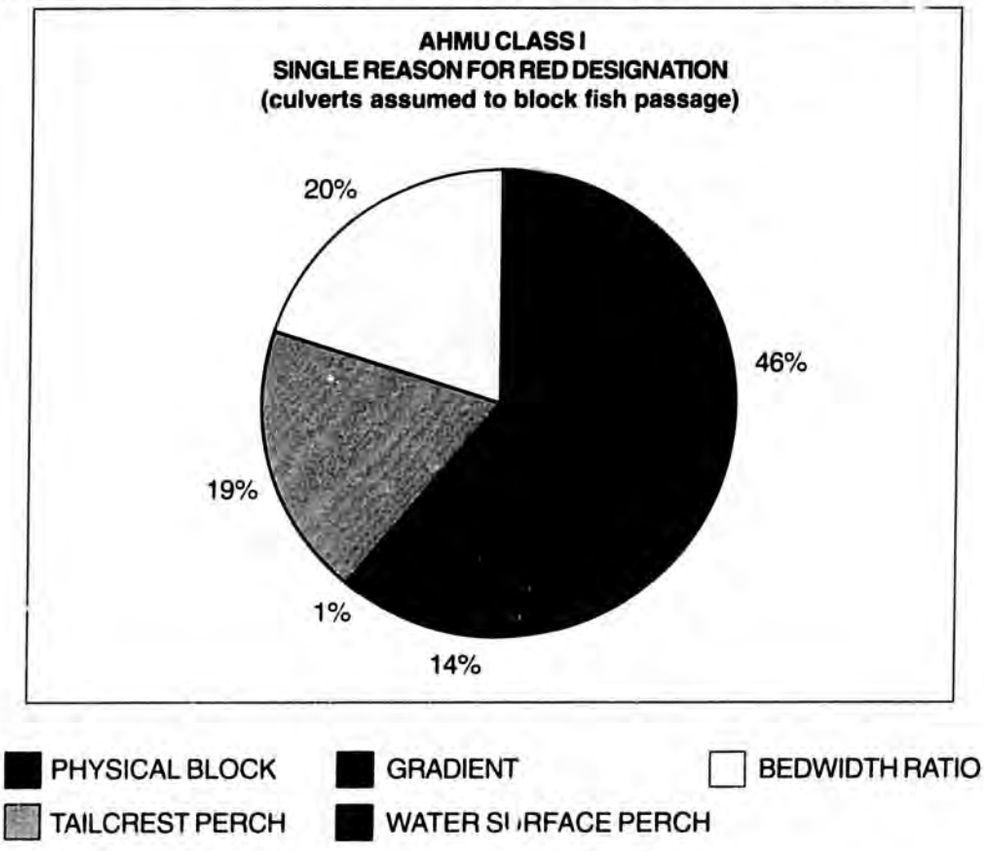
Figure 3. Anadromous fish streams: single reason for RED designation

Of the 74 culverts (41%) assumed not to be adequate for fish passage due to a single factor, unacceptably steep gradient was the most frequent cause. Of the 33 culverts with gradient as sole problem, 12 culverts had gradients less than 2% and 21 culverts had gradients between 2 and 11%. Further analysis of the twelve records with a gradient less than 2 % using FishXing software may be warranted to confirm the criteria used in the Fish Passage Evaluation Chart.

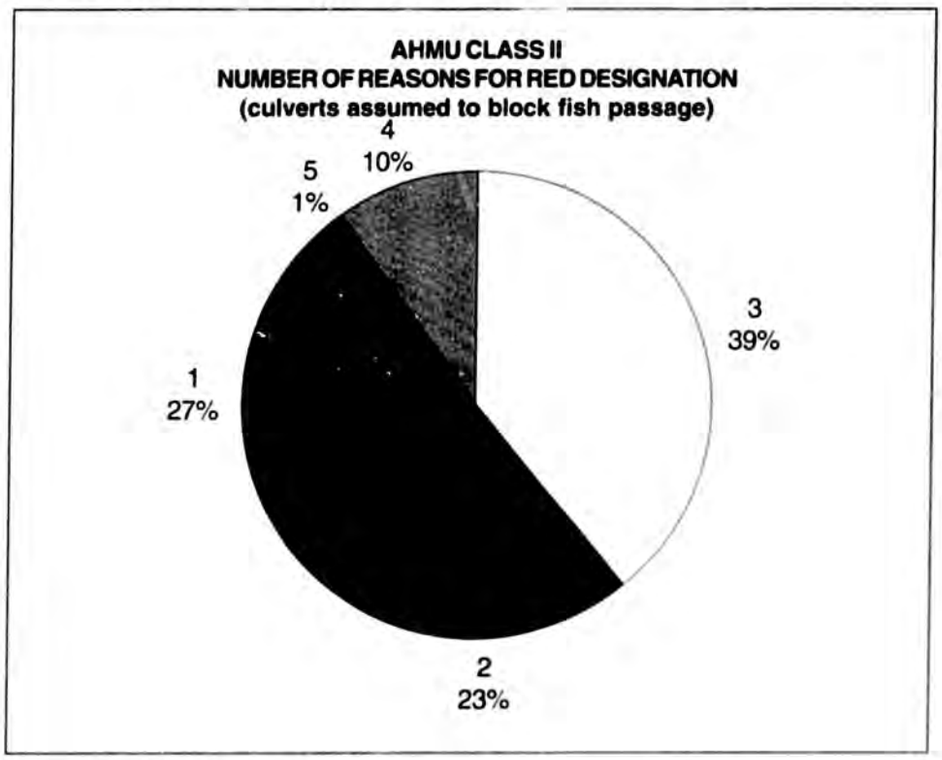
Figure 4. Resident Fish Streams: number of reasons for RED designation

Of the 531 Class II culverts in the RED category, 385 (73) exhibited multiple causes of assumed blockage to fish passage: 120 culverts had two causes, 210 culverts had three, 53 culverts had four and 3 culverts had five. Of the 145 culverts (27%) blocked by a single factor, unacceptably steep gradient (65%) was the most frequent cause. Of the 95 culverts with gradient as the sole problem, 19 culverts had gradients less than 2% and 76 culverts had gradients between 2 culverts and 17%. Further analysis with FishXing of the nineteen records with a gradient less than 2% may be warranted to confirm the criteria used in the Fish Passage Evaluation Chart. The following graphs display the frequency and reasons for assumed blockage to resident fish.

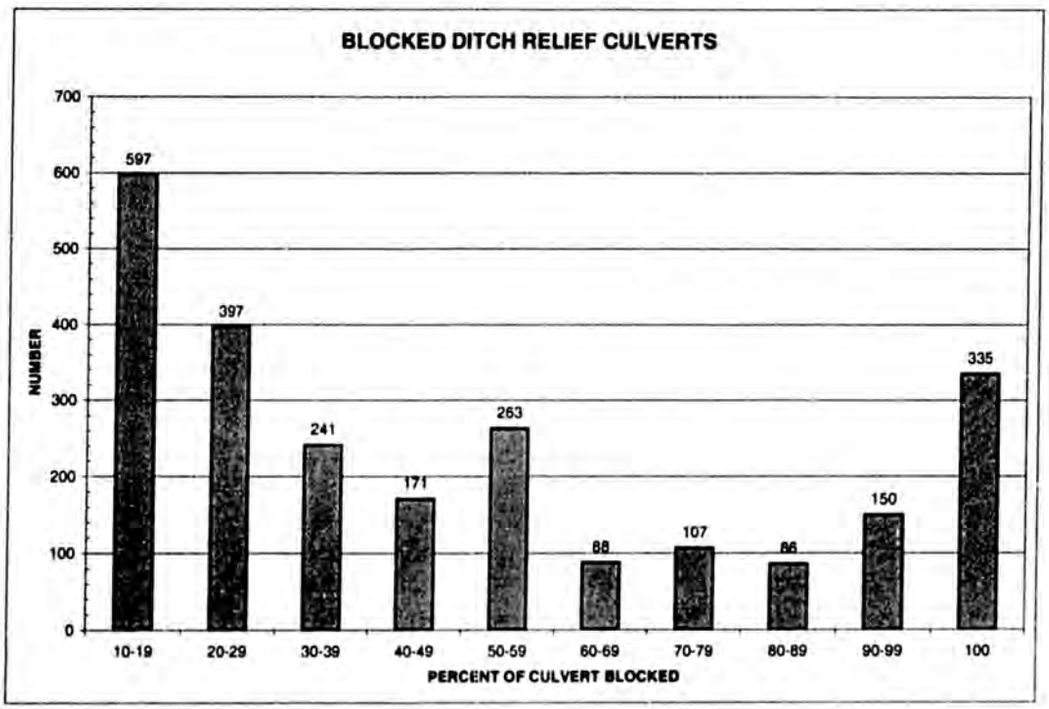
Figure 6- Number of blocked ditch relief culverts by percent blocked

The following graph displays the number of blocked ditch relief culverts grouped by percent blocked:
