ALASKA LEGISLATURE COMMITTEE FILES, 2005-2006 8672
11973 SENATE RESOURCES

Greater Kuparuk Area (GKA)
Alpine Field
Corrosion Programs Overview

Commitment to Corrosion Monitoring

Prepared by
ConocoPhillips Corrosion Team

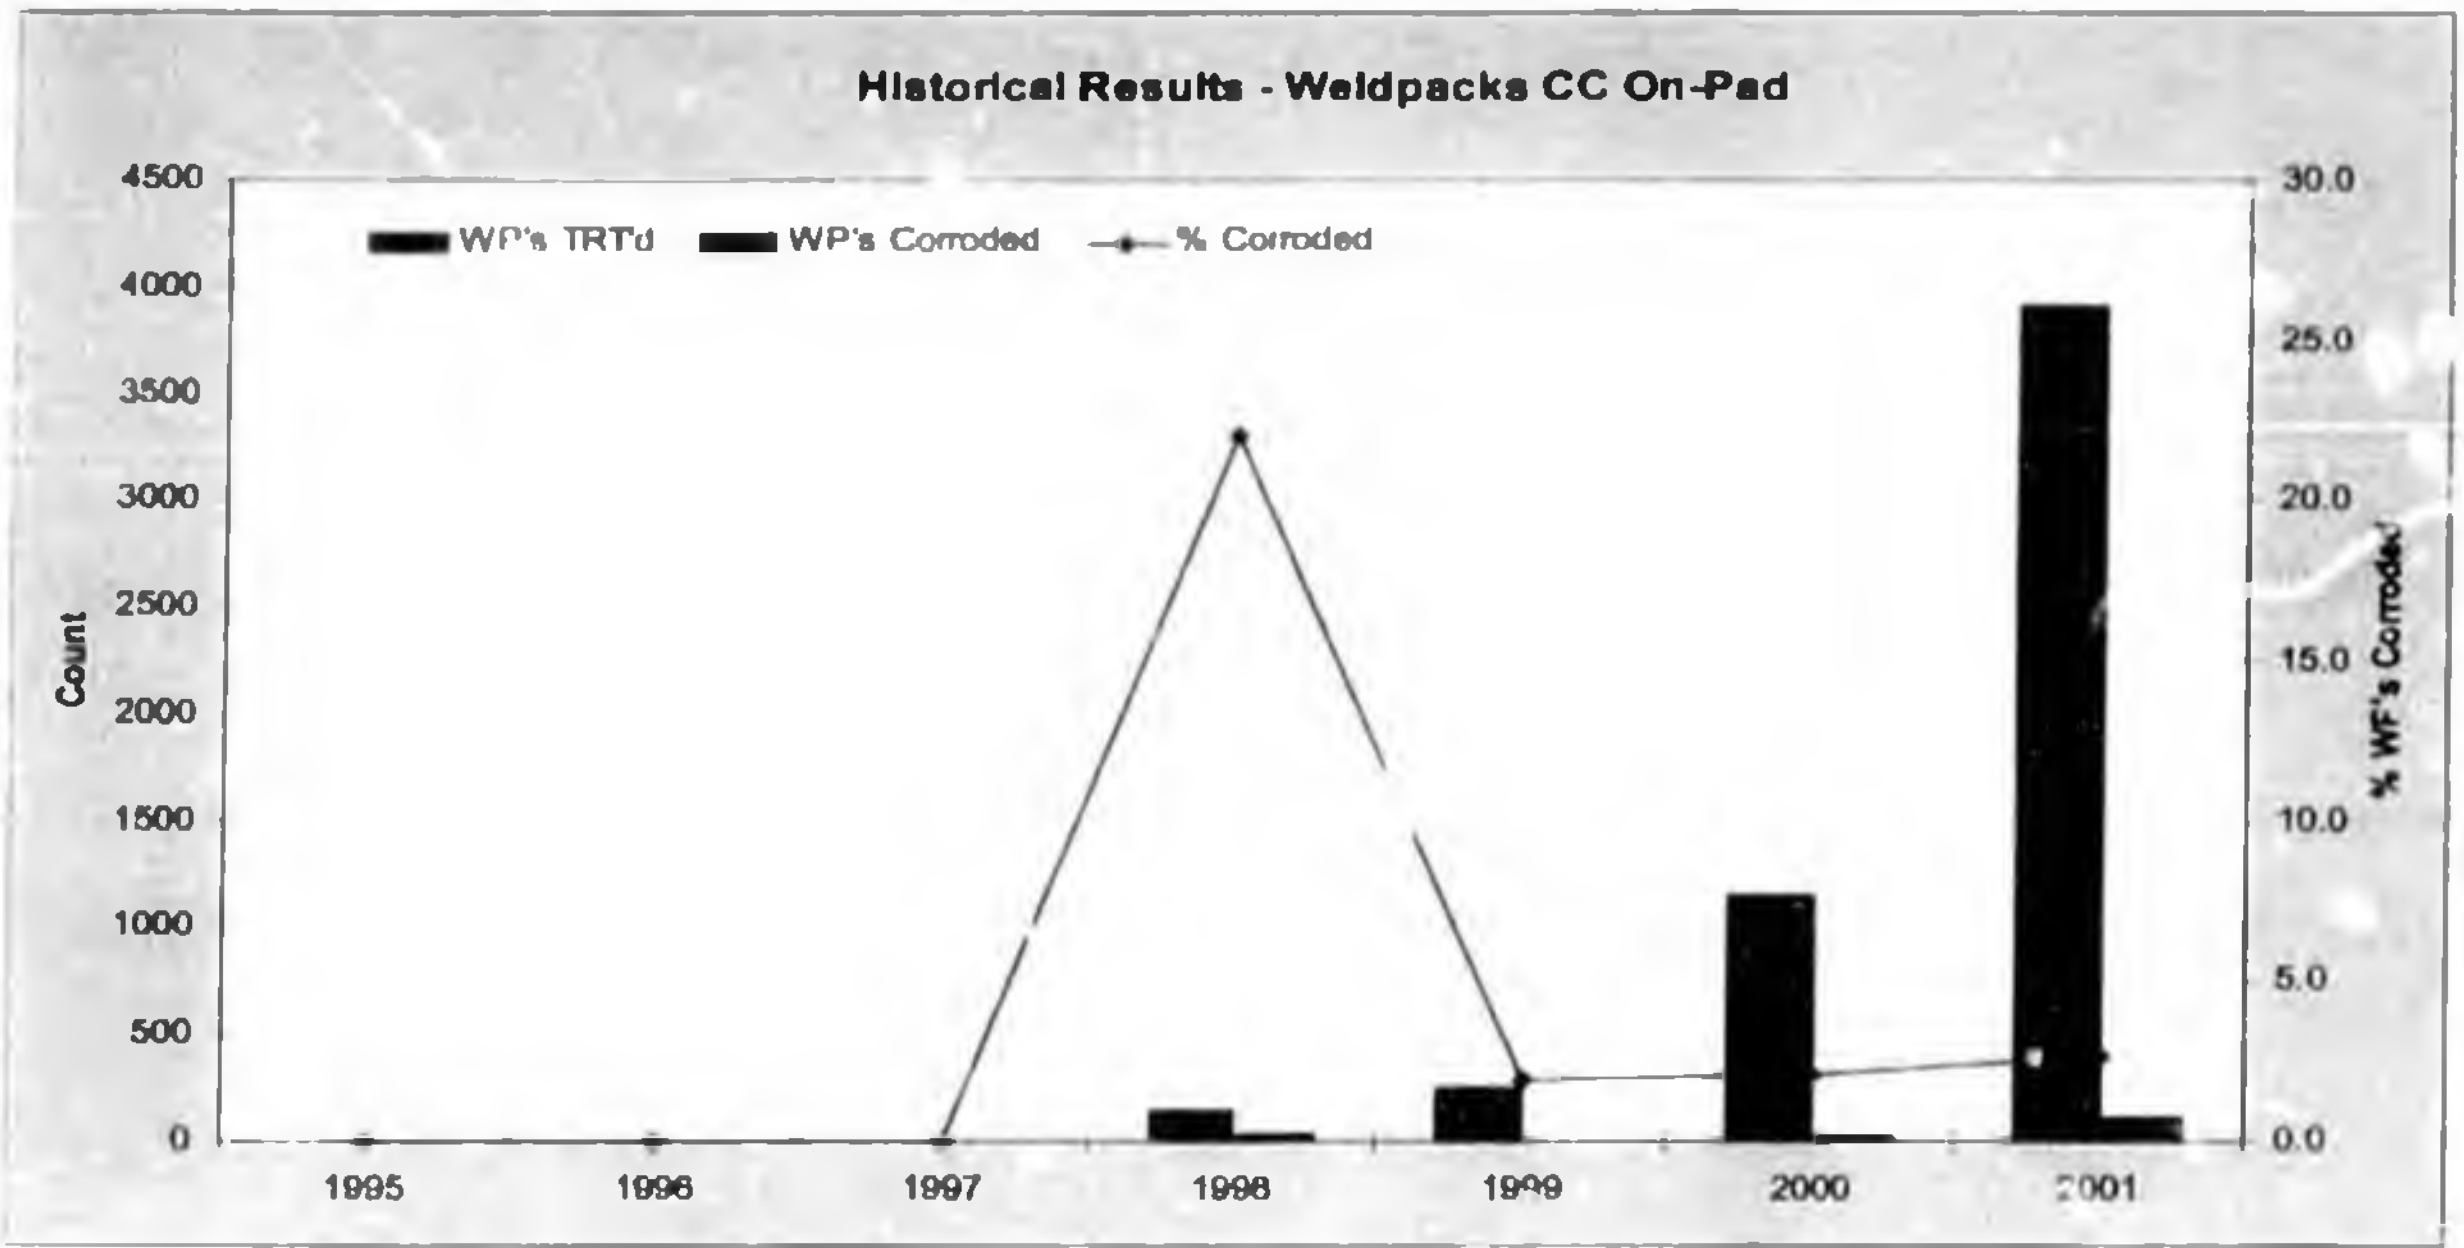
Figure 11. Summary of Weld Packs on Cross-Country Lines on Pads – number of weld packs inspected, number of weld packs corroded, and percent of weld packs corroded.

Figures 11 and 12 depict the results of the major focus of the external weld pack inspection program in 2001. The cross-country on-pad weld packs were inspected using a prioritization scheme based on the historical corroded to wet ratios of the over-tundra portions of the cross-country lines. The well line weld packs were inspected using a prioritization scheme that examined the oldest, the hottest, and thinnest-walled lines first. Based on the results in Figure 12, it appears that the worst weld packs have been inspected and the risk of a future leak has been minimized. Continued inspections in 2002 will confirm if this hypothesis is correct. As of Year-End 2001, 61% of the cross-country on-pad weld packs and 43% of the well line weld packs have received their baseline TRT inspection.

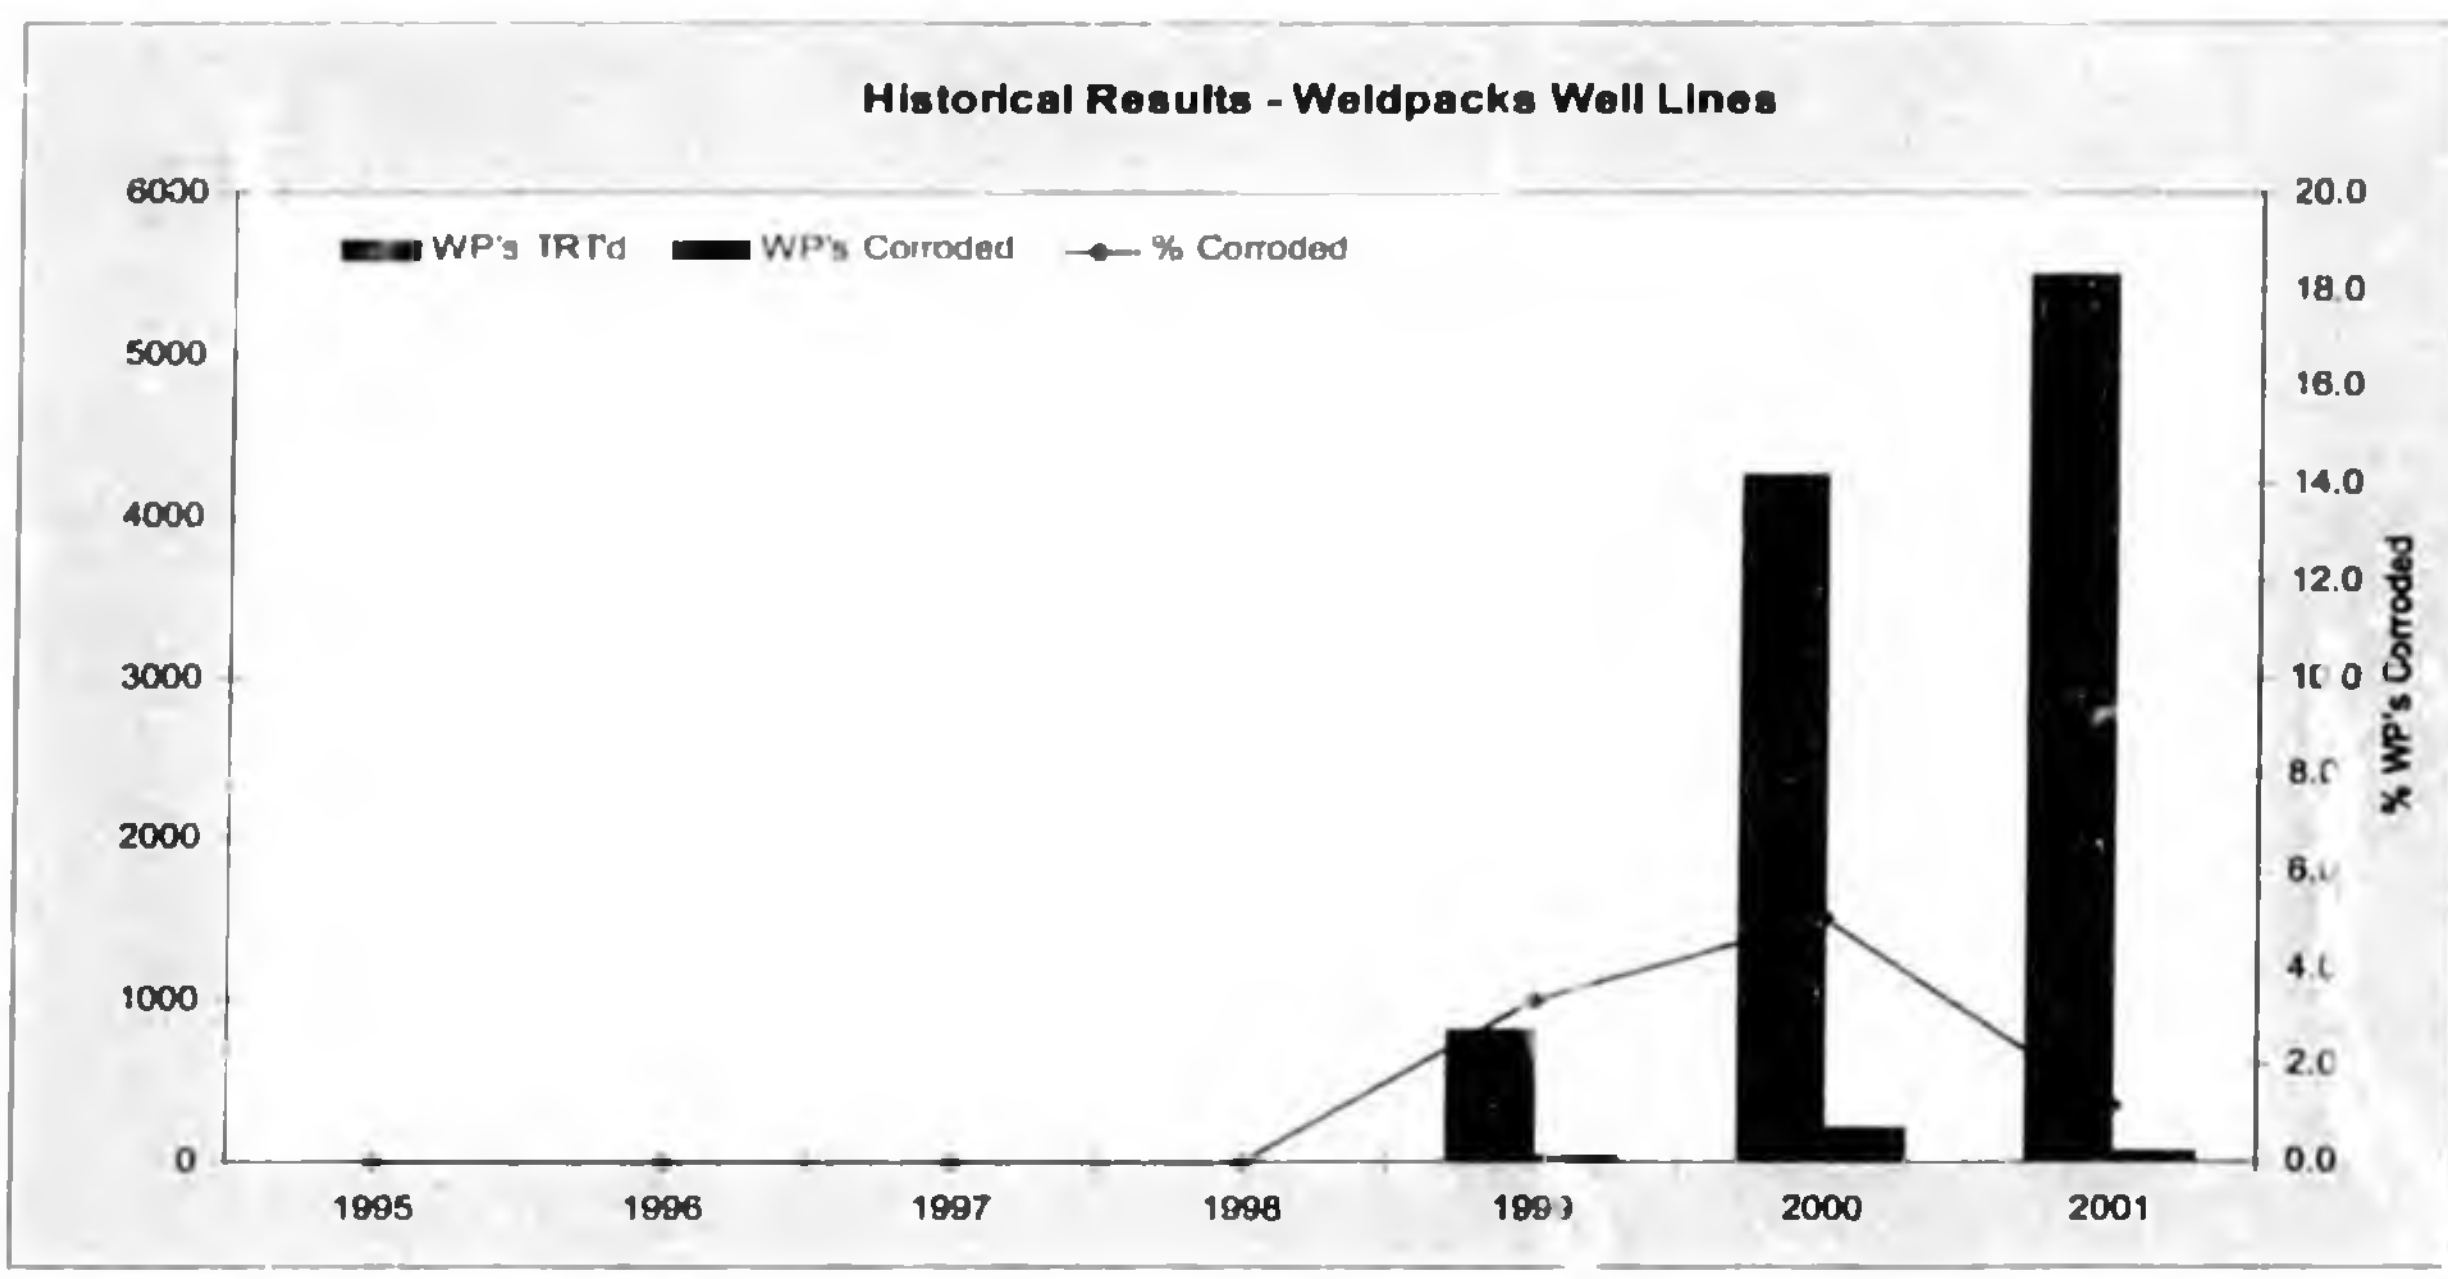
Figure 12. Summary of Weld Packs on Well Lines – number of weld packs inspected, number of weld packs corroded, and percent of weld packs corroded.

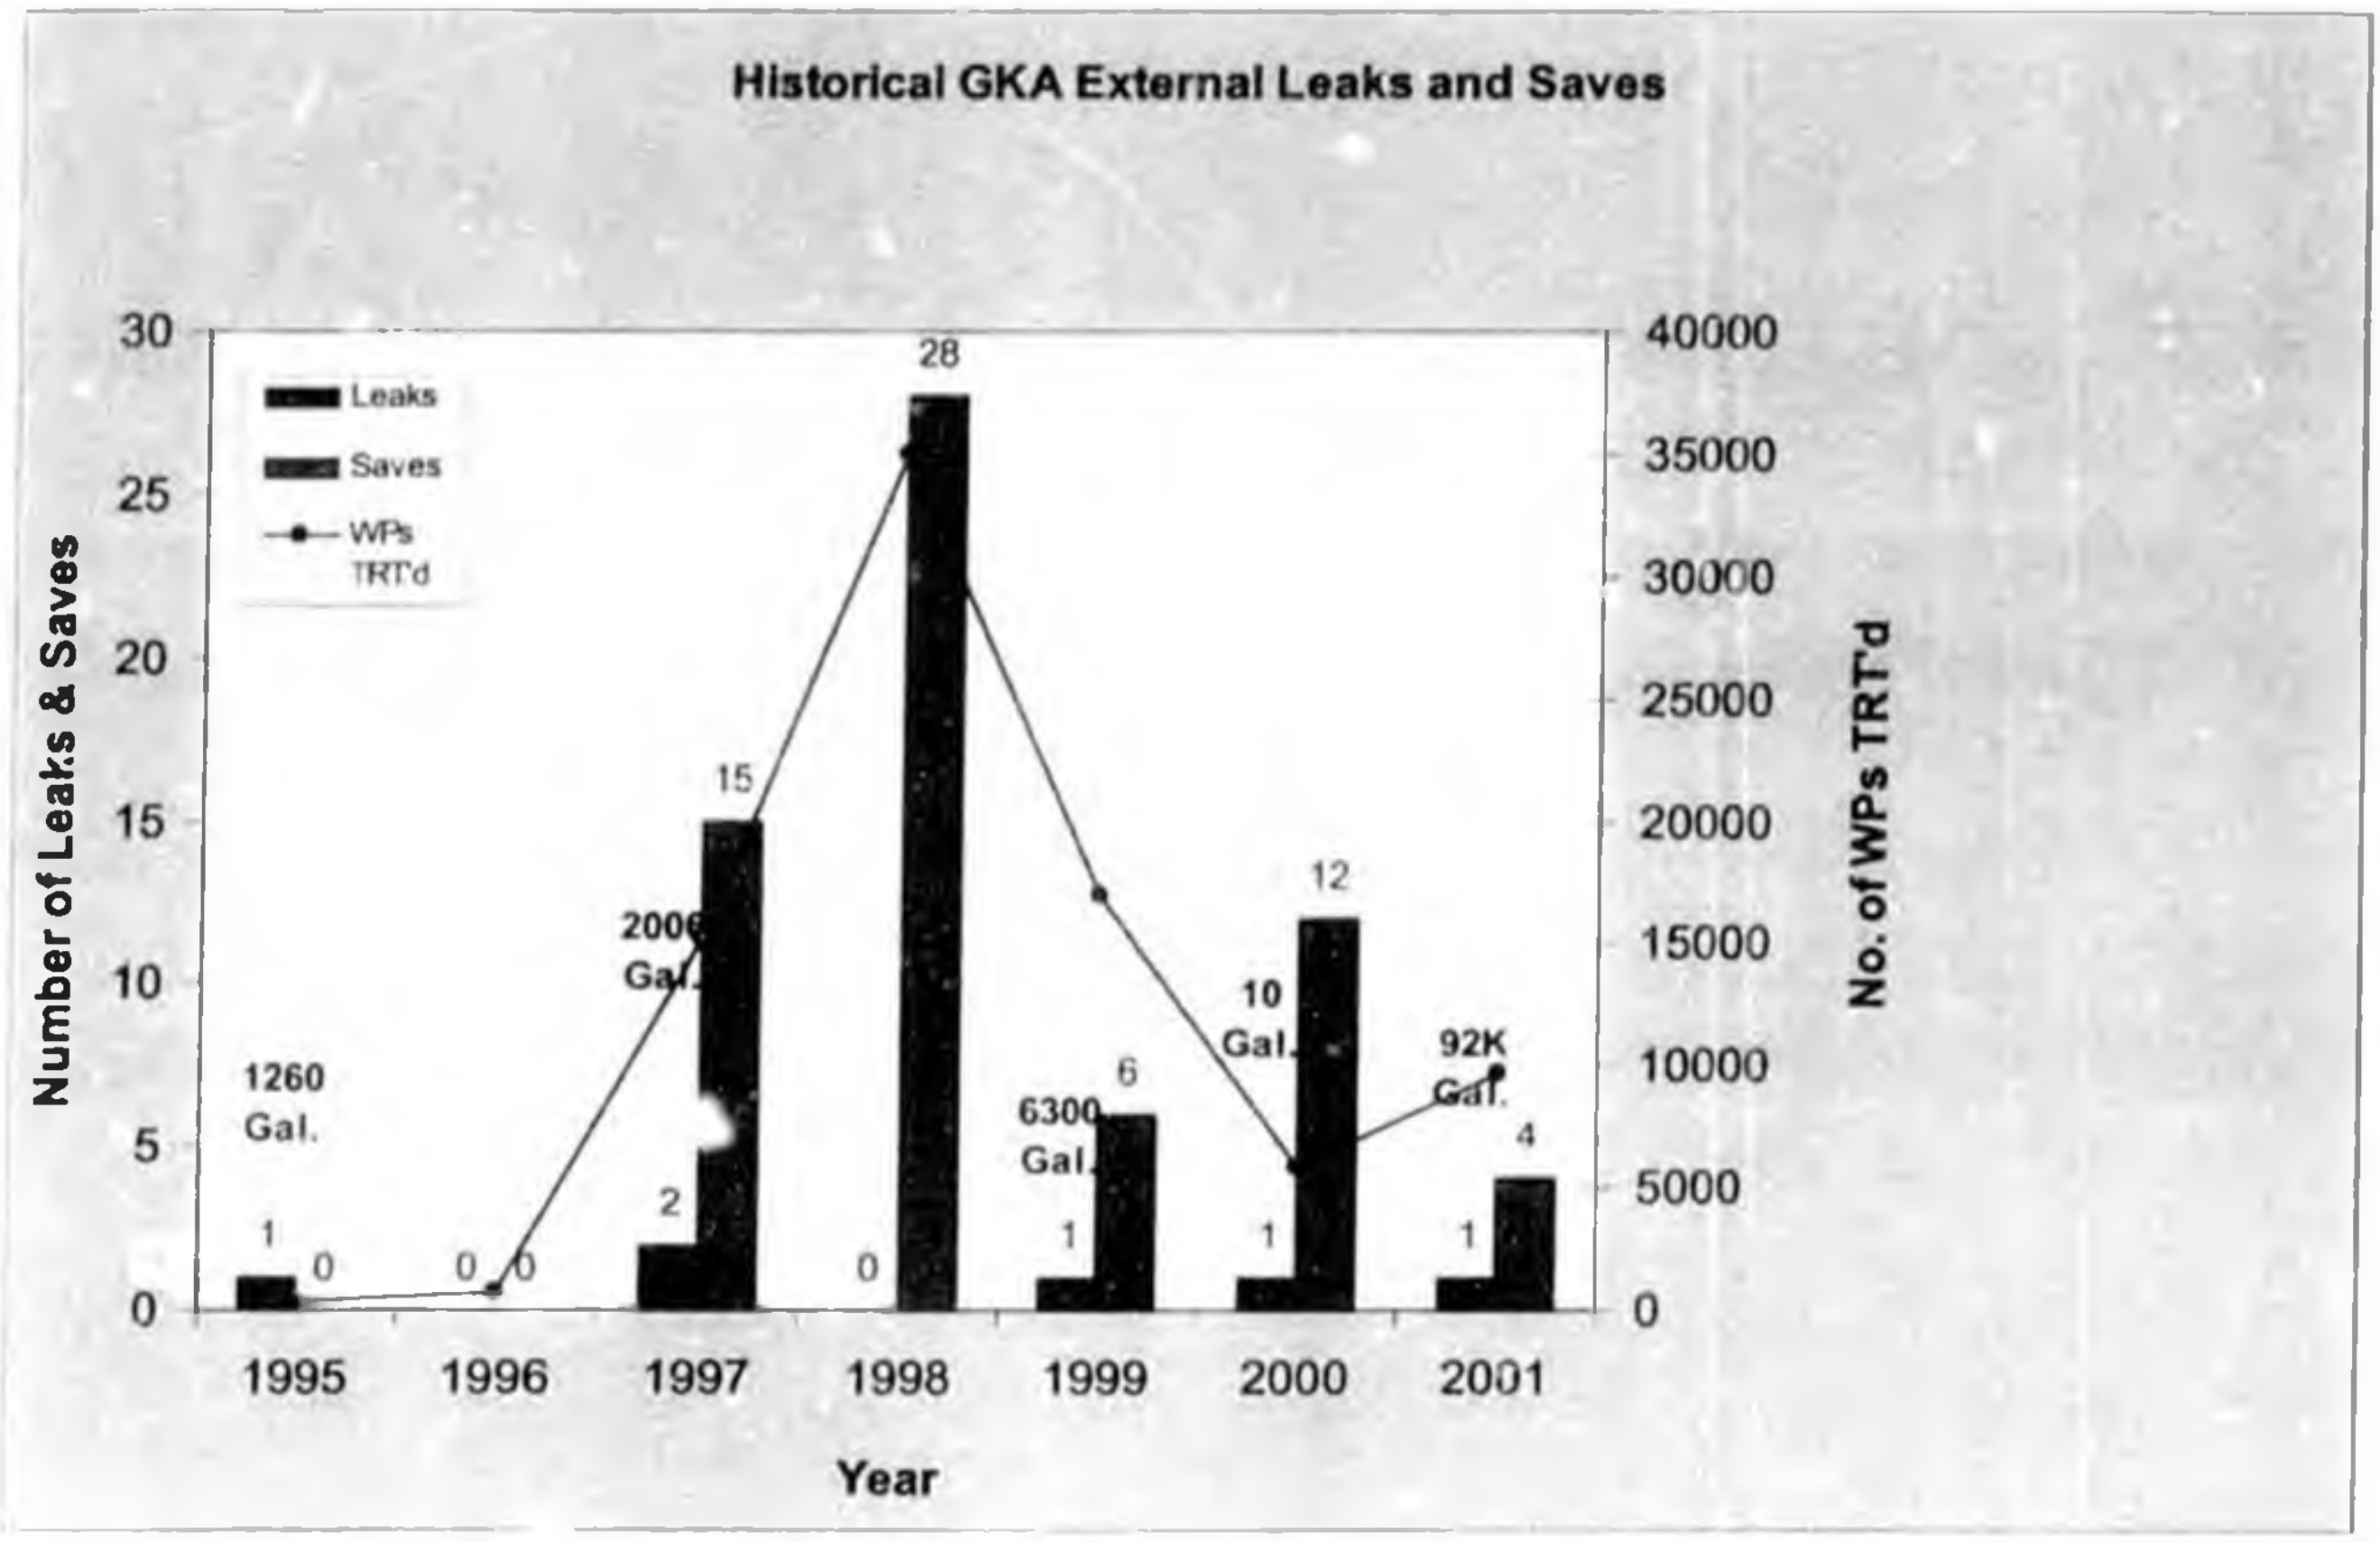
Figure A1. Leaks, saves, number of weld packs inspected with TRT, and volumes of leaks as a function of time.

Note: The leak in 2001 due to external corrosion was located in a weld pack in a below-grade piping segment, and as such, would not have been detected by the TRT inspection program. The location had not yet received PTI/TWI inspection.

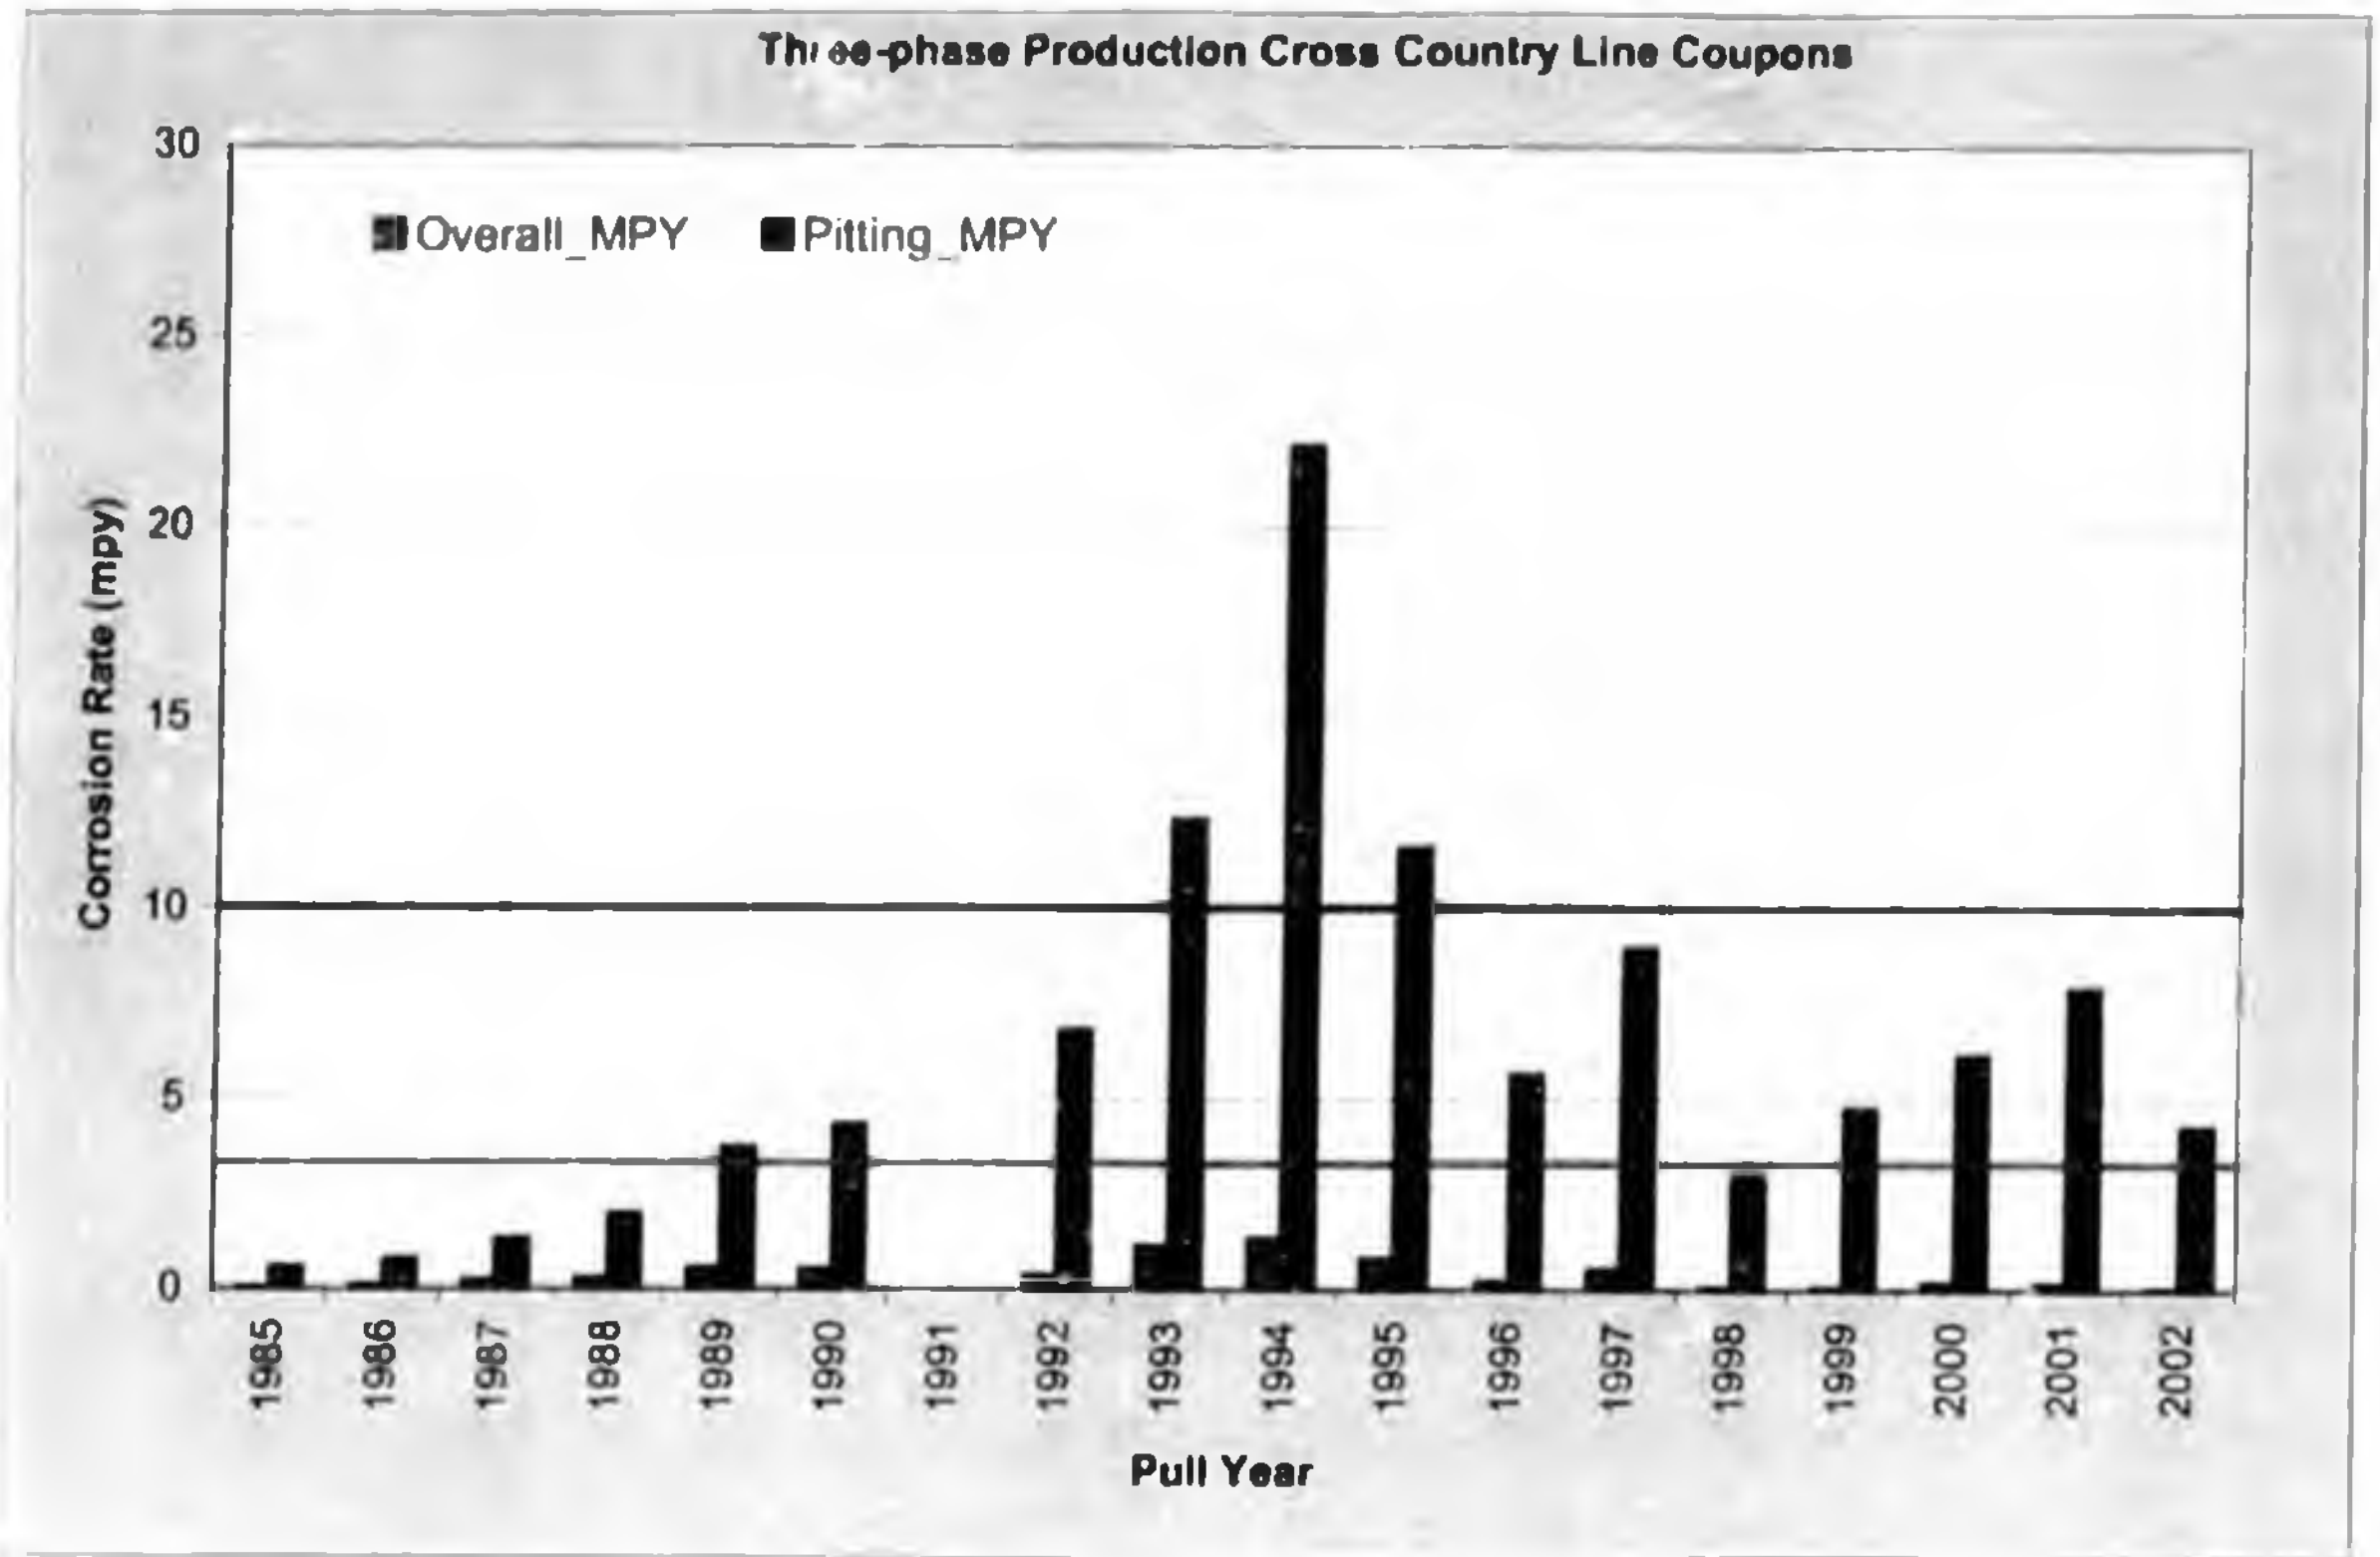
Figure 1. Three-phase Production Cross-Country Line Coupons – general and pitting corrosion rates as a function of time.

Three-phase Production Cross-Country Lines: The monitoring data summarized in Kuparuk Tables 1 and 2 and presented in Figure 1 suggest that general corrosion is under control. The data presented in the Tables 1 and 2 and in Figure 1 include corrosion coupon data from the wet oil lines.

Recurring CRM inspections also support the conclusion that corrosion is under control in the three-phase production cross-country lines. In 2002, 517 corrosion-rate monitoring (CRM) inspections were conducted, with 11 minor increases found (i.e. less than 3% of total CRM inspections resulted in an increase). Other internal inspection data also support the CRM data conclusions and are discussed in section 3.1.c, below.

Where corrosion rates exceeded targets, corrosion inhibitor concentrations were increased and/or the amount of inspection was increased. In 2002, coupon or probe corrosion rates exceeded targets on 10 lines and corrosion inhibitor concentrations were increased on all 10 of these lines. In 2002, inspection results indicated minor corrosion had occurred on 7 lines that did not have coupons or probes that exceeded the target corrosion rates; corrosion inhibitor concentrations were increased in all 7 of these lines. A complete listing of the 20 lines with corrosion rates that exceeded targets or where inspection indicated increase damage, is given Table A 1 of Appendix A.

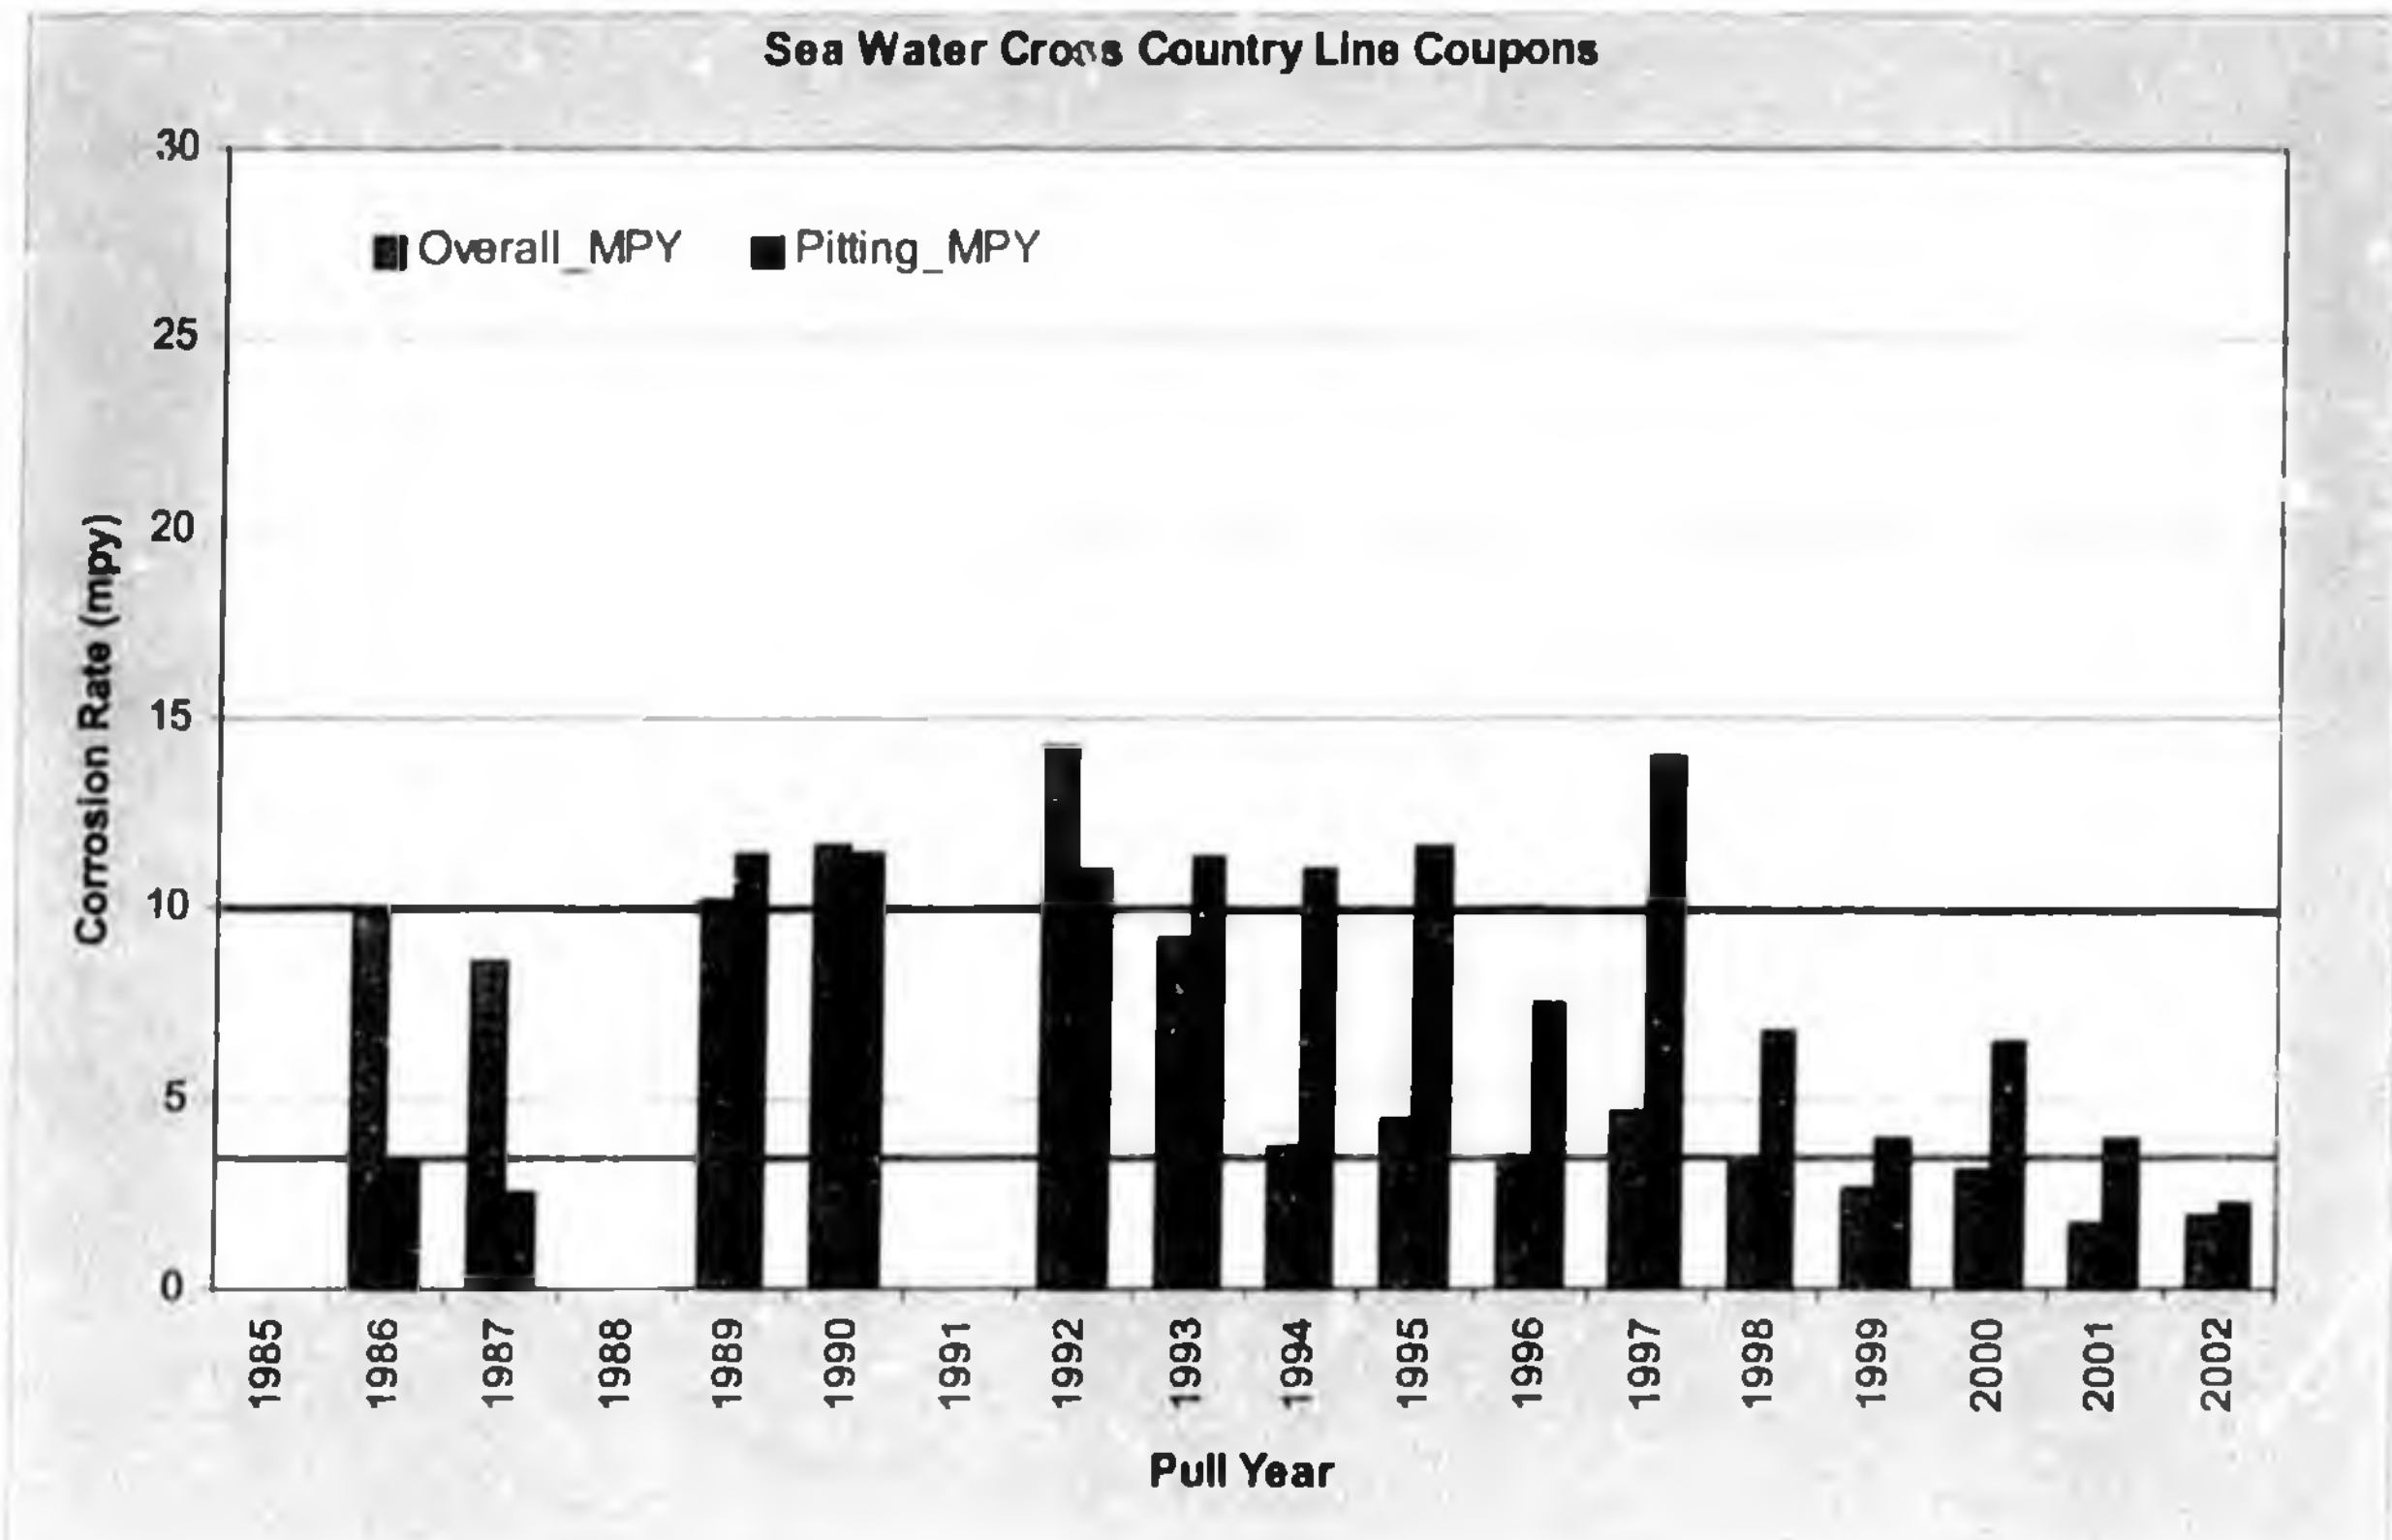
Figure 2. Seawater Cross-Country Line Coupons – general and pitting corrosion rates as a function of time.

Sea Water Cross-Country Lines: The monitoring data summarized in Kuparuk Tables 1 and 2 and presented in Figure 2 above, shows the average corrosion rates for the sea water cross-country line coupons remained under thresholds in 2002. UT inspections were conducted in the area of the coupons with the high general corrosion rates and no increases to existing minor damage were found. An ER probe has been installed in the same area with no appreciable corrosion rate noted.

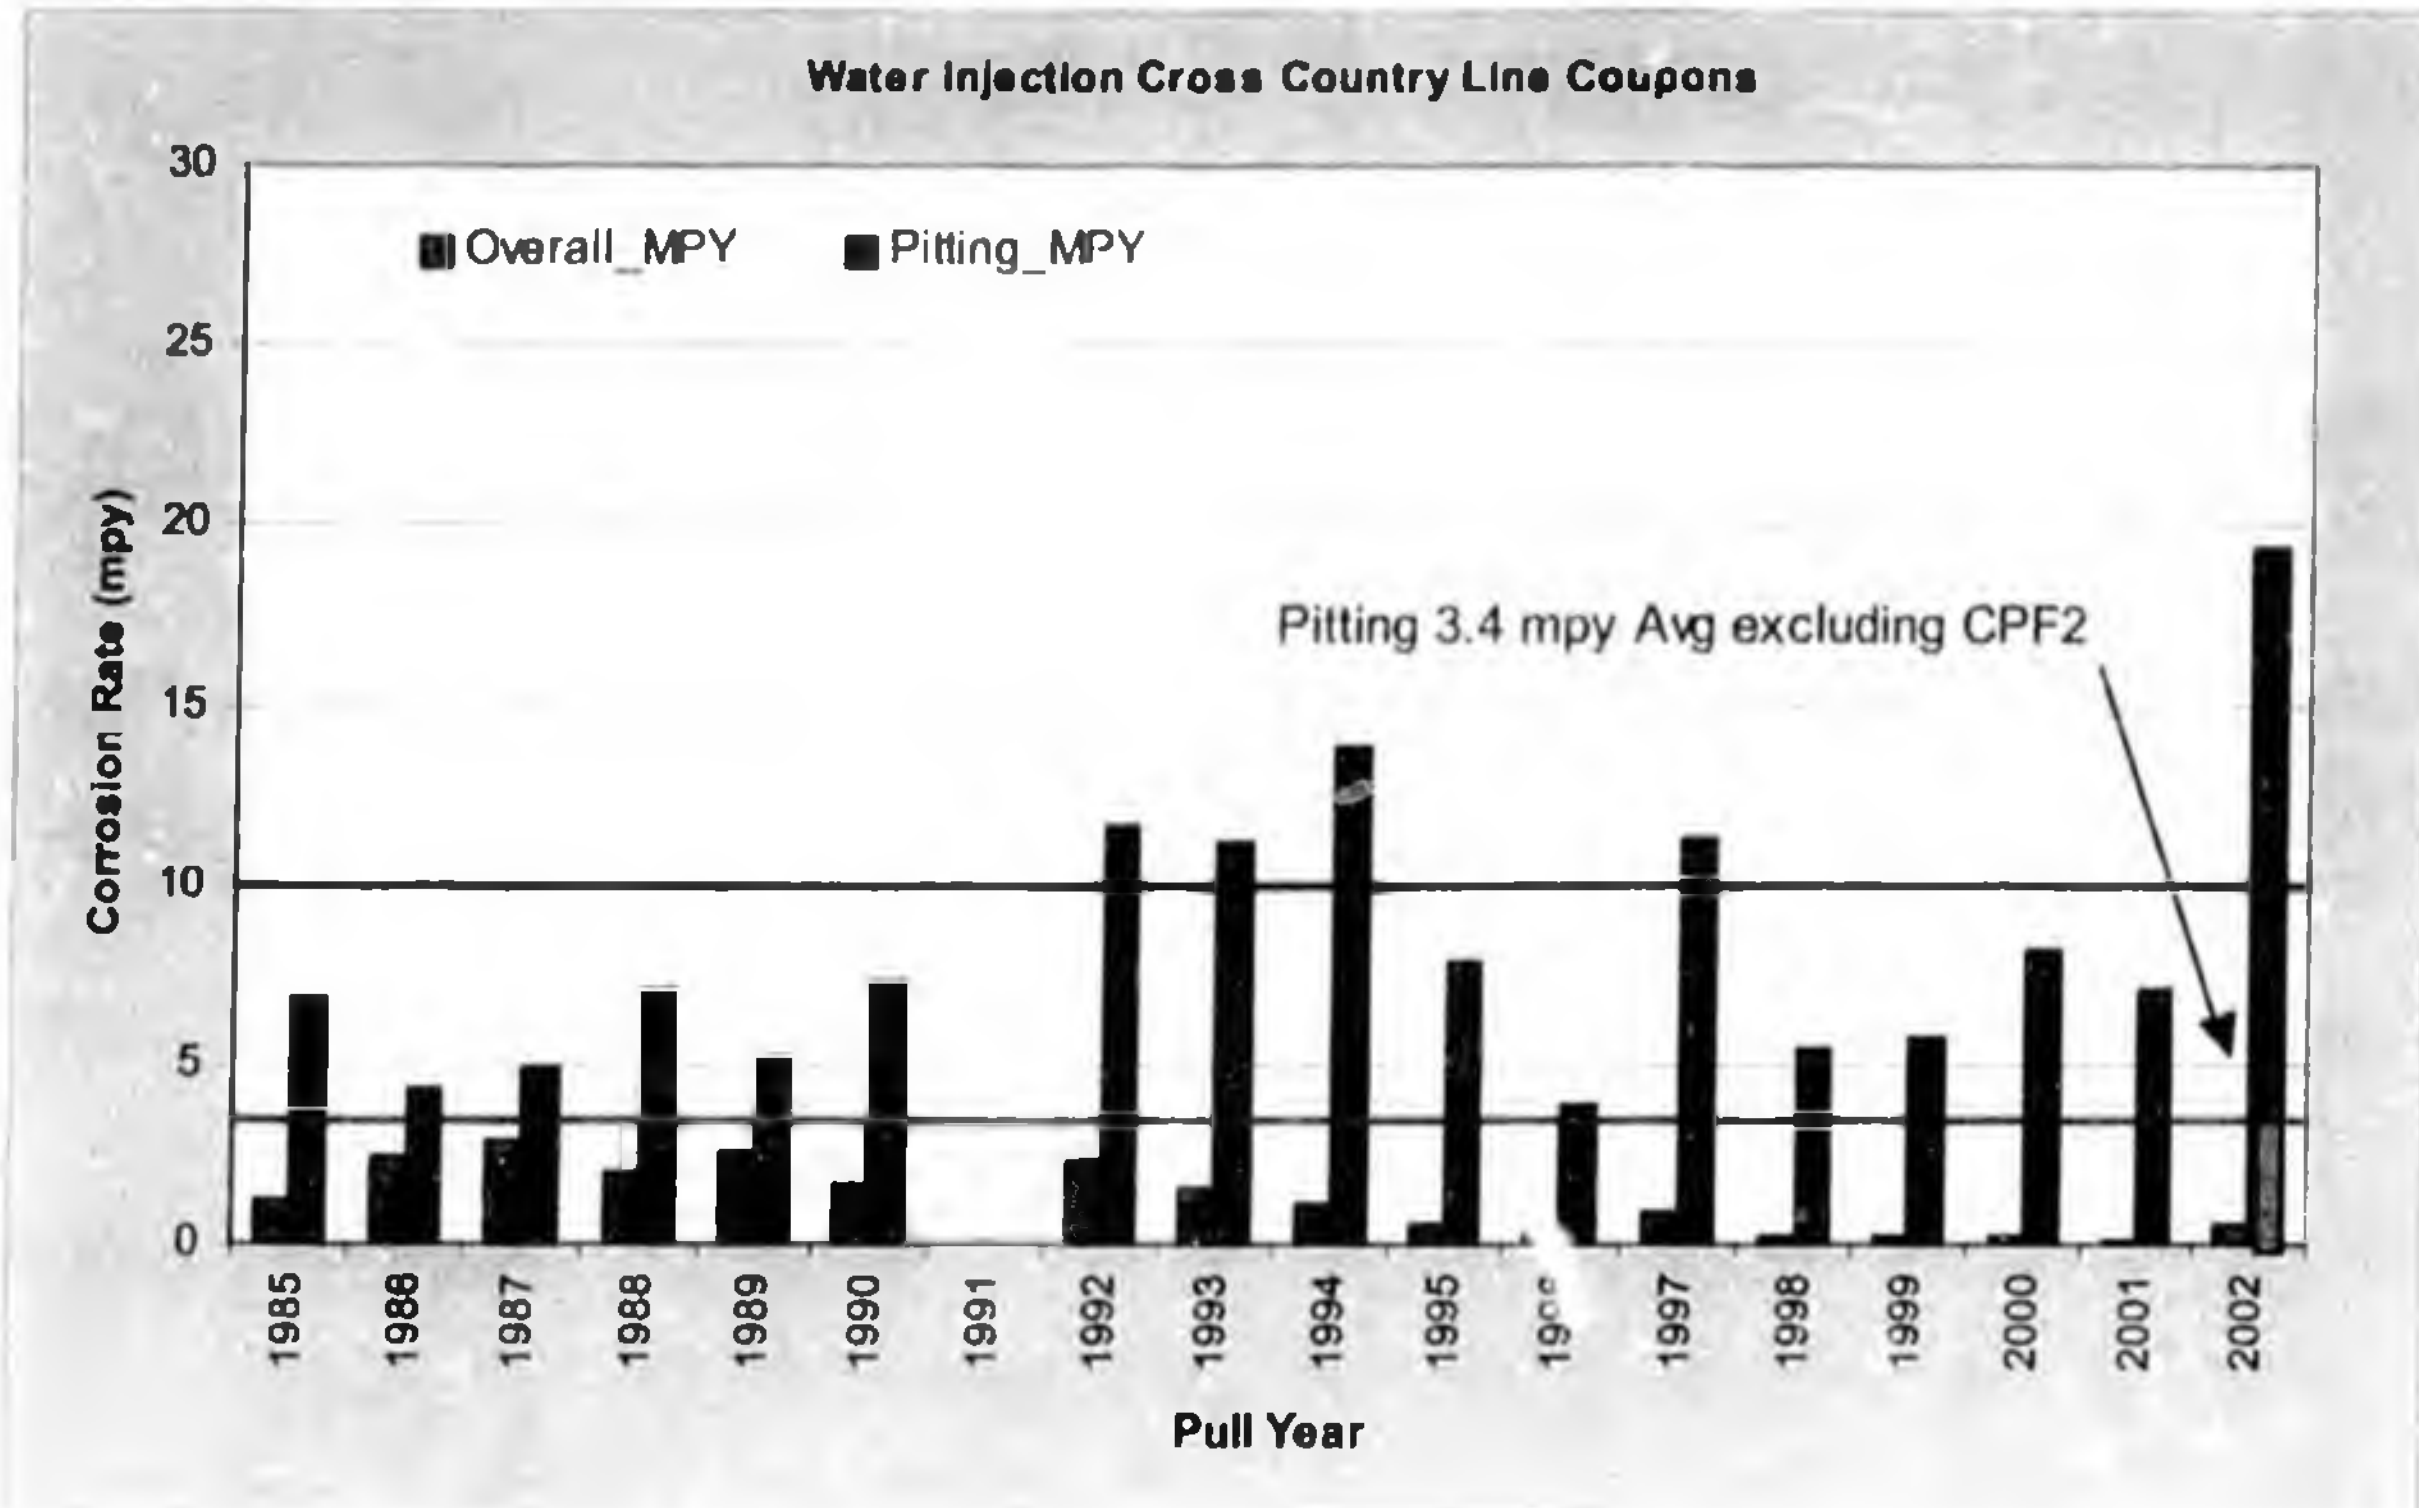
Figure 3. Water Injection Cross-Country Line Coupons – general and pitting corrosion rates as a function of time.

Mixed Water Injection Cross-Country Lines: The monitoring data summarized in Kuparuk Tables 1 and 2 and presented in Figure 3 show that average general corrosion rates are below the threshold, but that pitting rates for the field are above the threshold. Closer analysis of the data shows that the average pitting rate excluding CPF2 locations is well under the threshold. Recent inspection data from the CPF2 lines show some damage on three lines. This information, along with coupon results, was used to prioritize 2003 inspection efforts. RTR inspection work for 2003 will target 15,000 feet of cross-country water injection lines.
