ALASKA LEGISLATURE COMMITTEE FILES, 2005-2006 8672
11973 SENATE RESOURCES

Greater Kuparuk Area (GKA)
Alpine Field
Corrosion Programs Overview

Commitment to Corrosion Monitoring

Prepared by
ConocoPhillips Corrosion Team

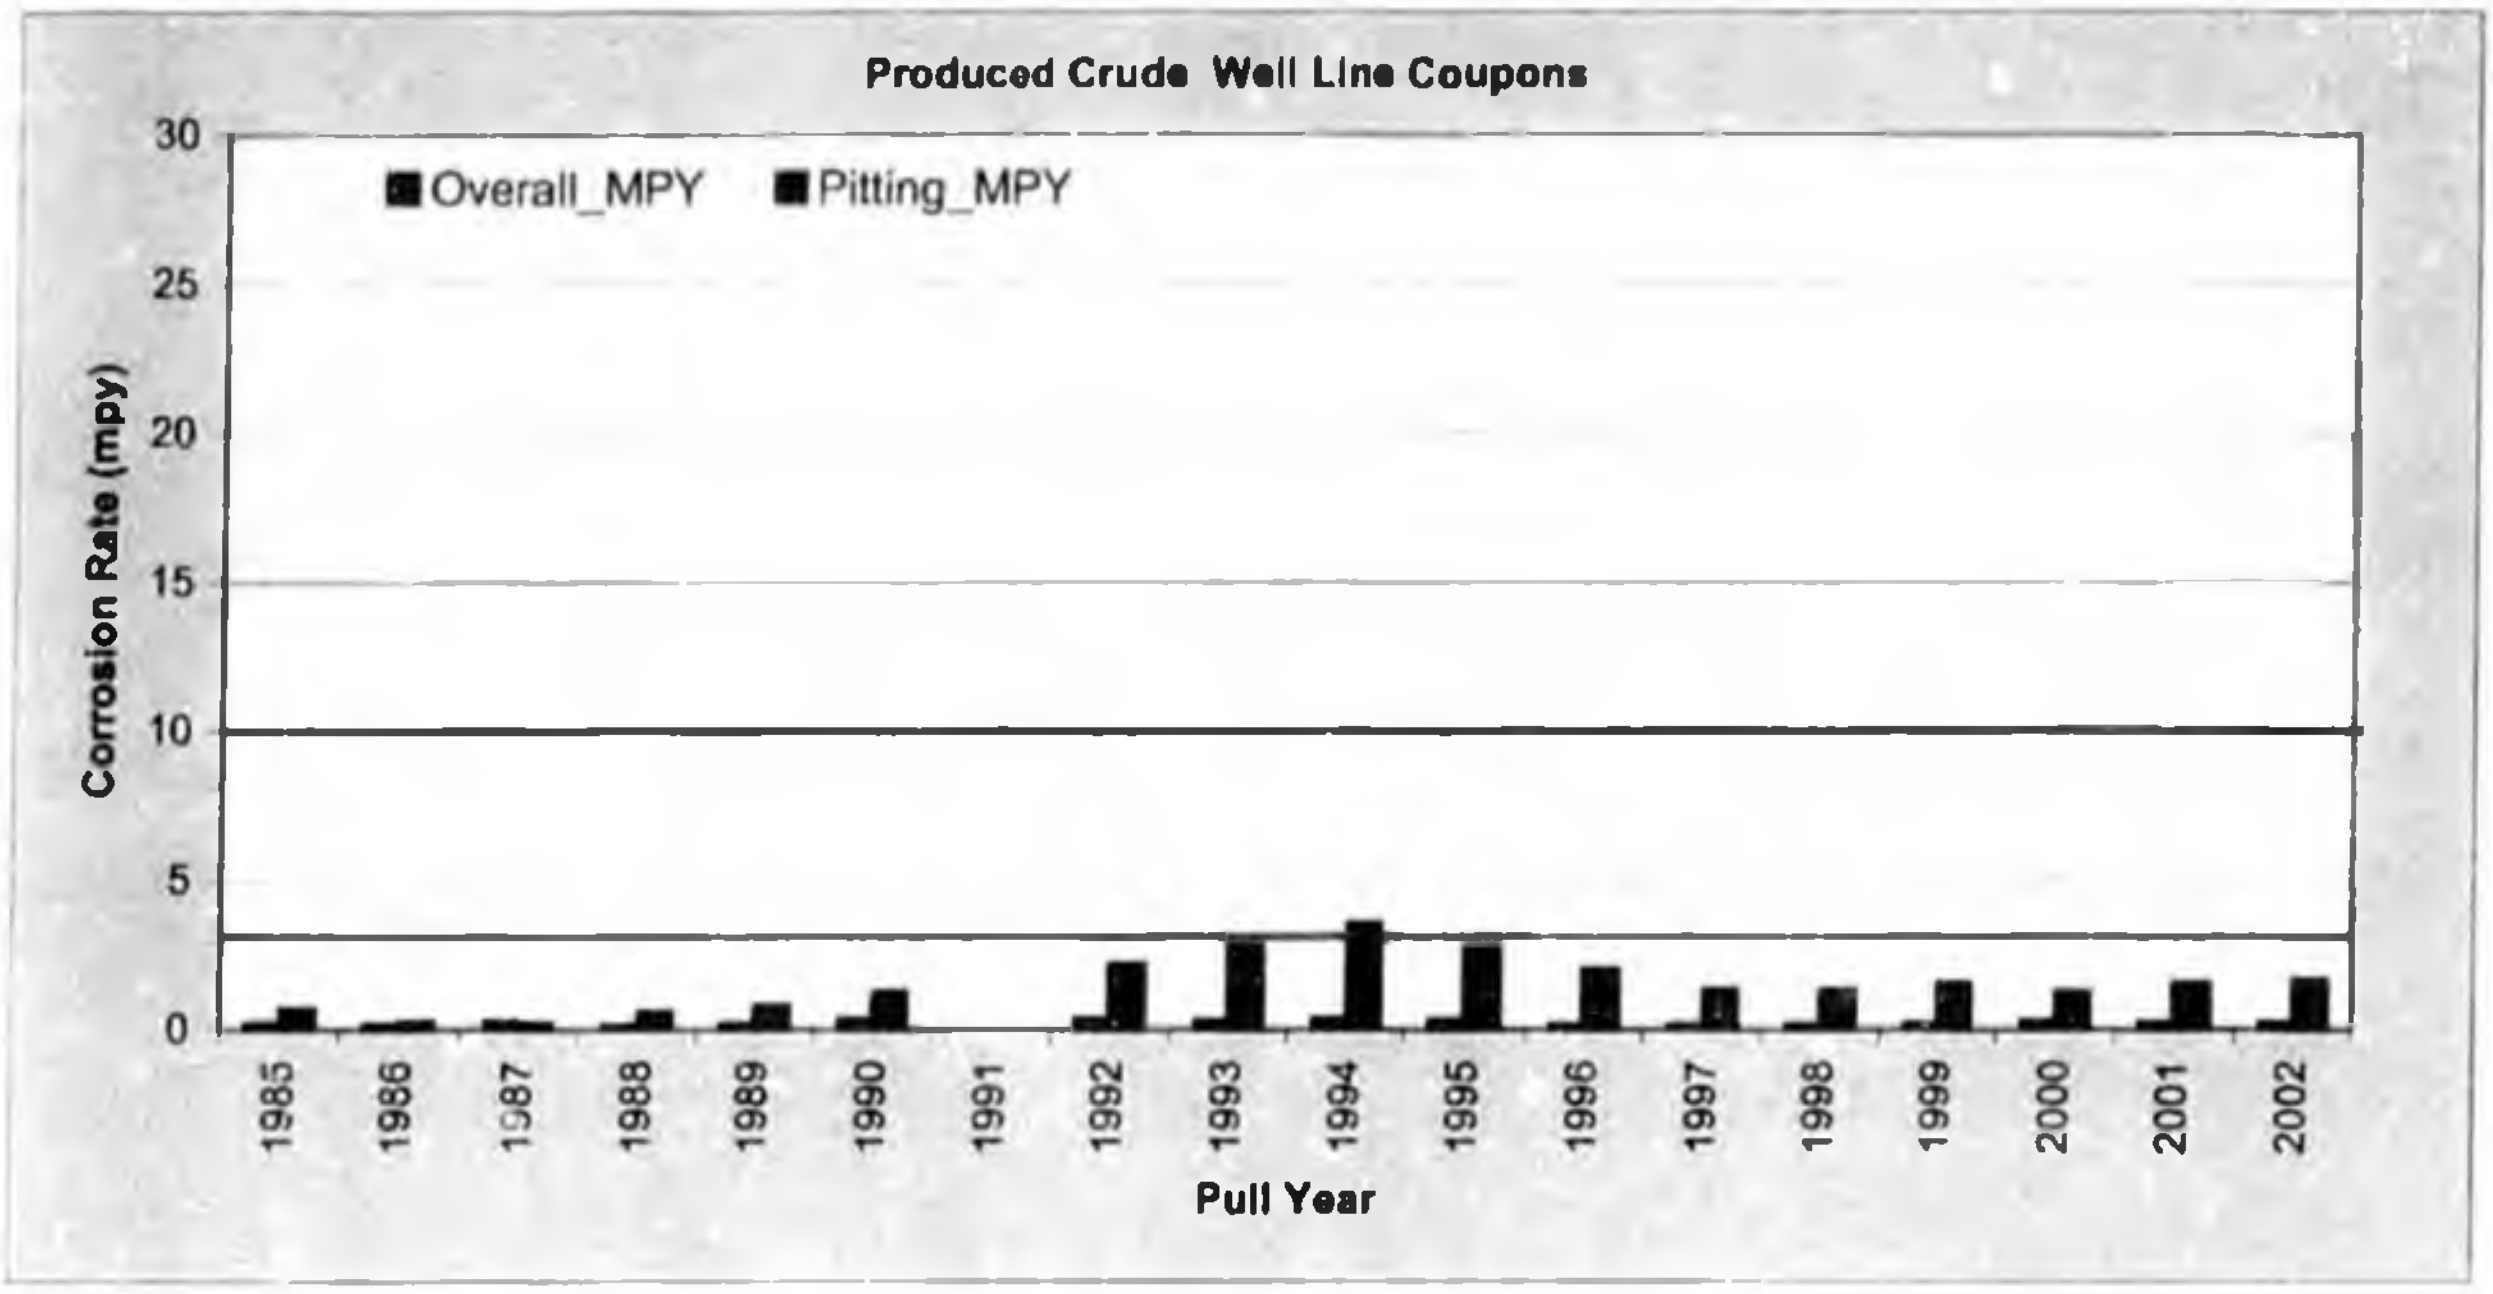
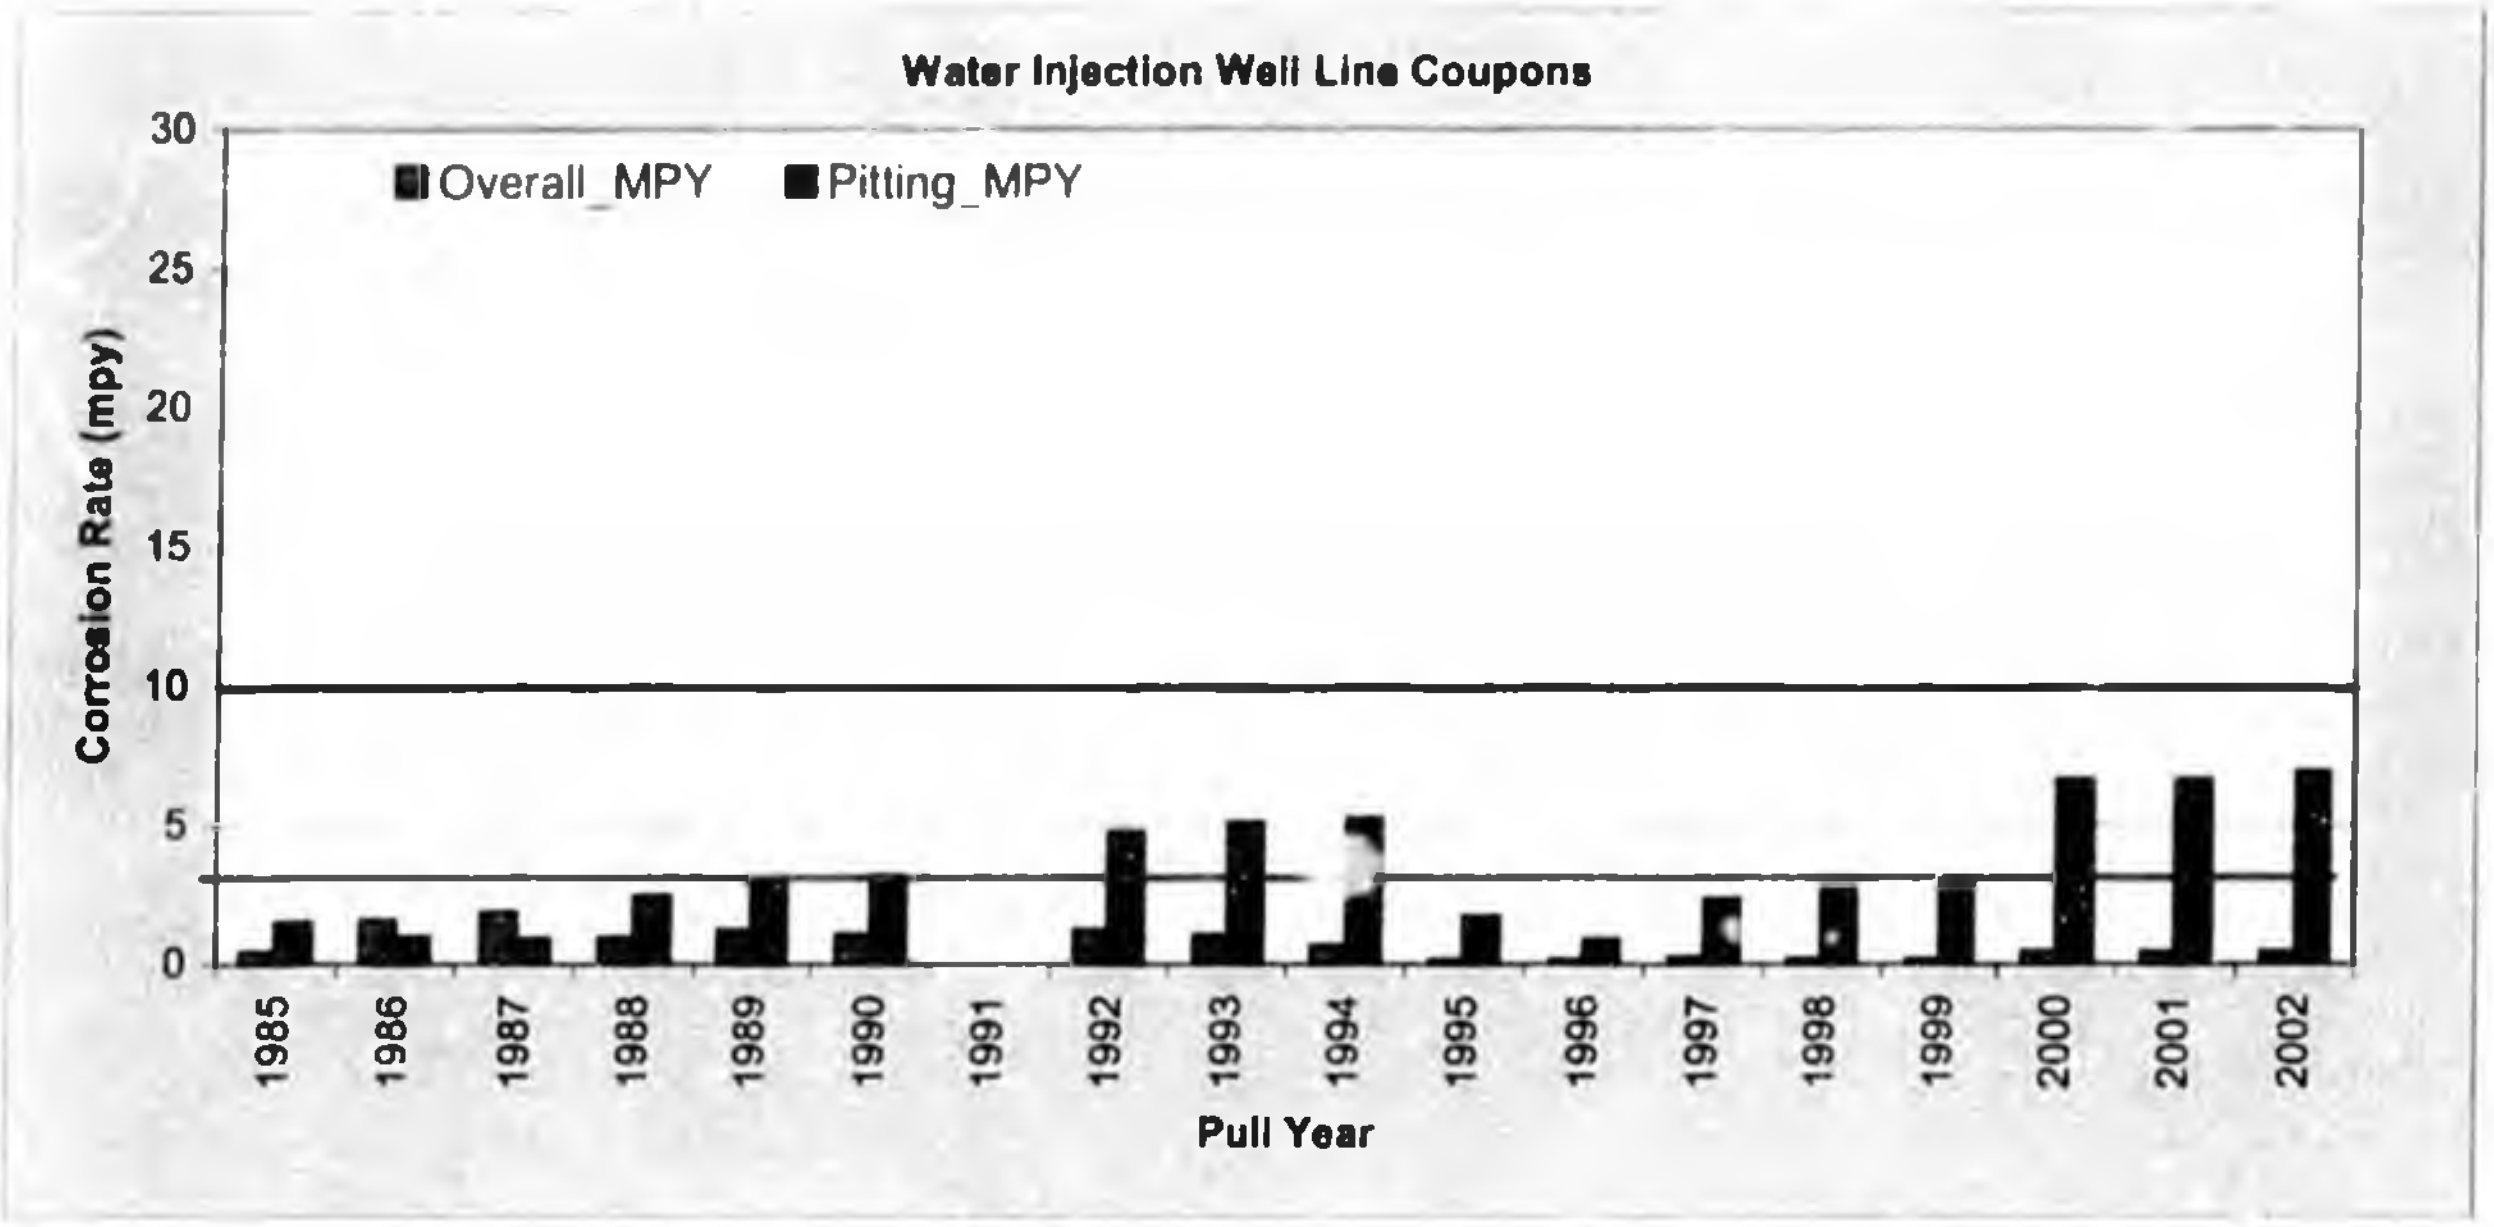
Figure 4. Three-phase Production Well Line Coupons – general and pitting corrosion rates as a function of time.

Three-phase Production and Mixed Water Injection Well Flow Lines: While the monitoring data summarized in Kuparuk Tables 1 and 2 and presented in Figures 4 and 5 suggest that corrosion rates are below targets, inspection data indicates that higher rates are actually being experienced. The well line inspection data are discussed in section 3.1.b below, and are a good example of why monitoring data alone cannot be relied upon to characterize corrosion in a given system.

Figure 5. Water Injection Well Line Coupons – general and pitting corrosion rates as a function of time.

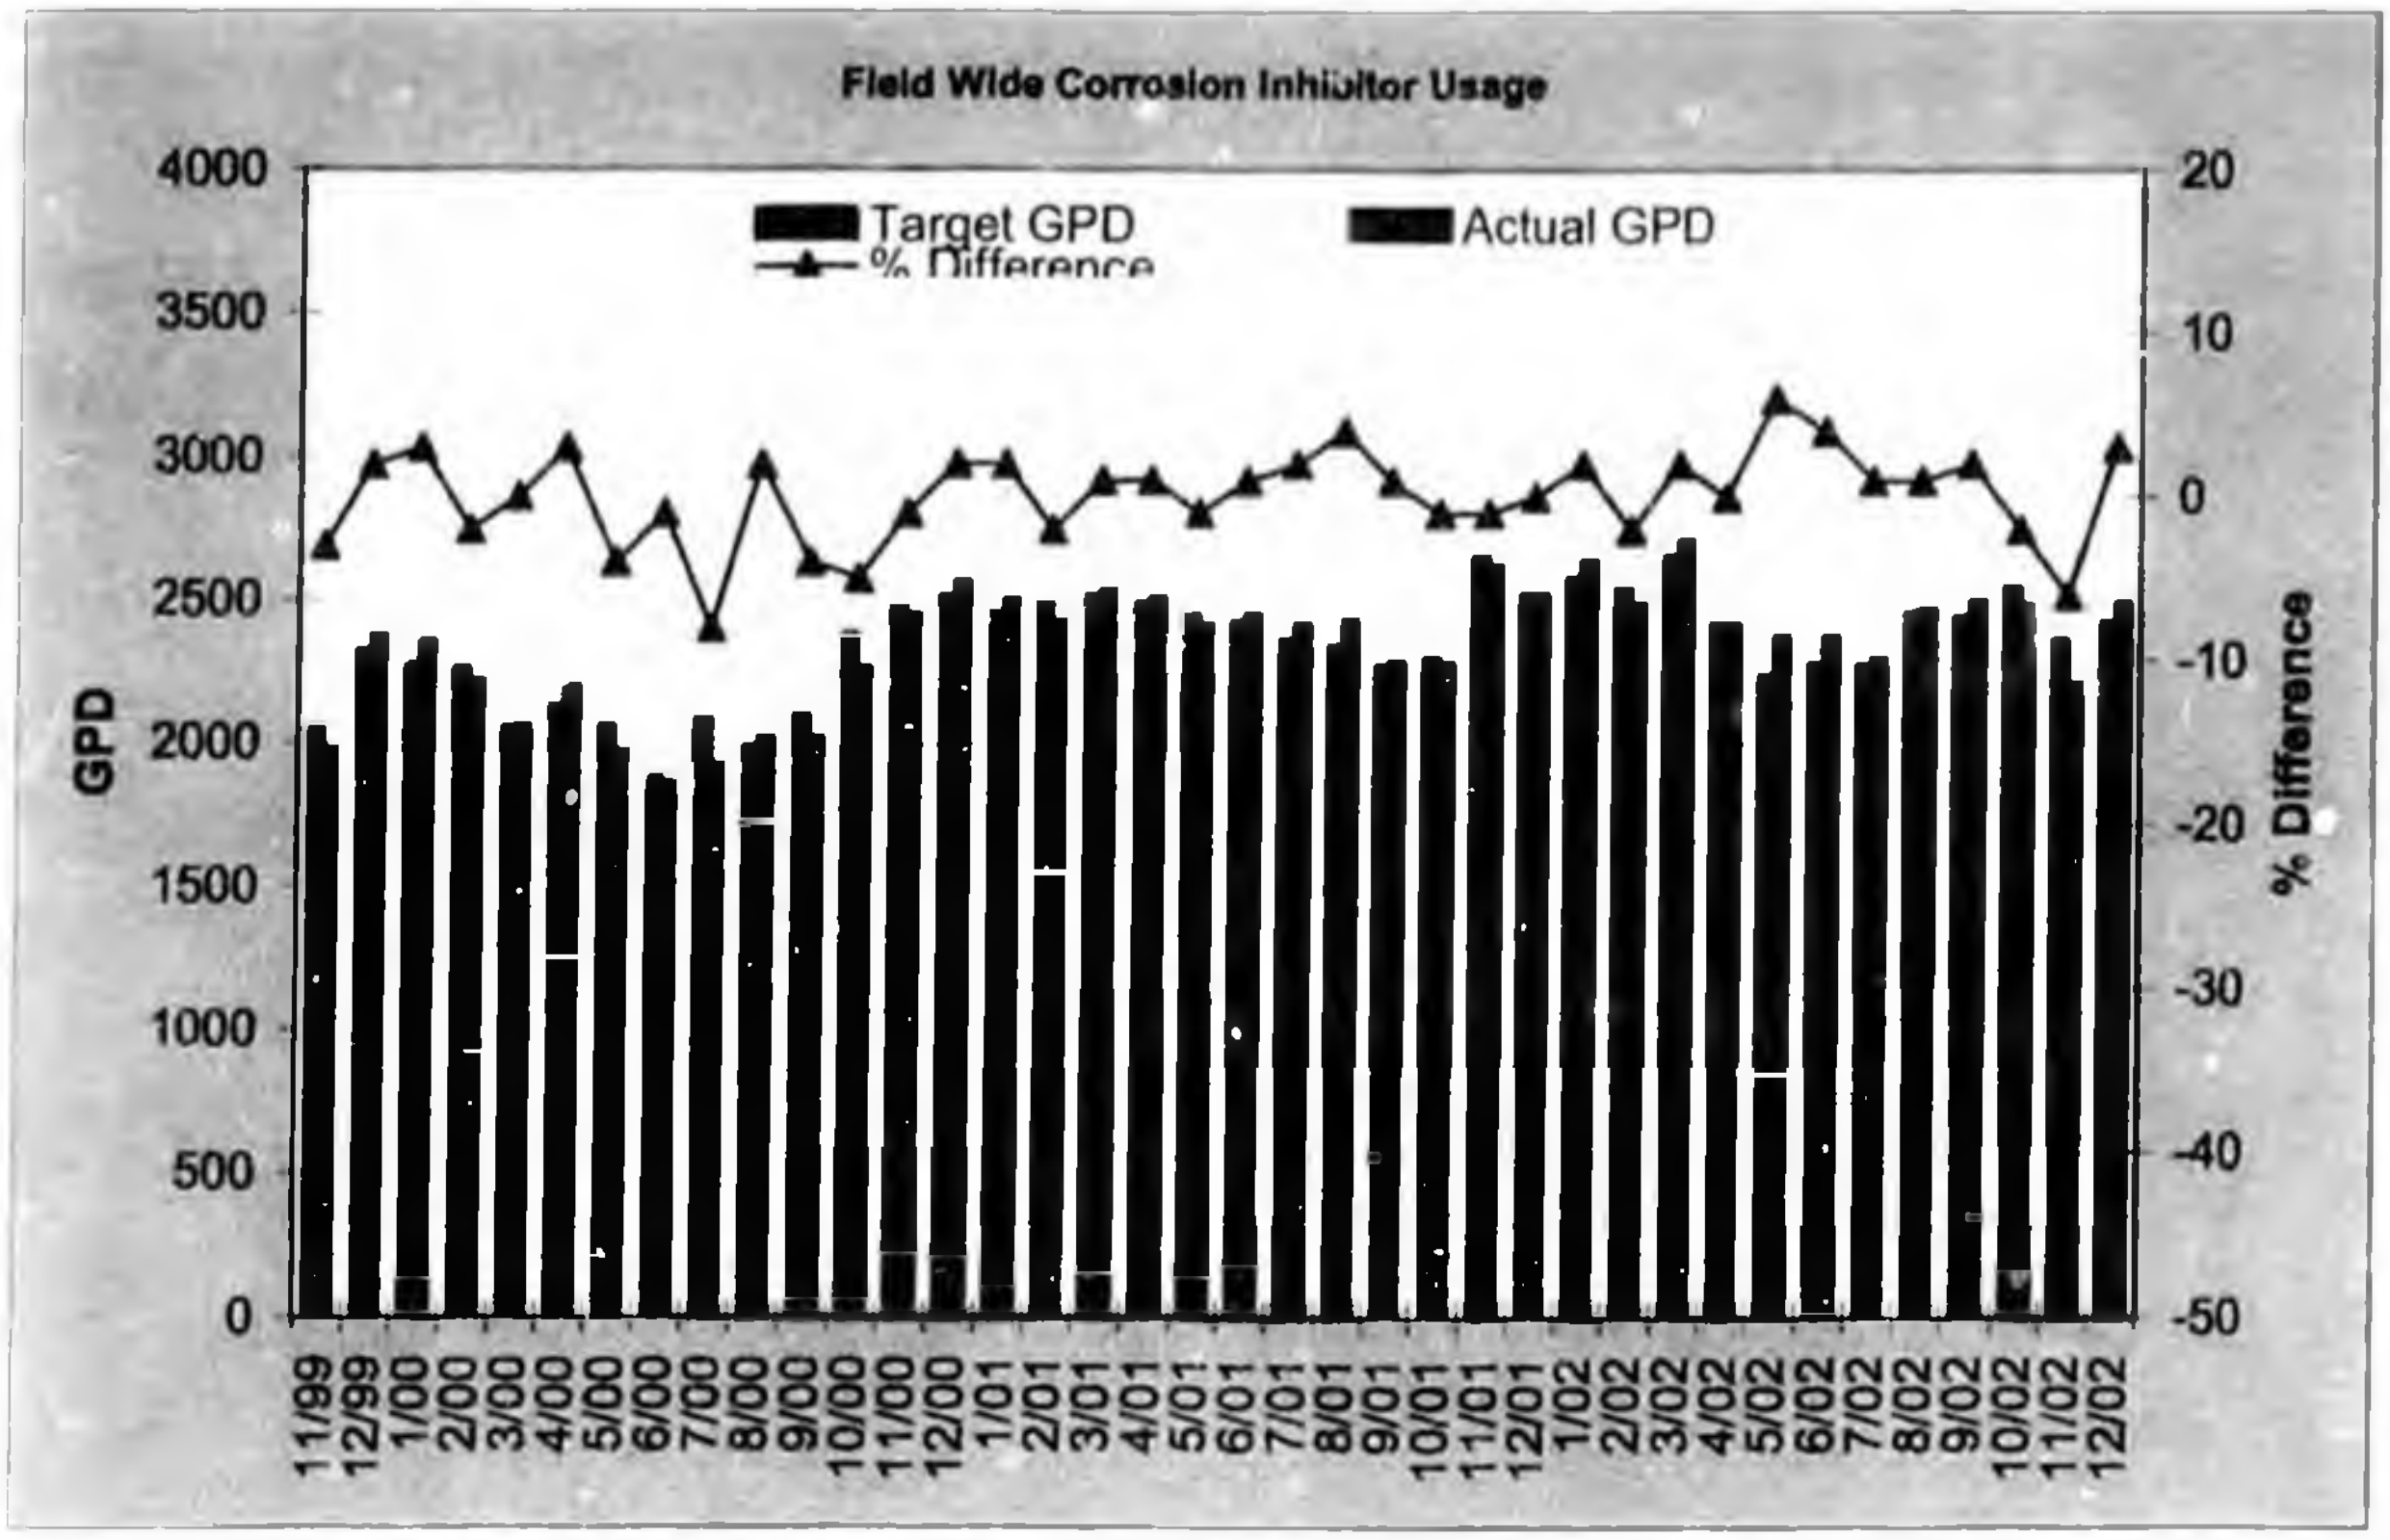
Figure 6. Field-wide Corrosion Inhibitor Use – actual amount of corrosion inhibitor used per day, recommended amount of corrosion inhibitor used per day, and the percent difference between the actual and the recommended amounts.

For the Kuparuk field, Figure 6 shows the actual number of gallons of corrosion inhibitor pumped per day, the recommended number of gallons of corrosion inhibitor per day, and the percent difference between the two. The difference fluctuated around zero percent deviation from the recommended amount of corrosion inhibitor; the average deviation for the year was 0.9%. The extreme variation seen in the November data was caused by the production upsets associated with the earthquake prorations.

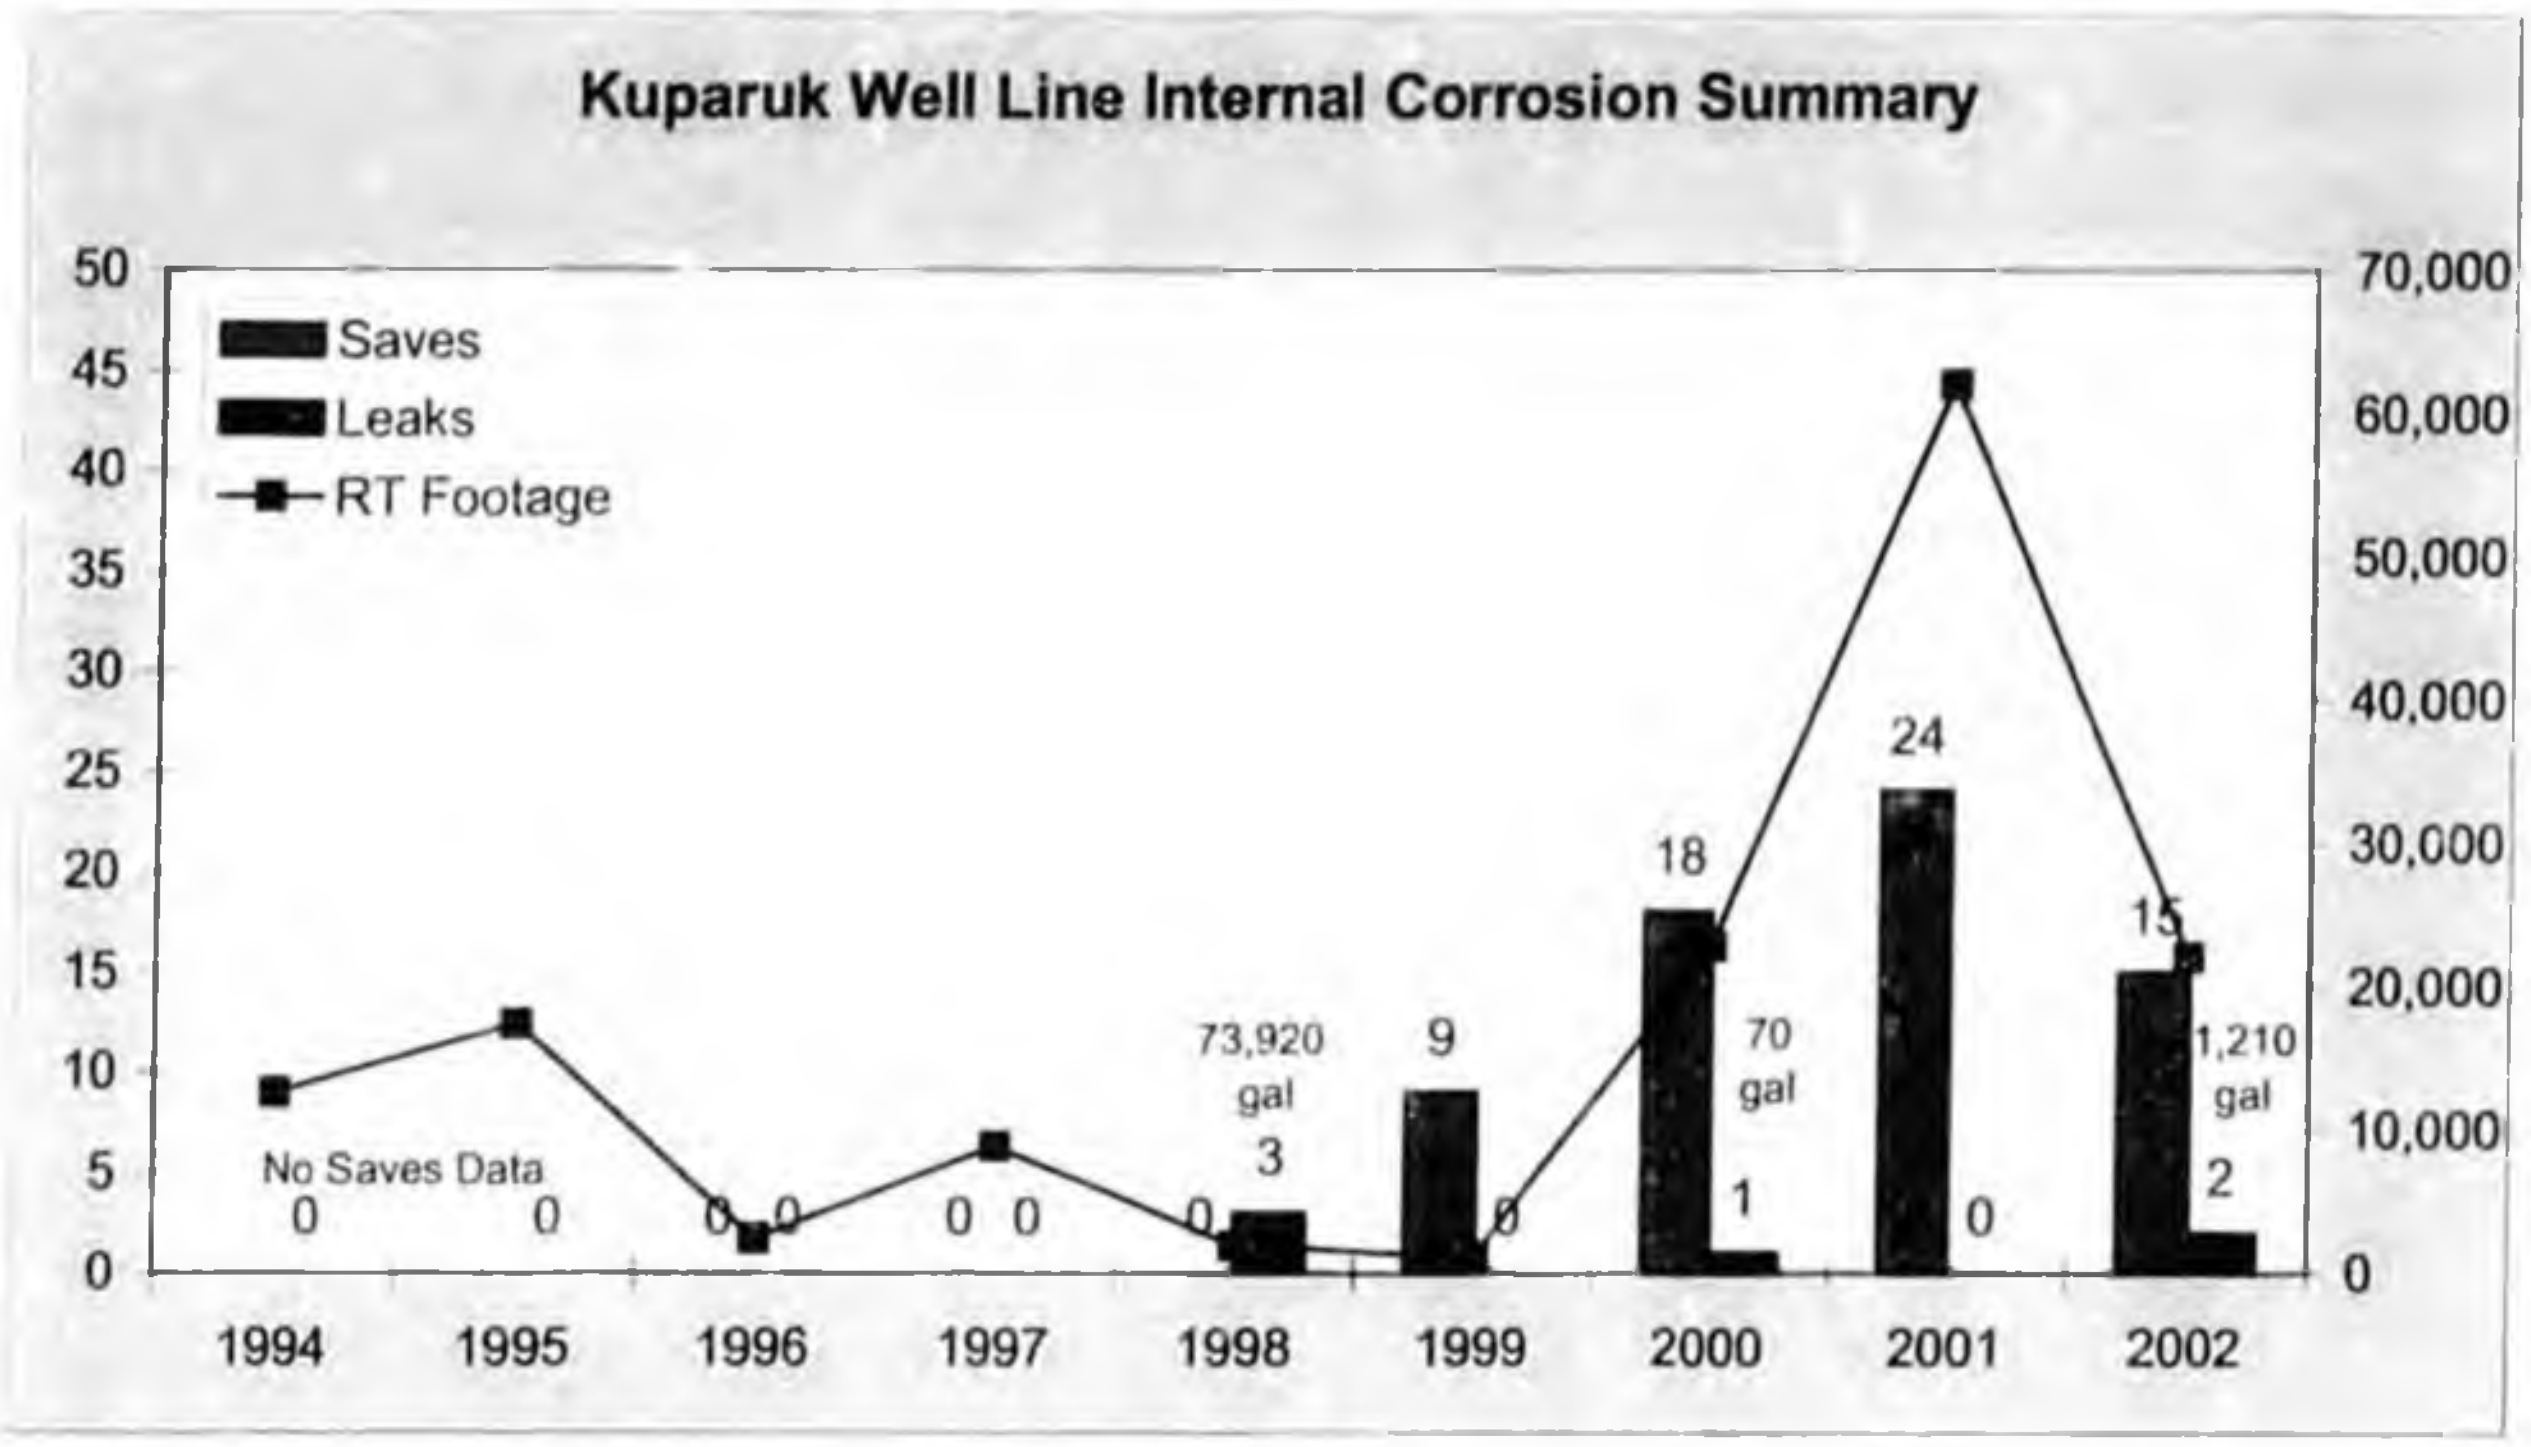
As indicated in Figure 8 below, repair recommendations were initiated on 17 lines (8 injection, 9 production) in 2002 because of internal corrosion damage. The two leaks were on production lines. Repairs typically consist of either sleeving or replacing the de-rated section of line. The graph indicates a decrease in inspection footage from 2001 to 2002. This was the first year we encountered well lines with obstructions that did not allow efficient use of the RTR crawler. As a result, these lines required manual RT as the primary inspection method. We met our primary 2002 goal of inspecting all well lines with a 0.312" nominal pipe wall thickness.

Figure 8. Summary of Well Line Internal Corrosion Inspections – RT footage, leaks, and saves as a function of time.

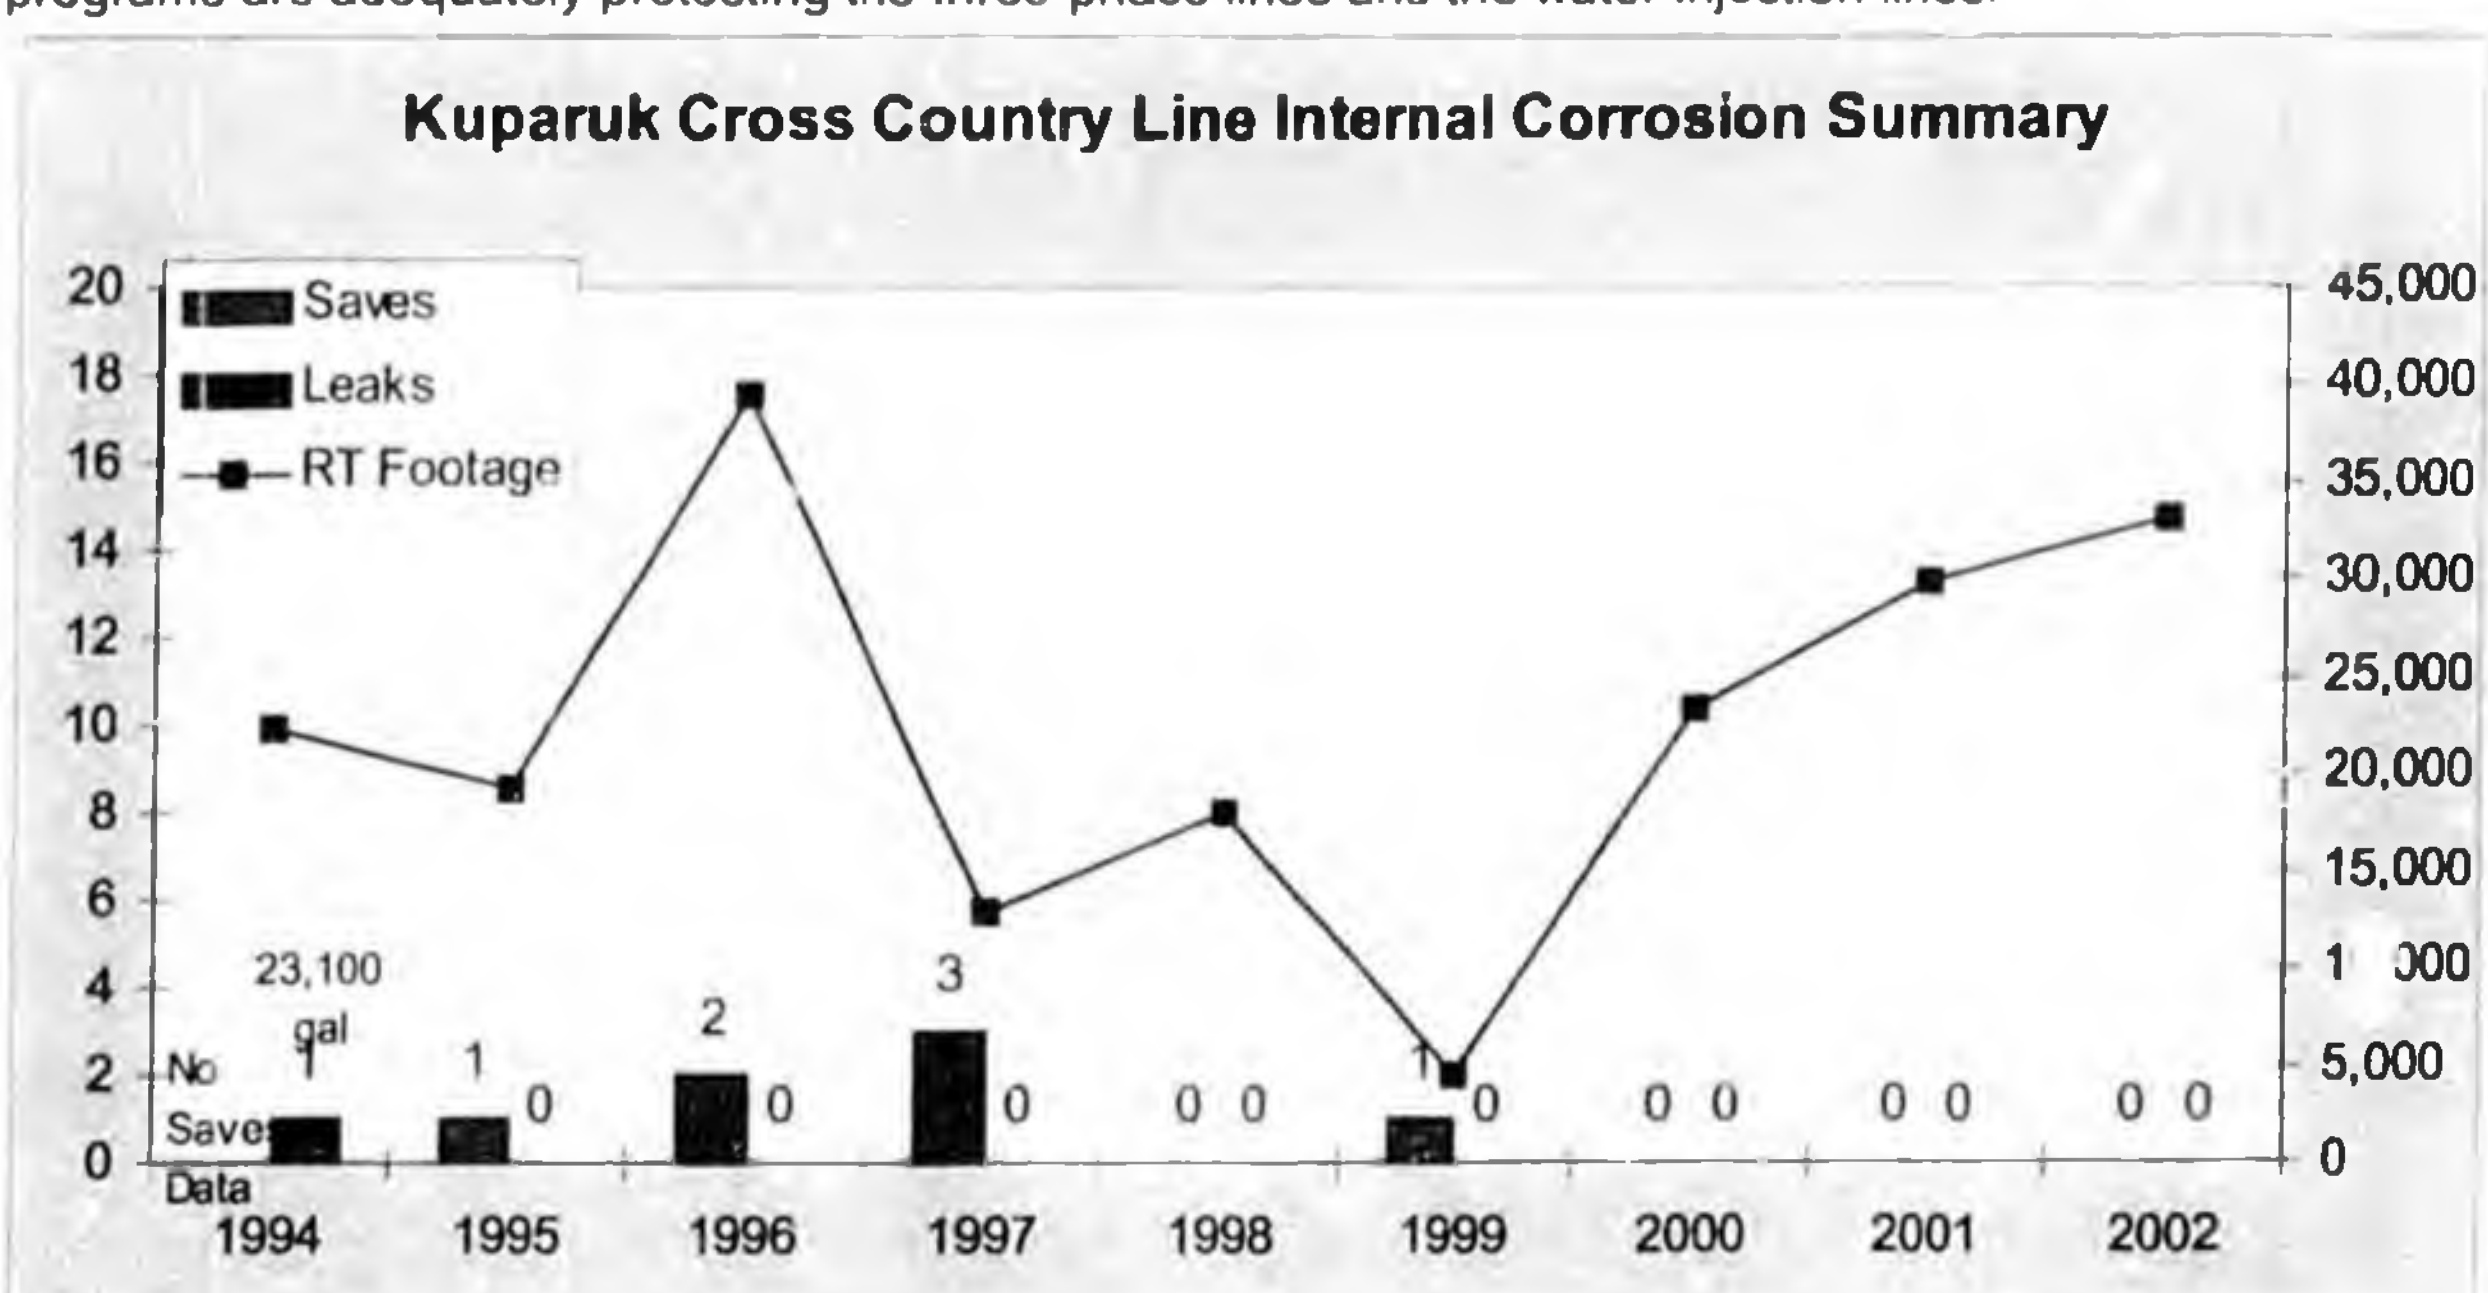
As indicated in Figure 9, no (0) repair recommendations were initiated on cross-country lines because of internal corrosion damage in 2002. Inspection results in Figure 9 indicate that the corrosion mitigation programs are adequately protecting the three-phase lines and the water injection lines.

Figure 9. Summary of Cross-Country Line Internal Corrosion Inspections – RT footage, leaks, and saves as a function of time.

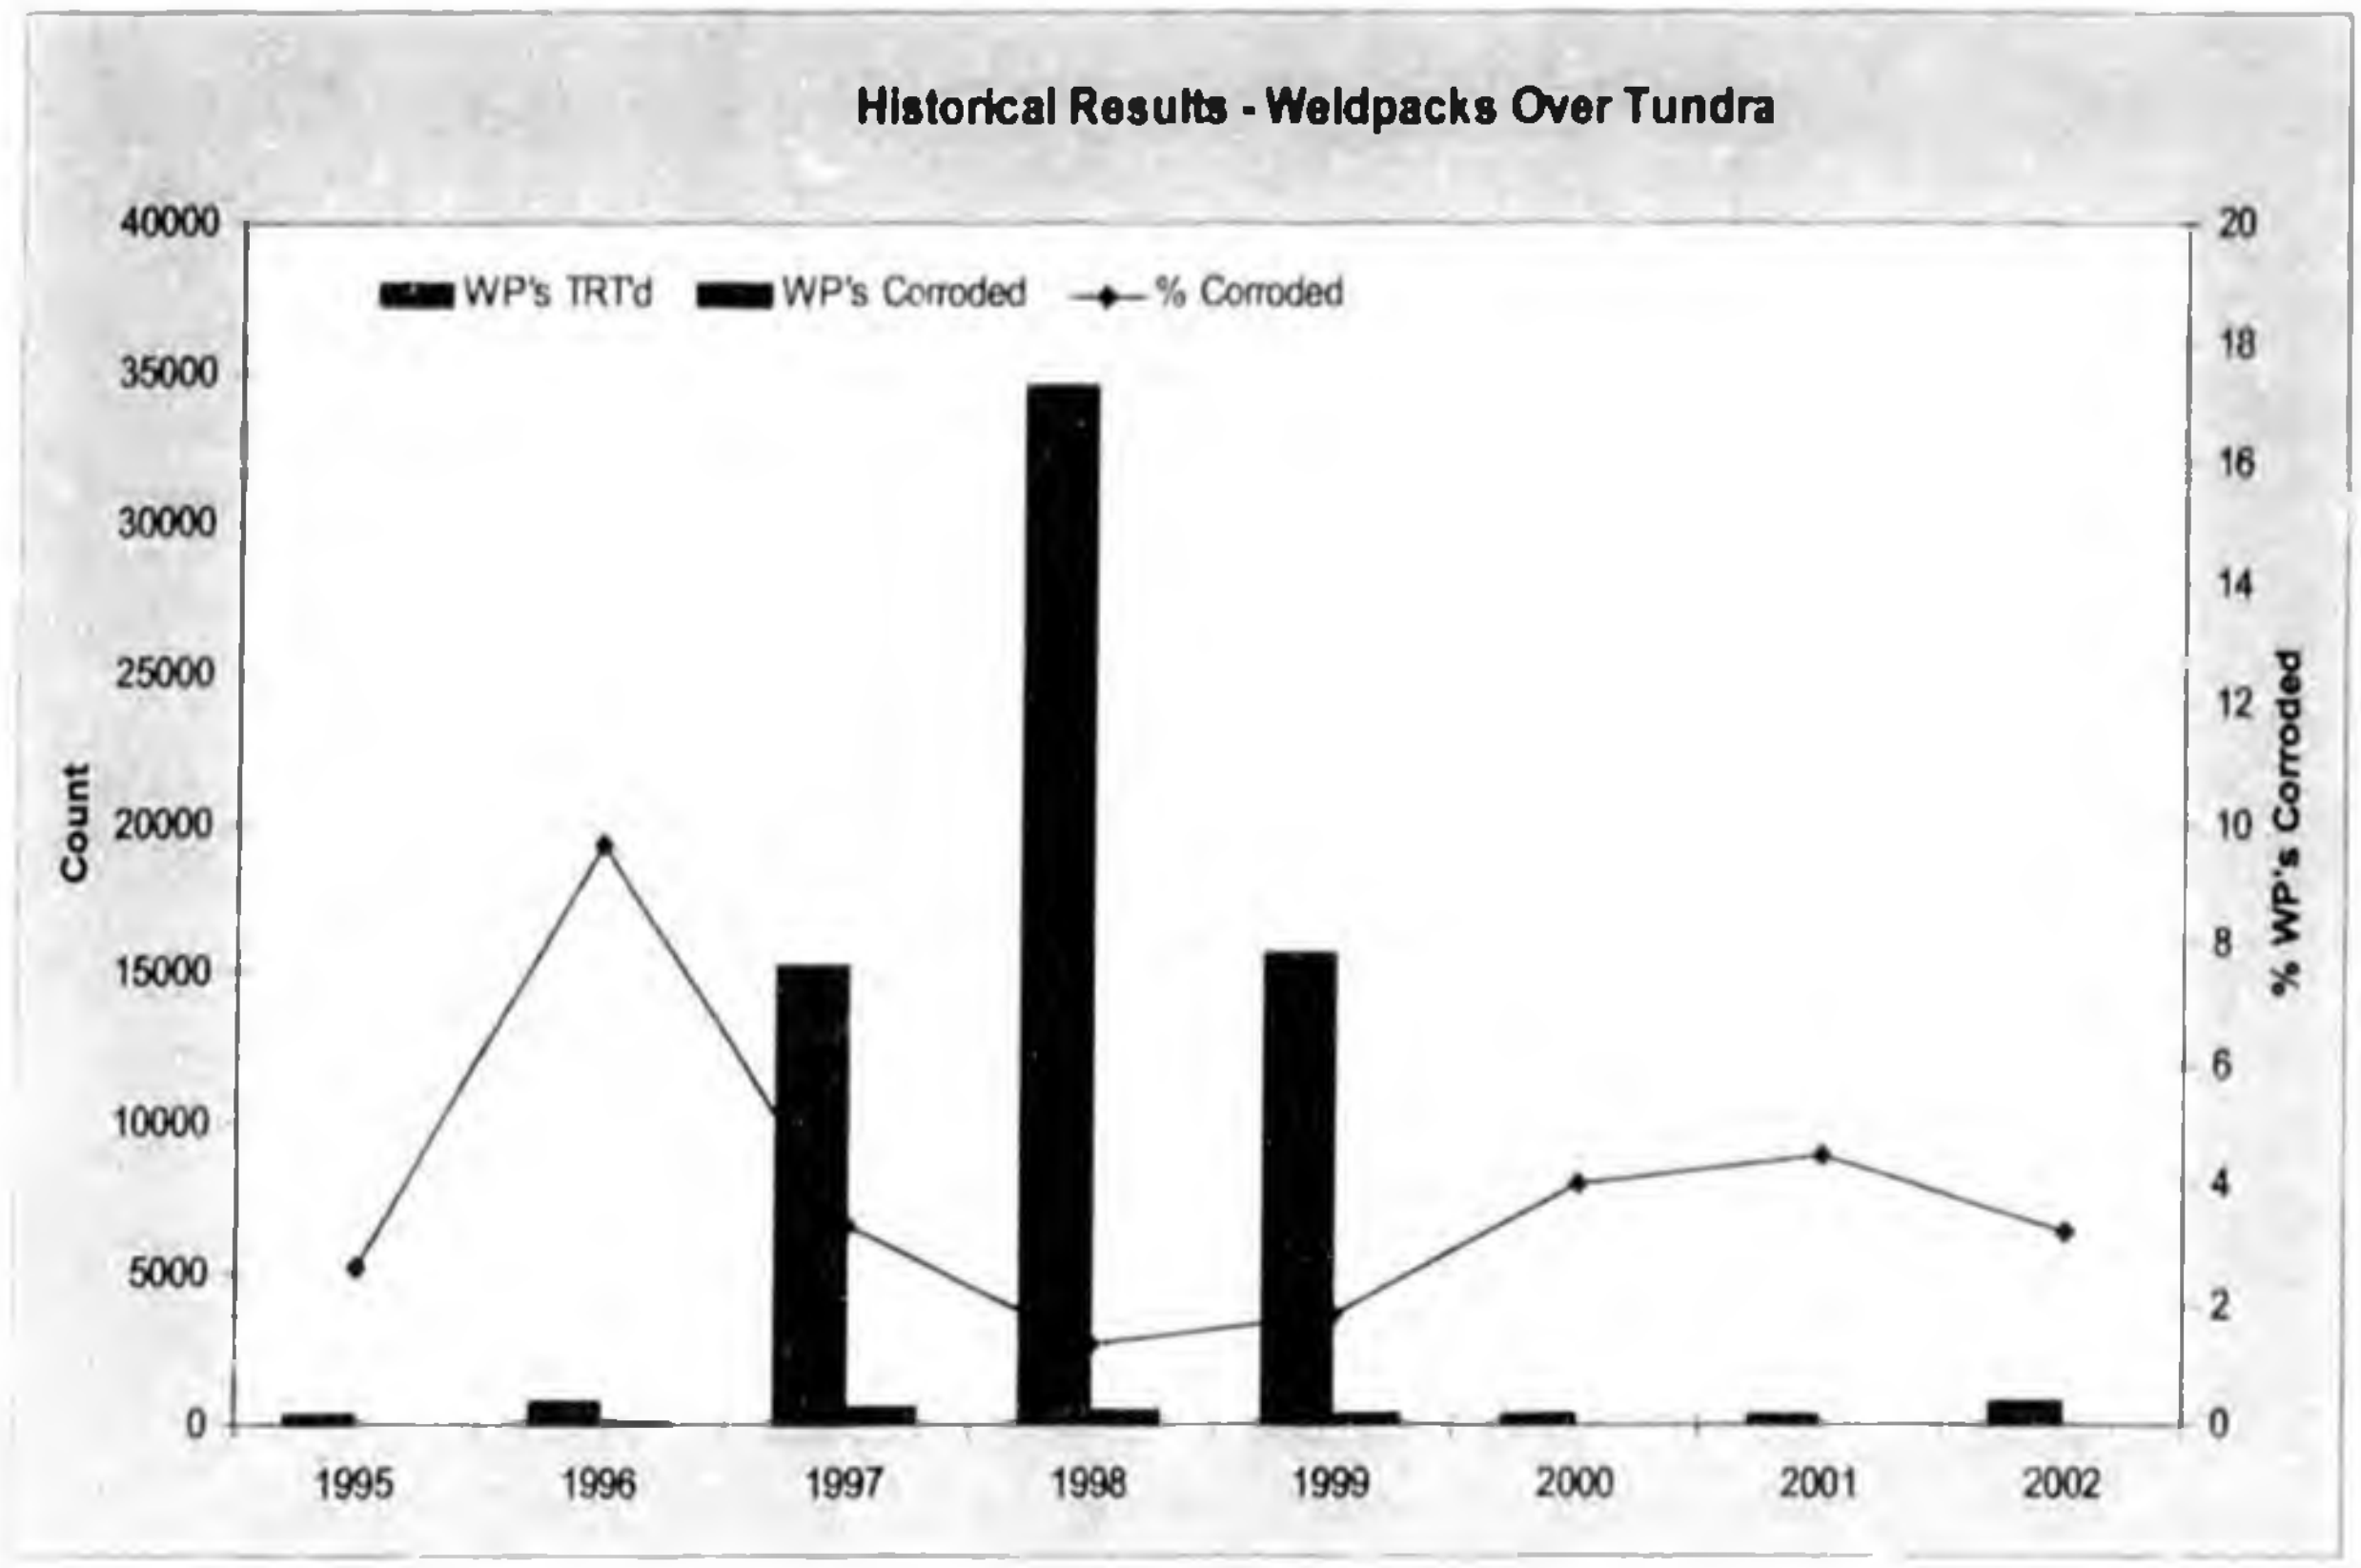
Figure 10. Summary of Weld Packs on Cross-Country Lines over Tundra (off-pad) – number of weld packs inspected, number of weld packs corroded, and percent of weld packs corroded.

Figure 10 illustrates the most-mature external corrosion inspection program of the three external corrosion programs. A review of results, obtained early in this program was initiated in 2002. A larger recur inspection program for these weld packs is scheduled to begin in 2003.
