ALASKA LEGISLATURE COMMITTEE FILES, 2005-2006 8672
11973 SENATE RESOURCES

Greater Kuparuk Area (GKA)
Alpine Field
Corrosion Programs Overview

Commitment to Corrosion Monitoring

Prepared by
ConocoPhillips Corrosion Team

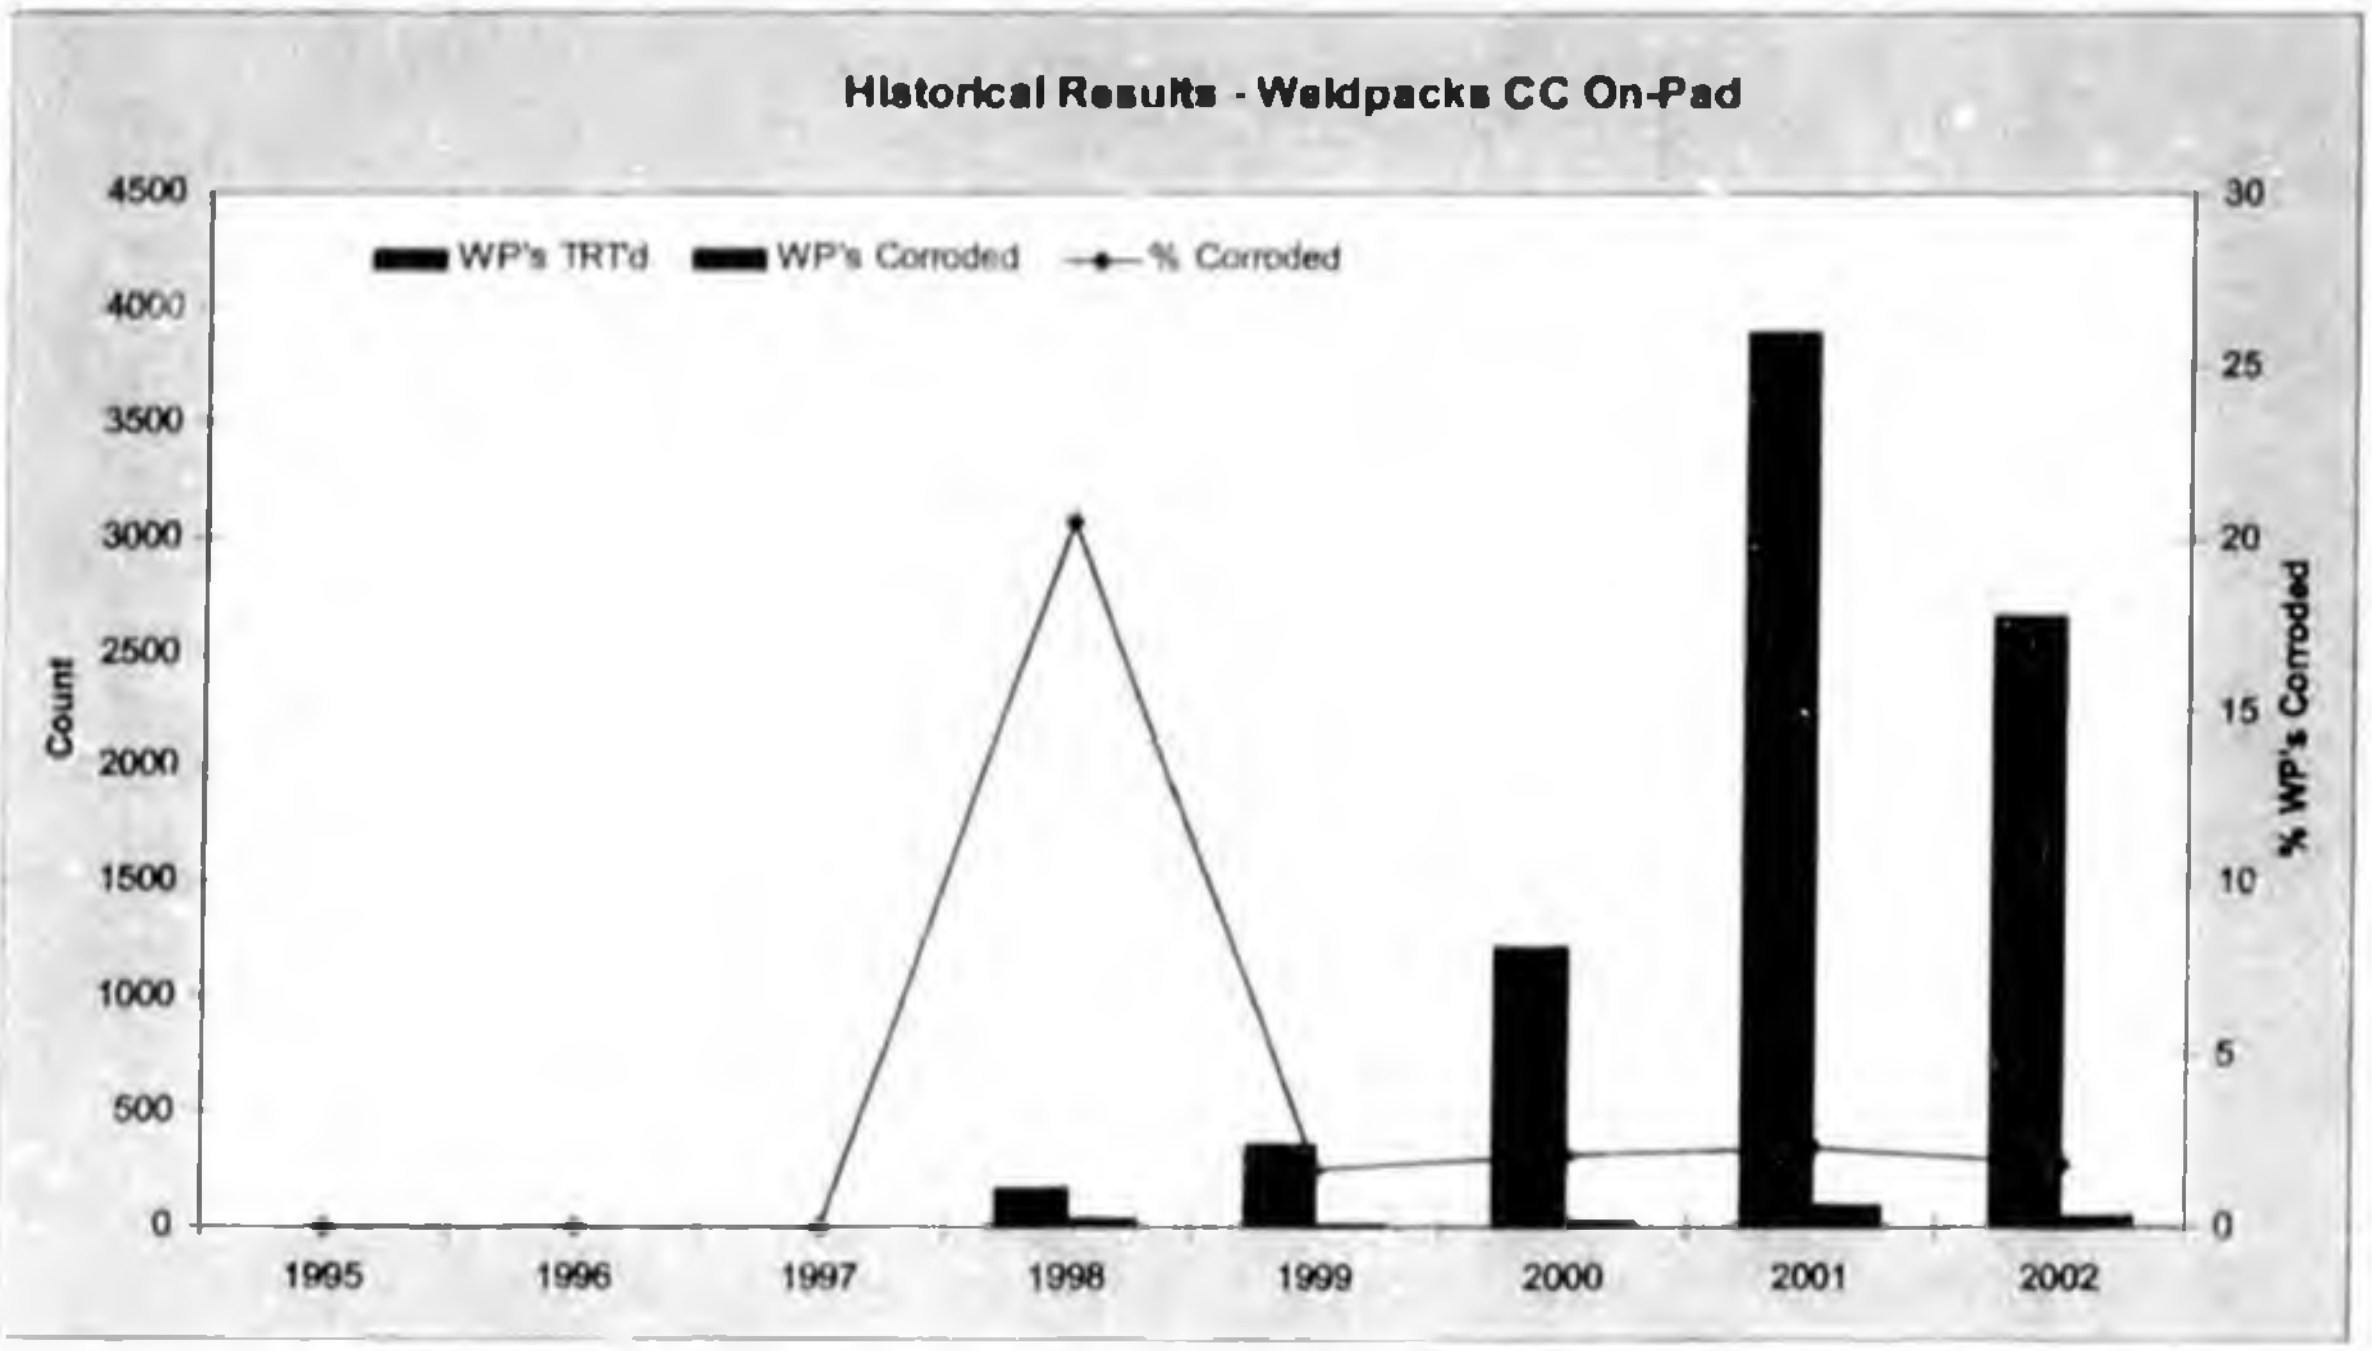
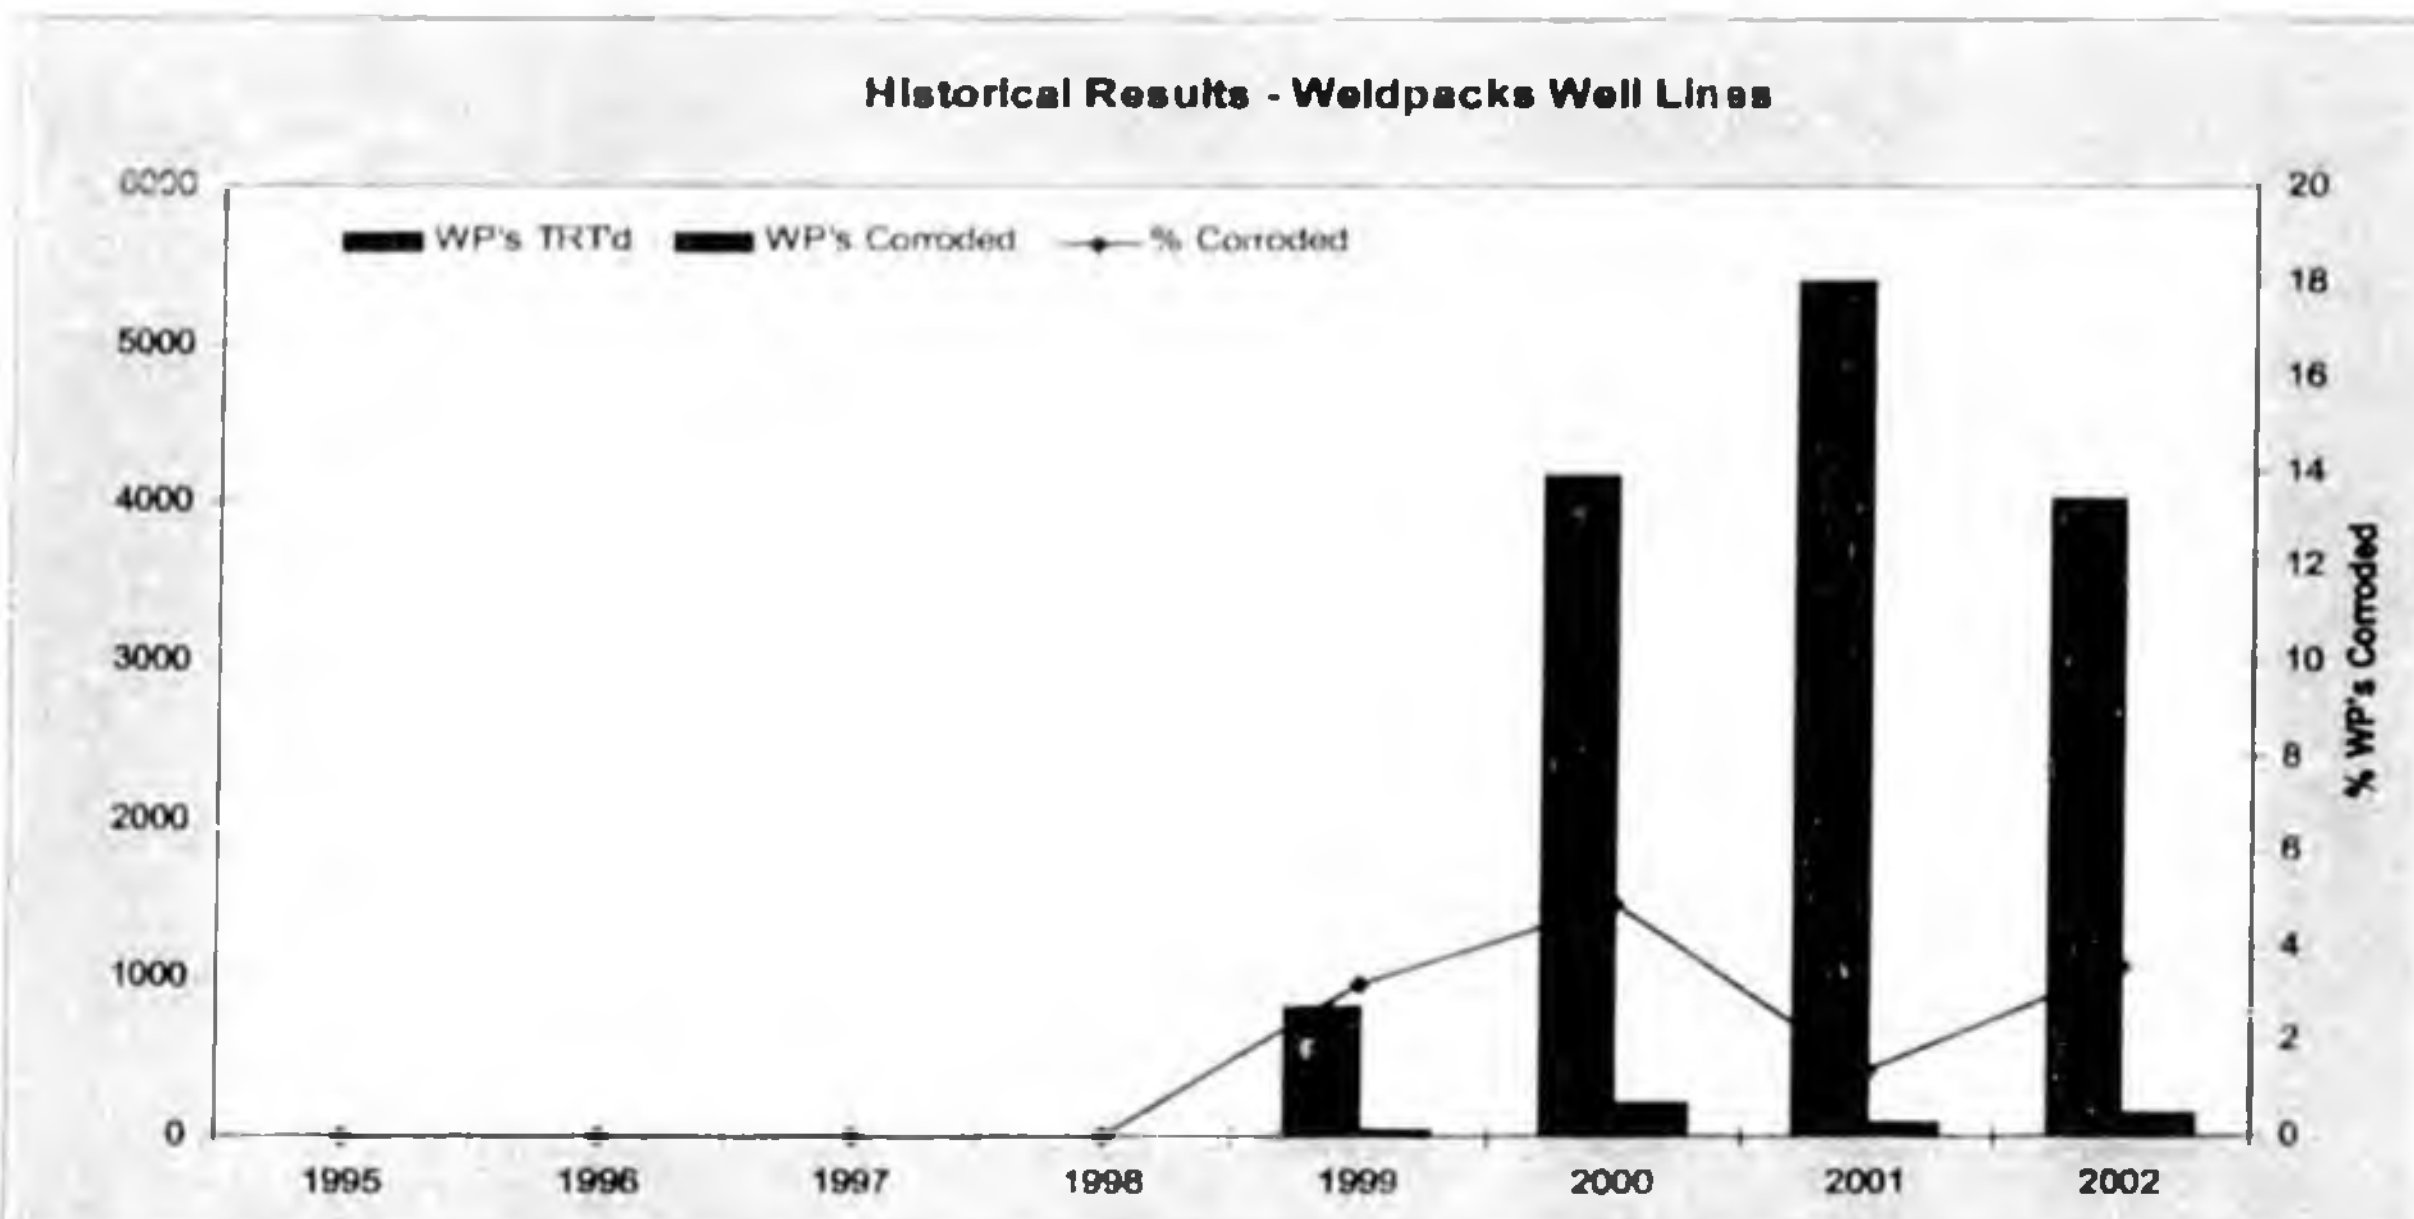
Figure 11. Summary of Weld Packs on Cross-Country Lines on Pads – number of weld packs inspected, number of weld packs corroded, and percent of weld packs corroded.

Figures 11 and 12 depict the results of the major focus of the external weld pack inspection program in 2002. The cross-country on-pad weld packs were inspected using a prioritization scheme based on the historical corroded-to-wet ratios of the over-tundra portions of the cross-country lines. The well line weld-packs were inspected using a prioritization scheme that examined the oldest, the hottest, and thinnest-walled lines first. As of year-end 2002, 92% of the cross-country on-pad weld-packs and 60% of the well line weld-packs have received their baseline TRT inspection.

Figure 12. Summary of Weld Packs on Well Lines – number of weld packs inspected, number of weld packs corroded, and percent of weld packs corroded.

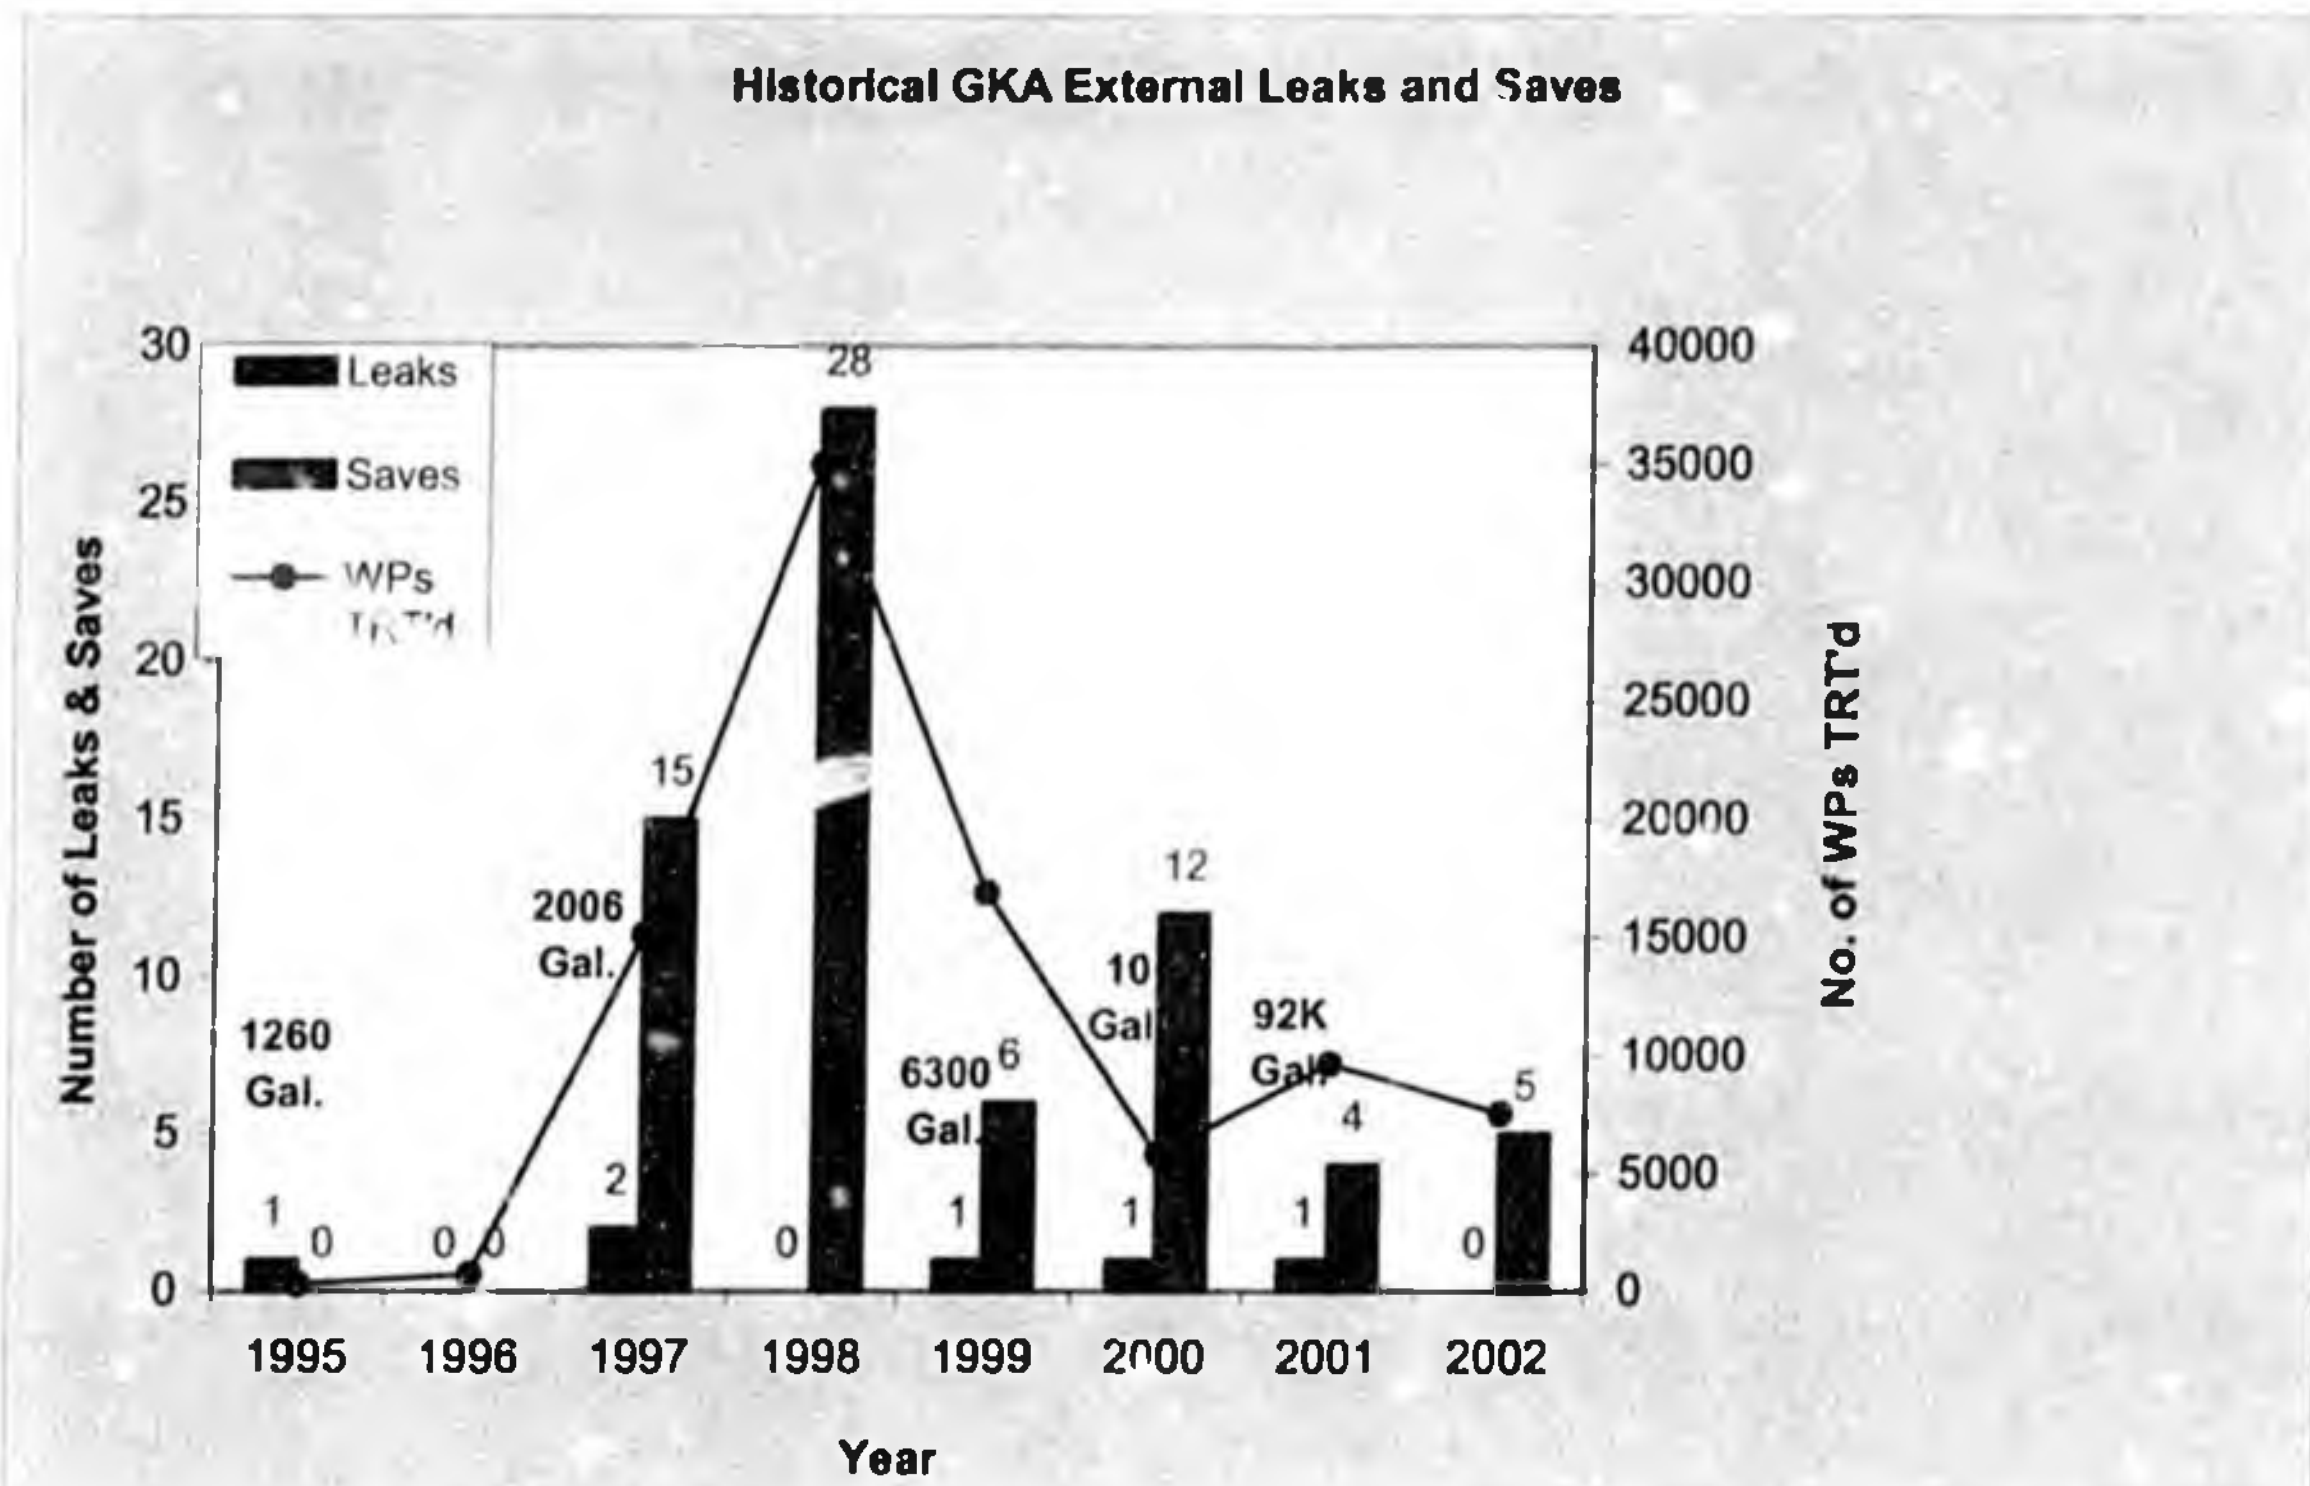
Figure A1. Leaks, saves, number of weld packs inspected with TRT, and volumes of leaks as a function of time.

Note: The leak in 2001 due to external corrosion was located in a weld pack in a below-grade piping segment, and as such, would not have been detected by the TRT inspection program. The location had not yet received PTi/TWI inspection.

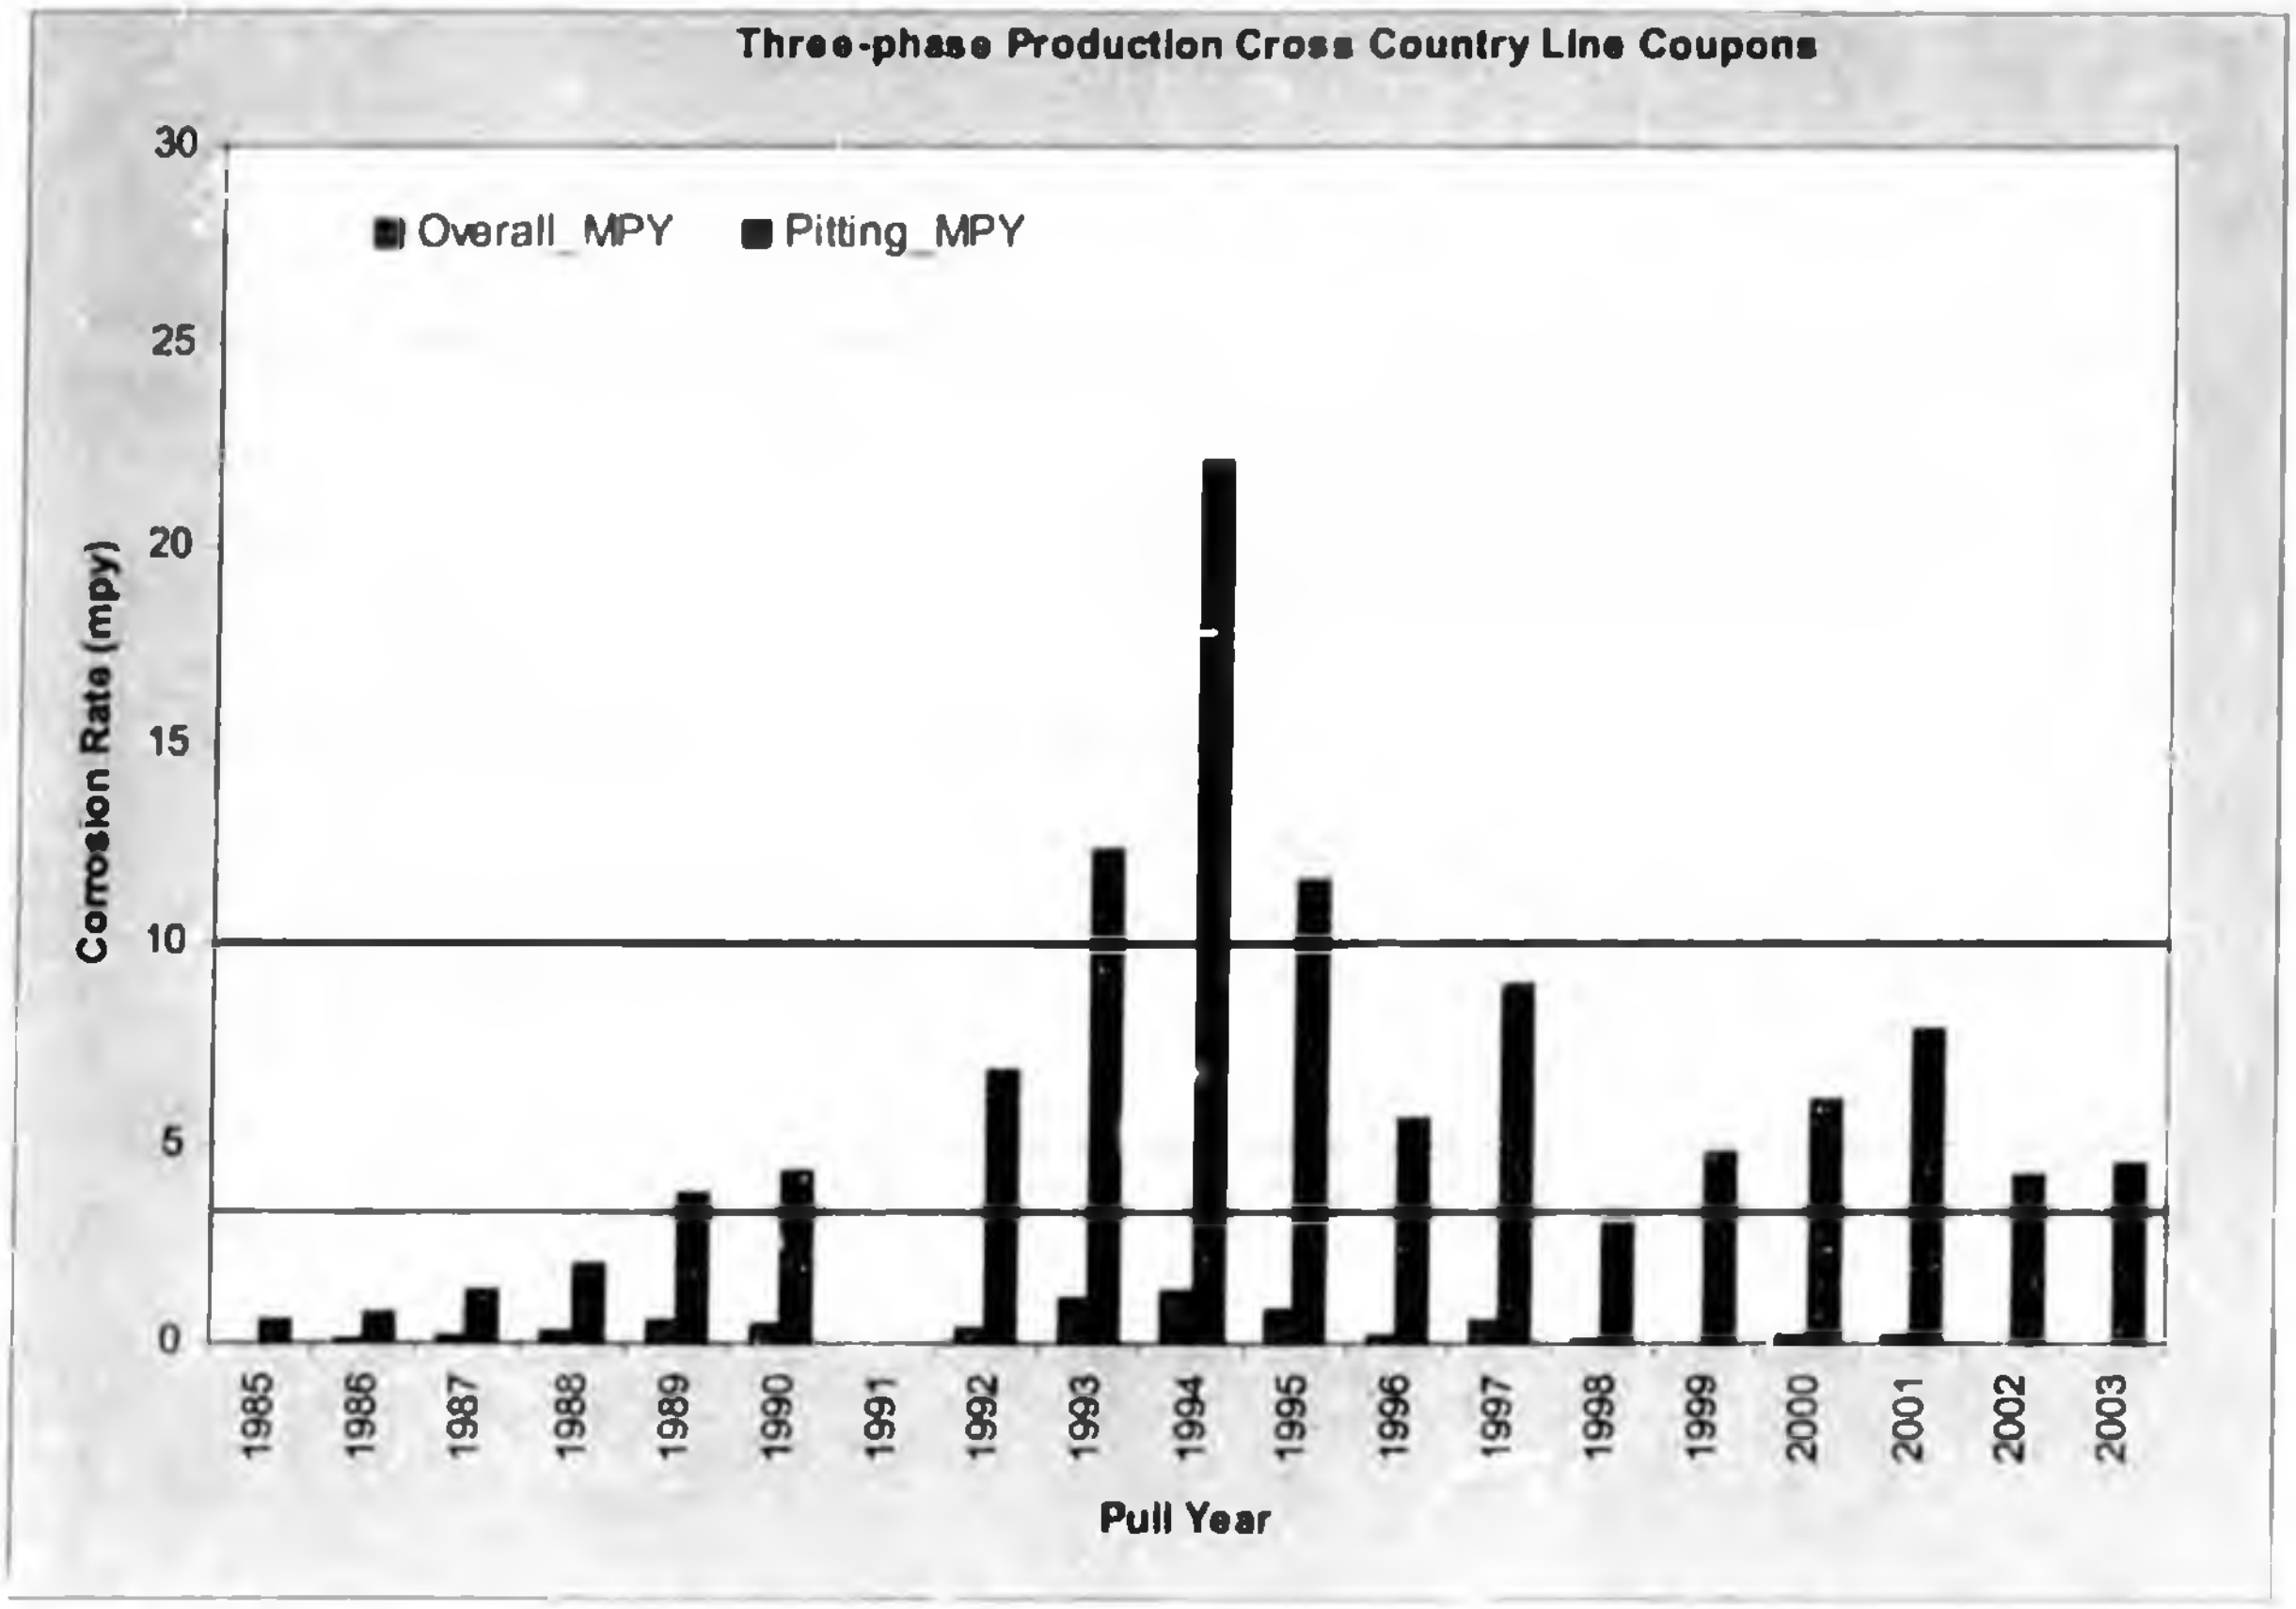
Figure 1. Three-phase Production Cross-Country Line Coupons – general and pitting corrosion rates as a function of time.

Three-phase Production Cross-Country Lines: The monitoring data summarized in Kuparuk Tables 1 and 2 and presented in Figure 1 suggest that general corrosion is under control. The data presented in the Tables 1 and 2 and in Figure 1 include corrosion coupon data from the wet oil lines starting at CPF3 and going to CPF1 and CPF2.

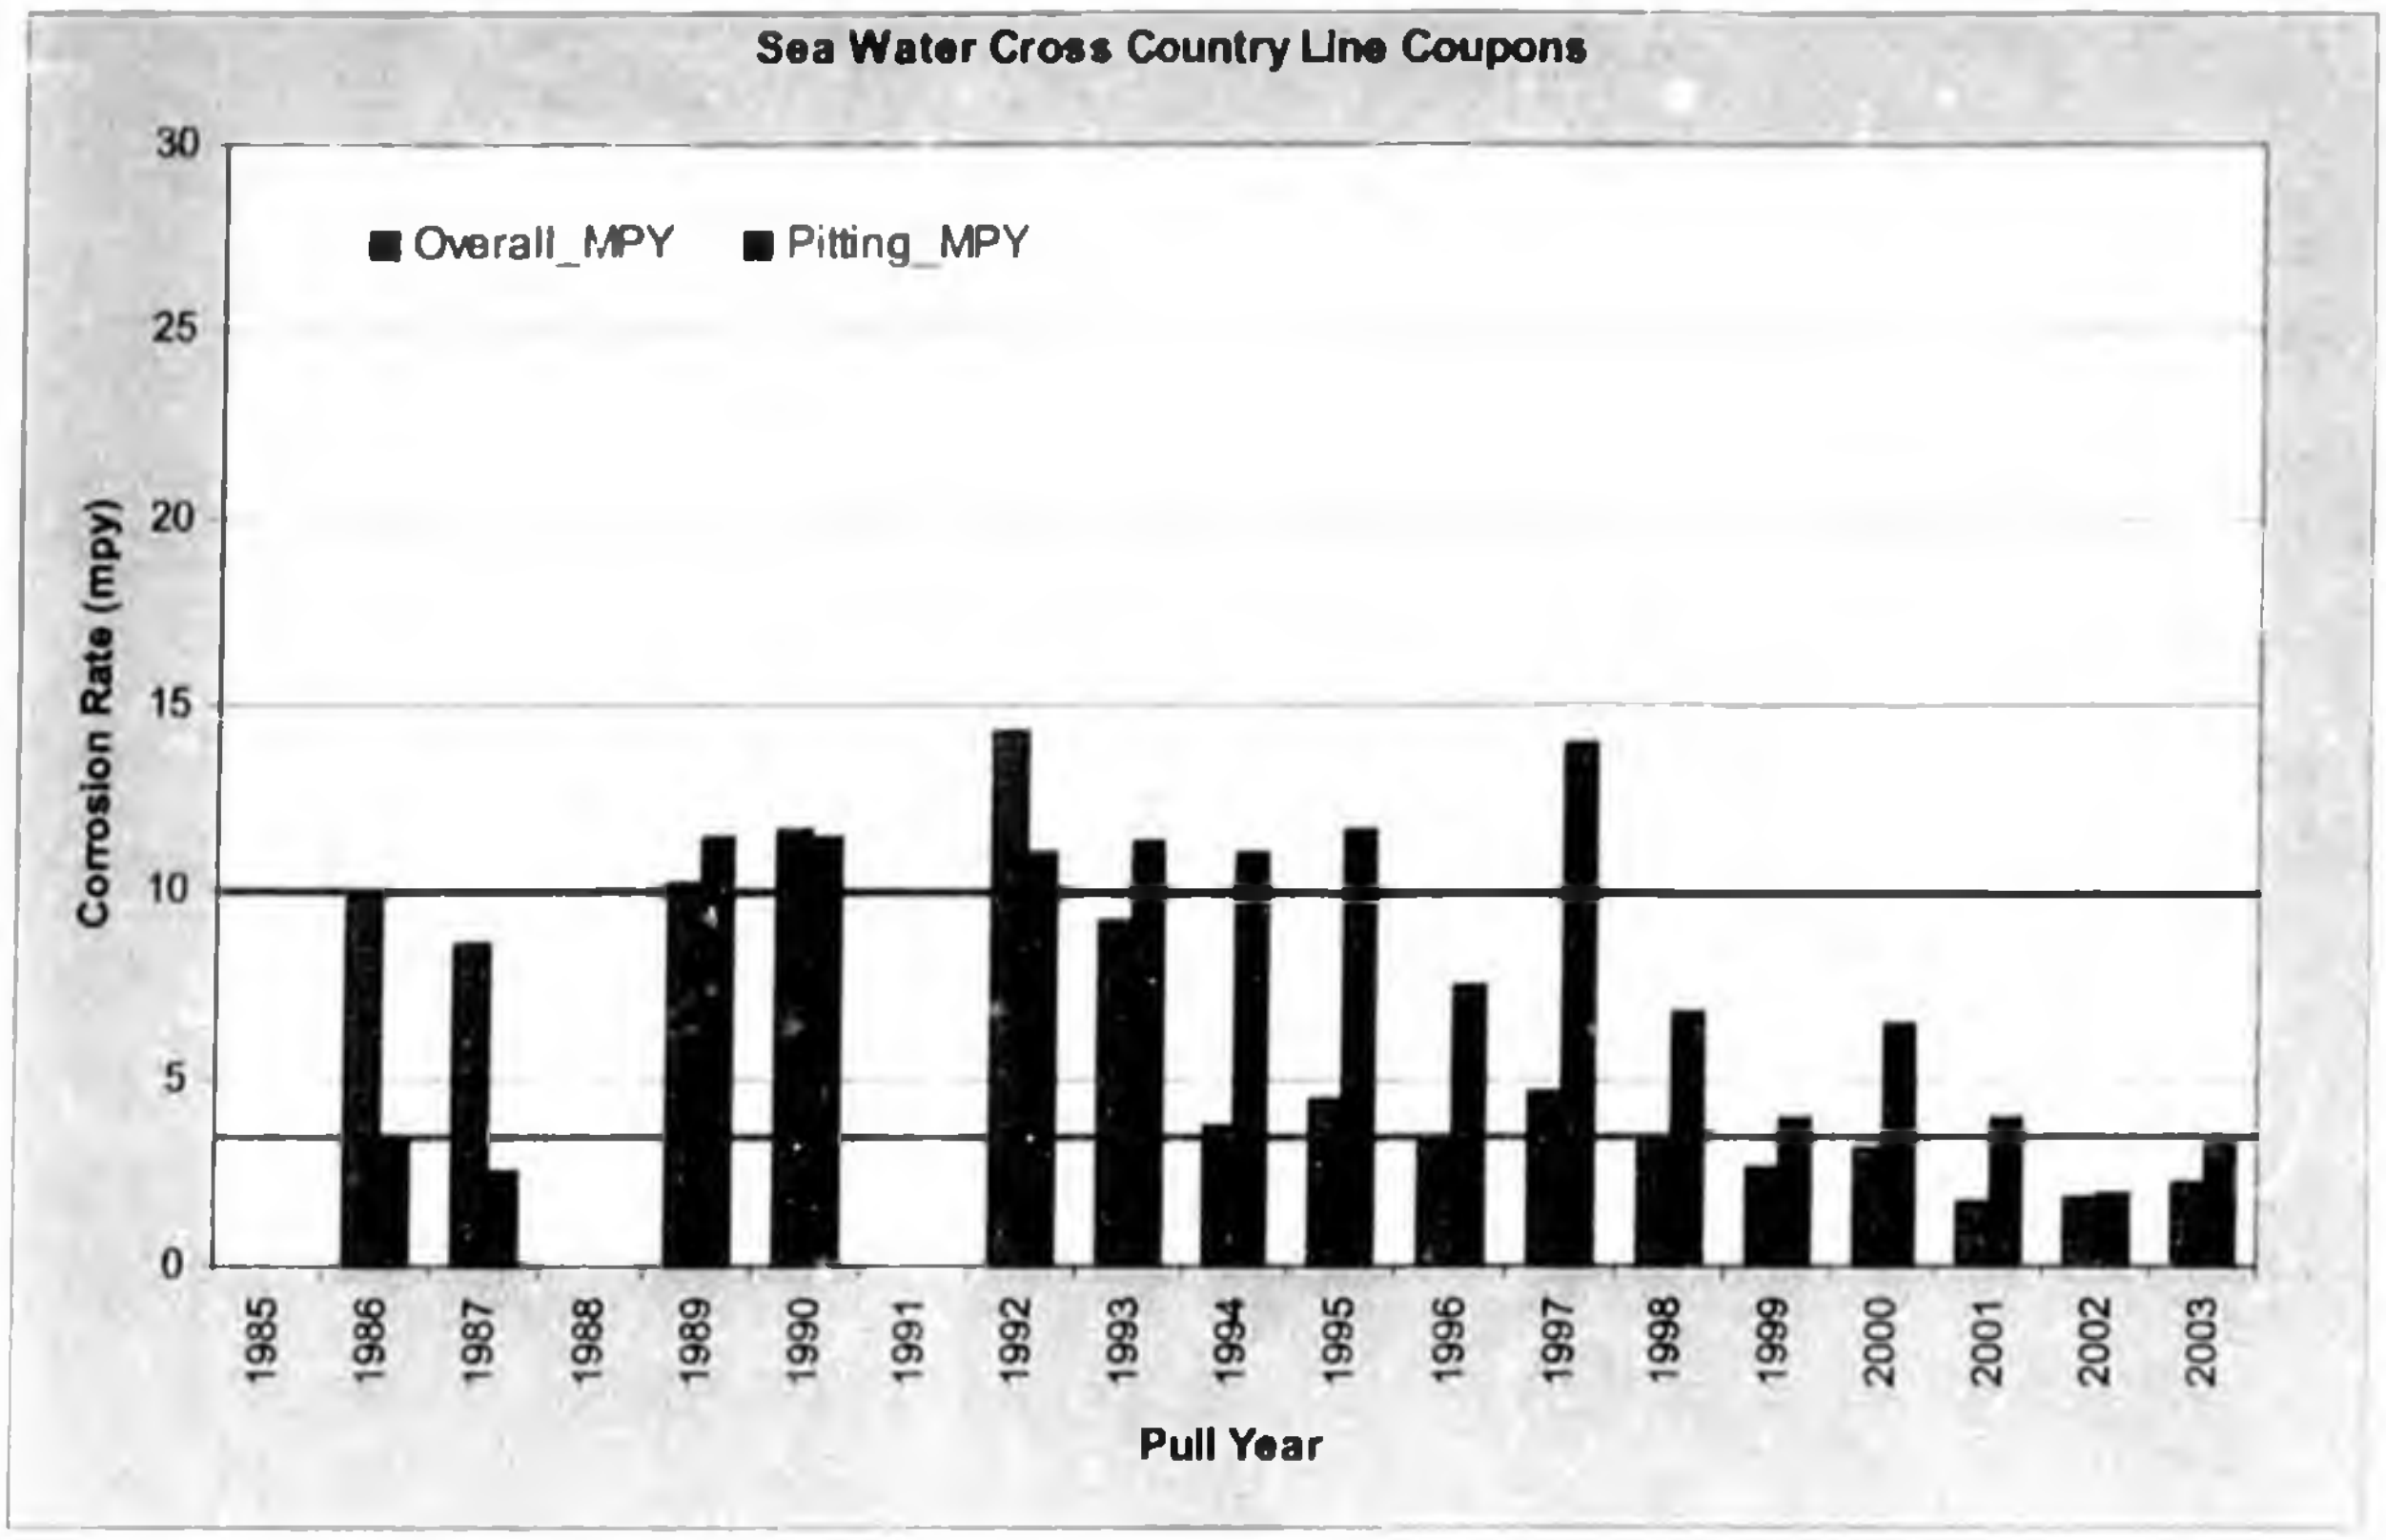
Figure 2. Seawater Cross-Country Line Coupons – general and pitting corrosion rates as a function of time.

Sea Water Cross-Country Lines: The monitoring data summarized in Kuparuk Tables 1 and 2 and presented in Figure 2 above, shows the average corrosion rates for the sea water cross-country line coupons remained under thresholds in 2003. The coupon location on the 30" STP discharge line showed general corrosion rates above threshold in 2003. This is likely due to short term increased dissolved oxygen levels, the origin of which is under investigation.

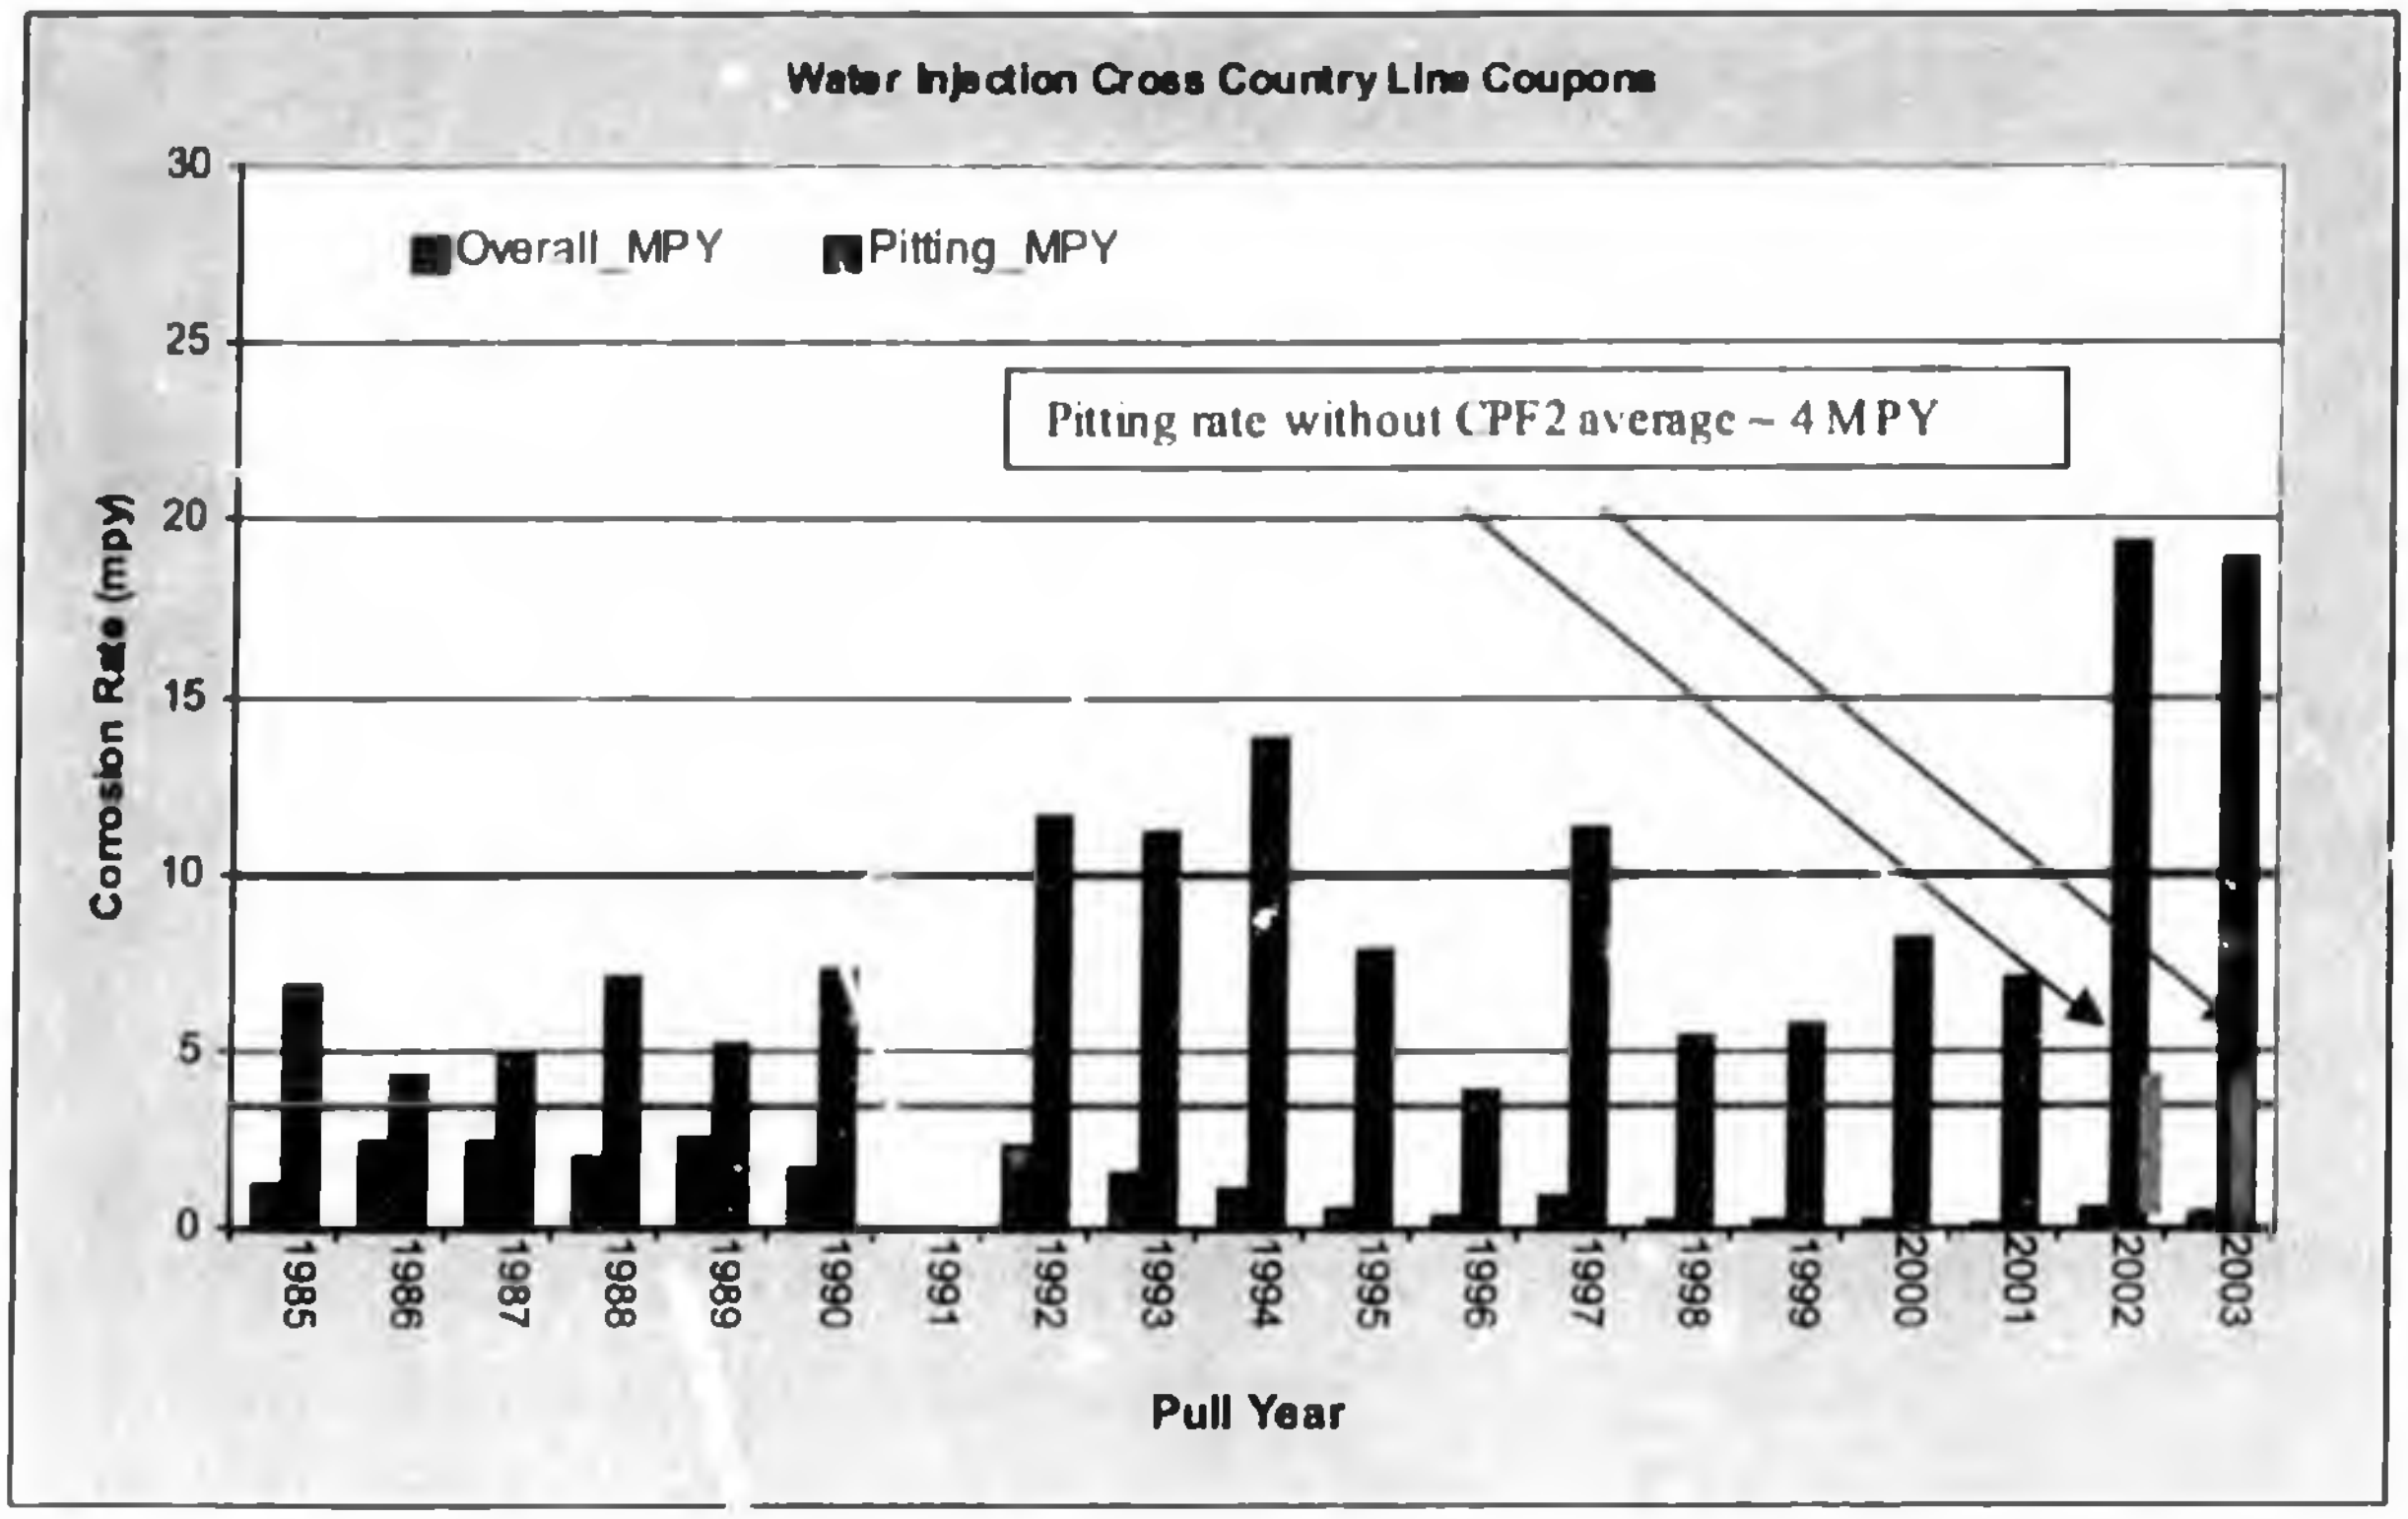
Figure 3. Water Injection Cross-Country Line Coupons – general and pitting corrosion rates as a function of time.

Mixed Water Injection Cross-Country Lines: The monitoring data summarized in Kuparuk Tables 1 and 2 and presented in Figure 3 show that average general corrosion rates are below the threshold, but that pitting rates for the field are above the threshold. Closer analysis of the data shows that the average pitting rate excluding CPF2 locations is well under the threshold. Recent inspection data from the CPF2 lines show some damage on three lines. This information, along with coupon results, was used to prioritize 2003 inspection efforts. RTR inspection performed in 2003 included 23,099 feet on 28 cross-country water injection lines. A review of the CPF biocide programs has been conducted and new treatment procedures are in place.
