ALASKA LEGISLATURE COMMITTEE FILES, 2005-2006 8672
11973 SENATE RESOURCES

Greater Kuparuk Area (GKA)
Alpine Field
Corrosion Programs Overview

Commitment to Corrosion Monitoring

Prepared by
ConocoPhillips Corrosion Team

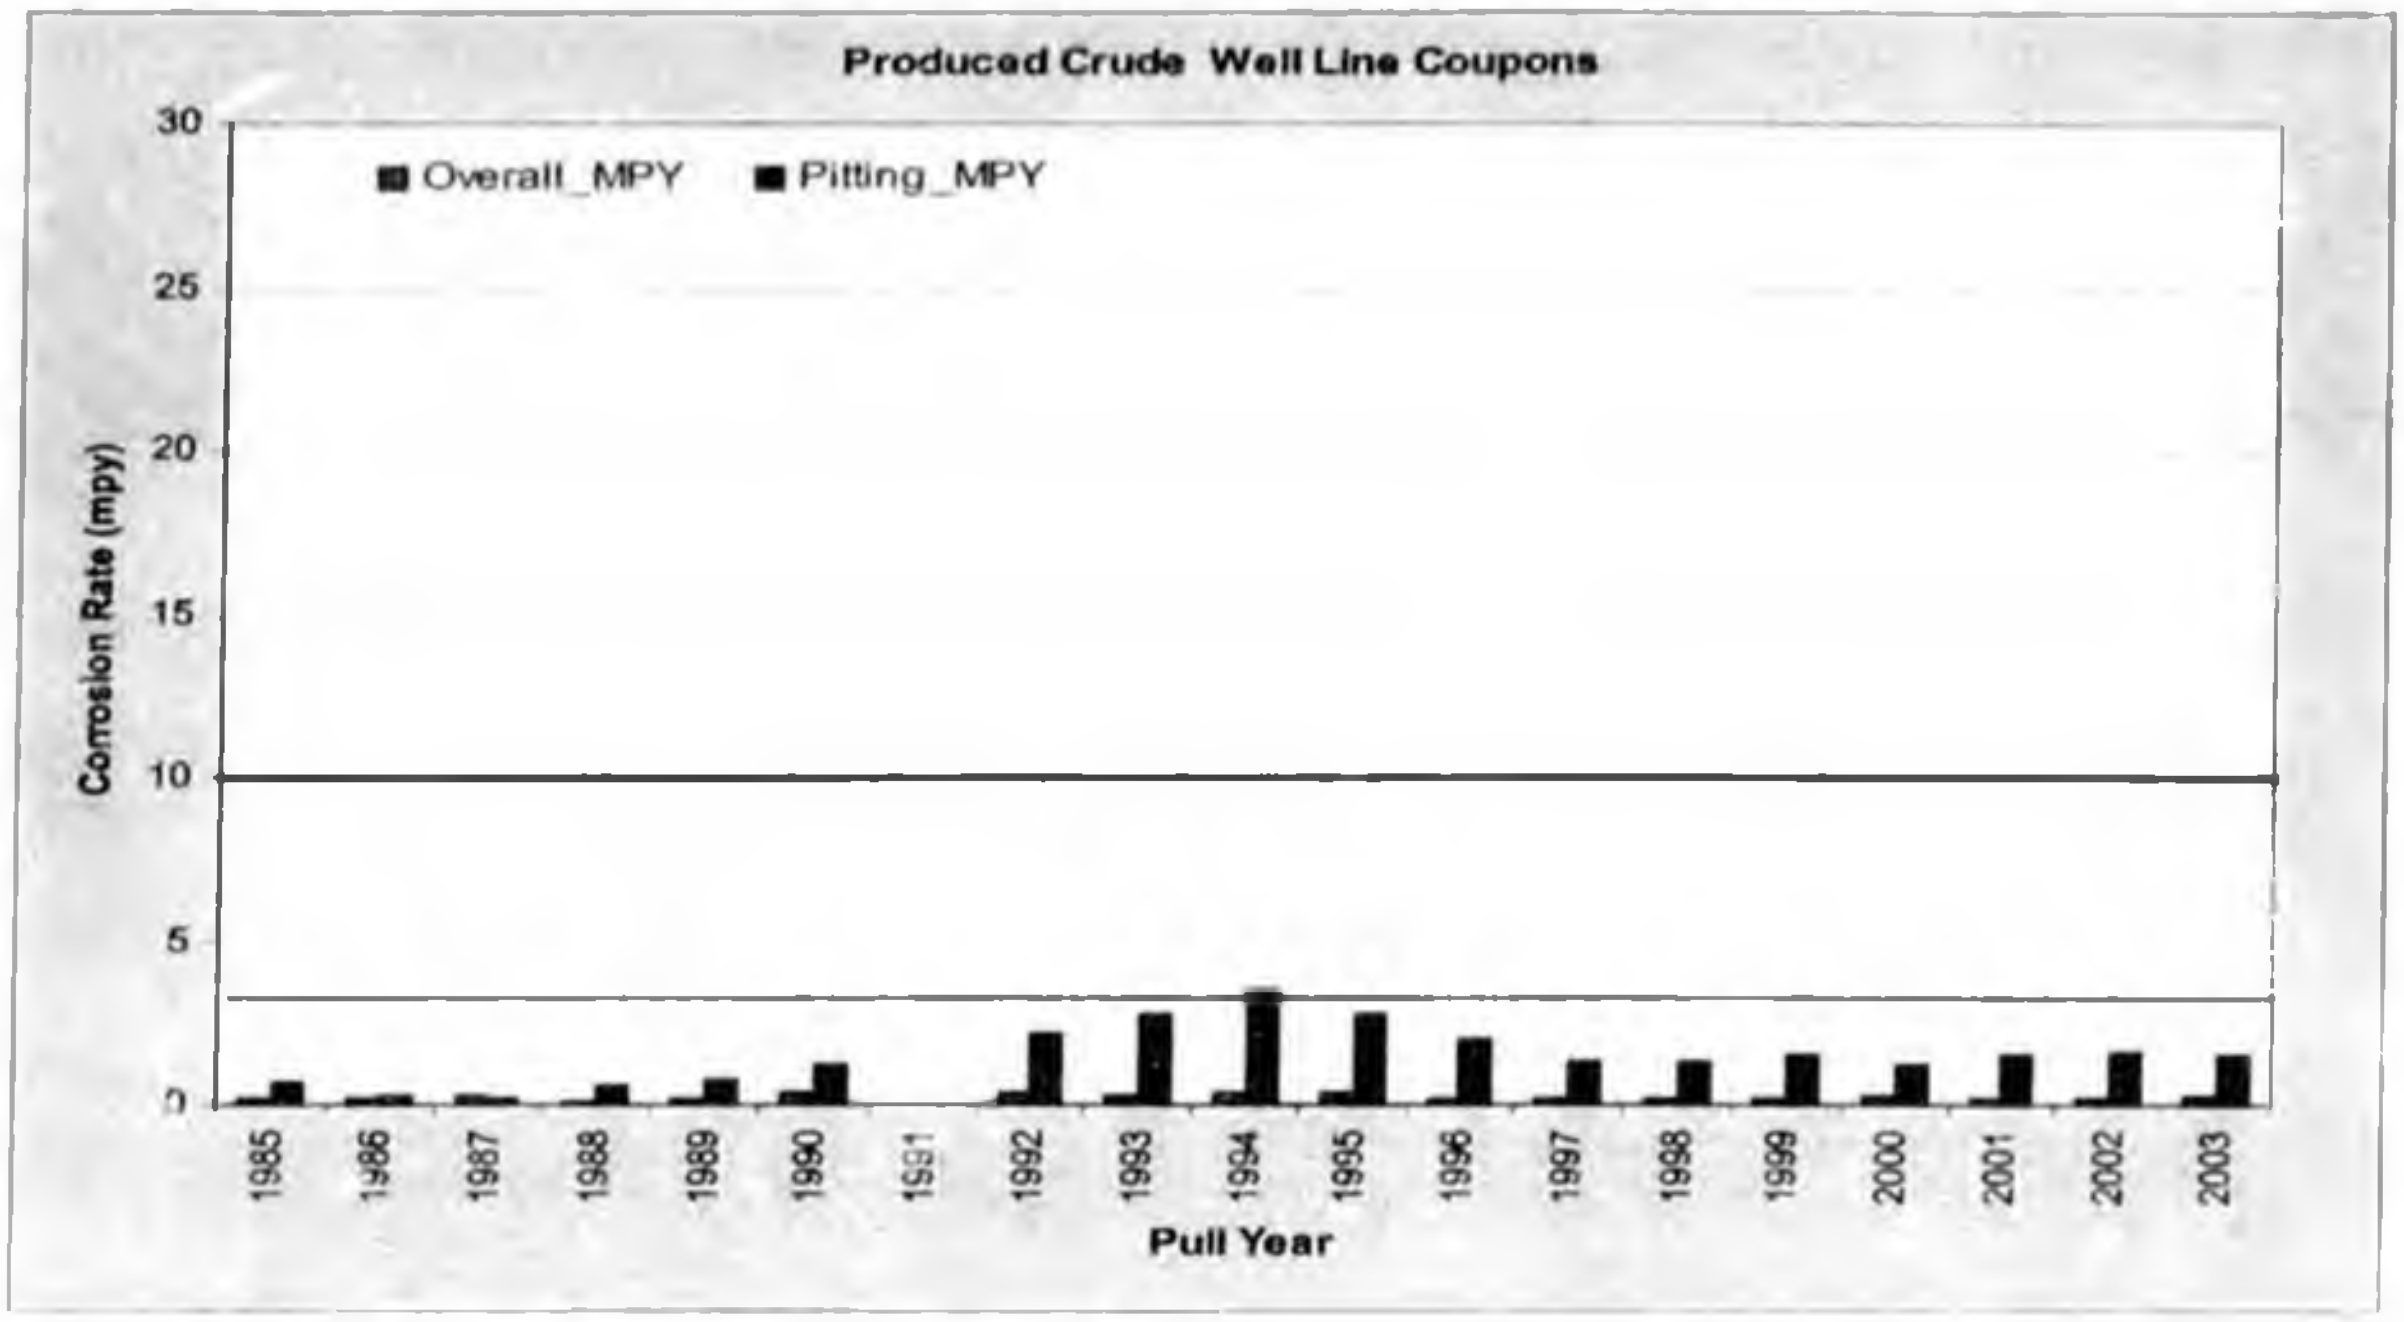
Figure 4. Three-phase Production Well Line Coupons – general and pitting corrosion rates as a function of time.

Three-phase Production Well Flow Lines: While the monitoring data summarized in Kuparuk Tables 1 and 2 and presented in Figures 4 and 5 suggest that corrosion rates are below targets, inspection data indicate that higher corrosion rates have been experienced historically. The well line inspection data are discussed in section 3.1.b below, and are a good example of why monitoring data alone cannot be relied upon to characterize corrosion in a given system. For three-phase production, coupons monitor free flowing fluid and have not shown the predominant, under-deposit corrosion mechanism.

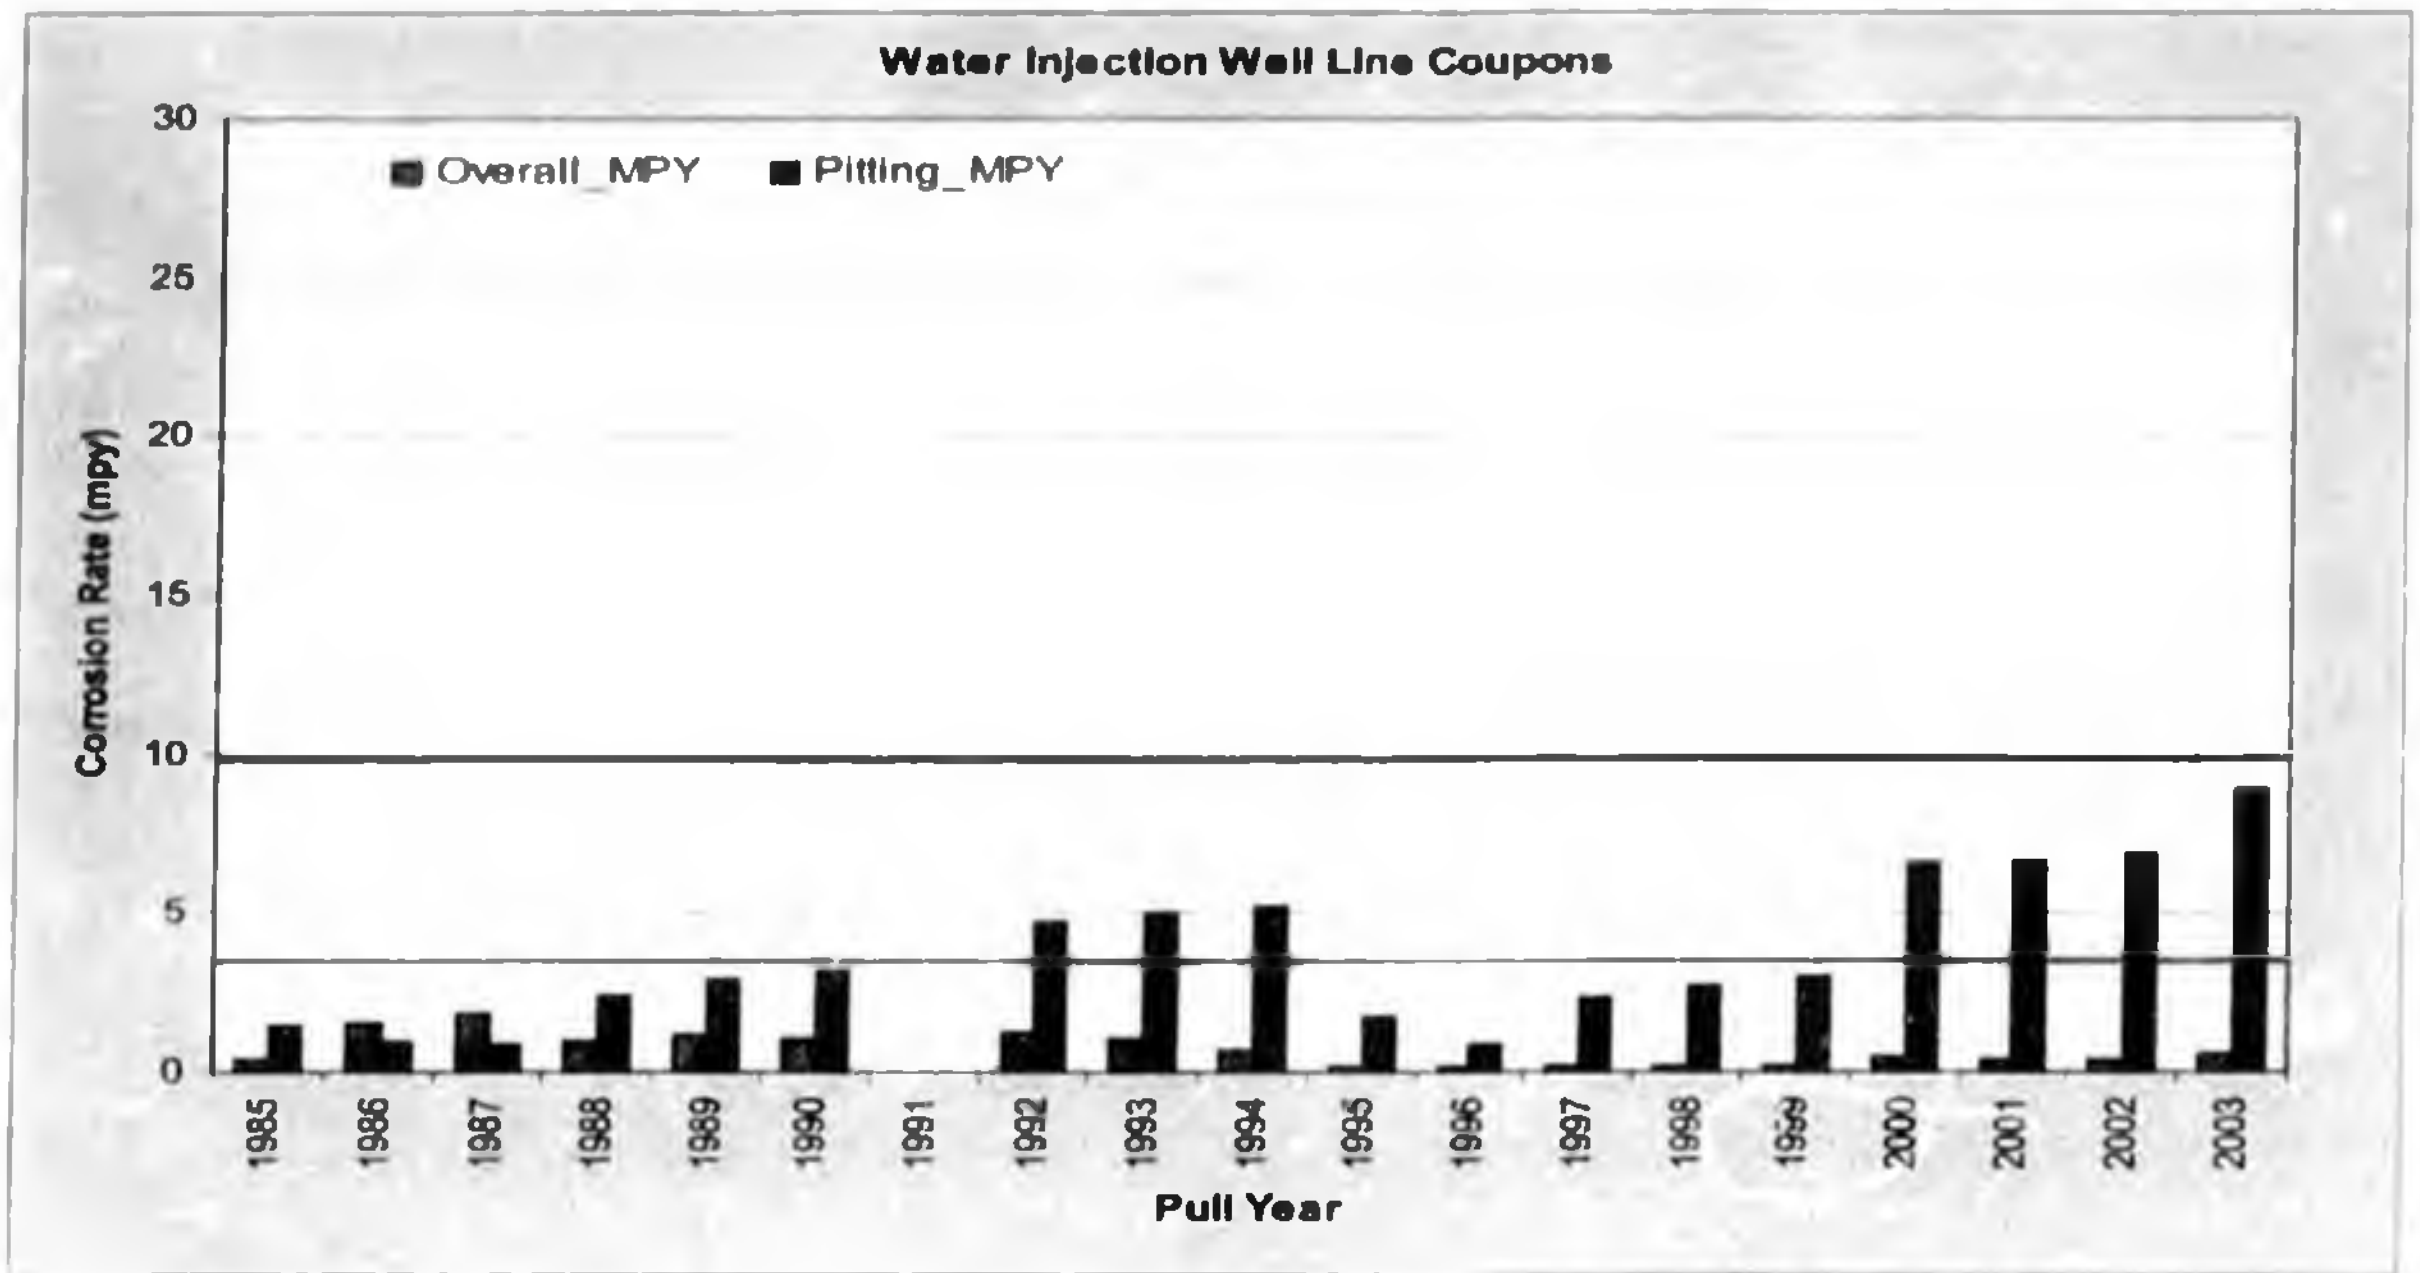
Figure 5. Water Injection Well Line Coupons – general and pitting corrosion rates as a function of time.

Water Injection Well Flow Lines: There is an increasing trend in the coupon pitting rates. As discussed in section 3.1.b below, the well line inspection data on water injectors show that there are a significant (22) and an increasing number of corrosion related repairs.

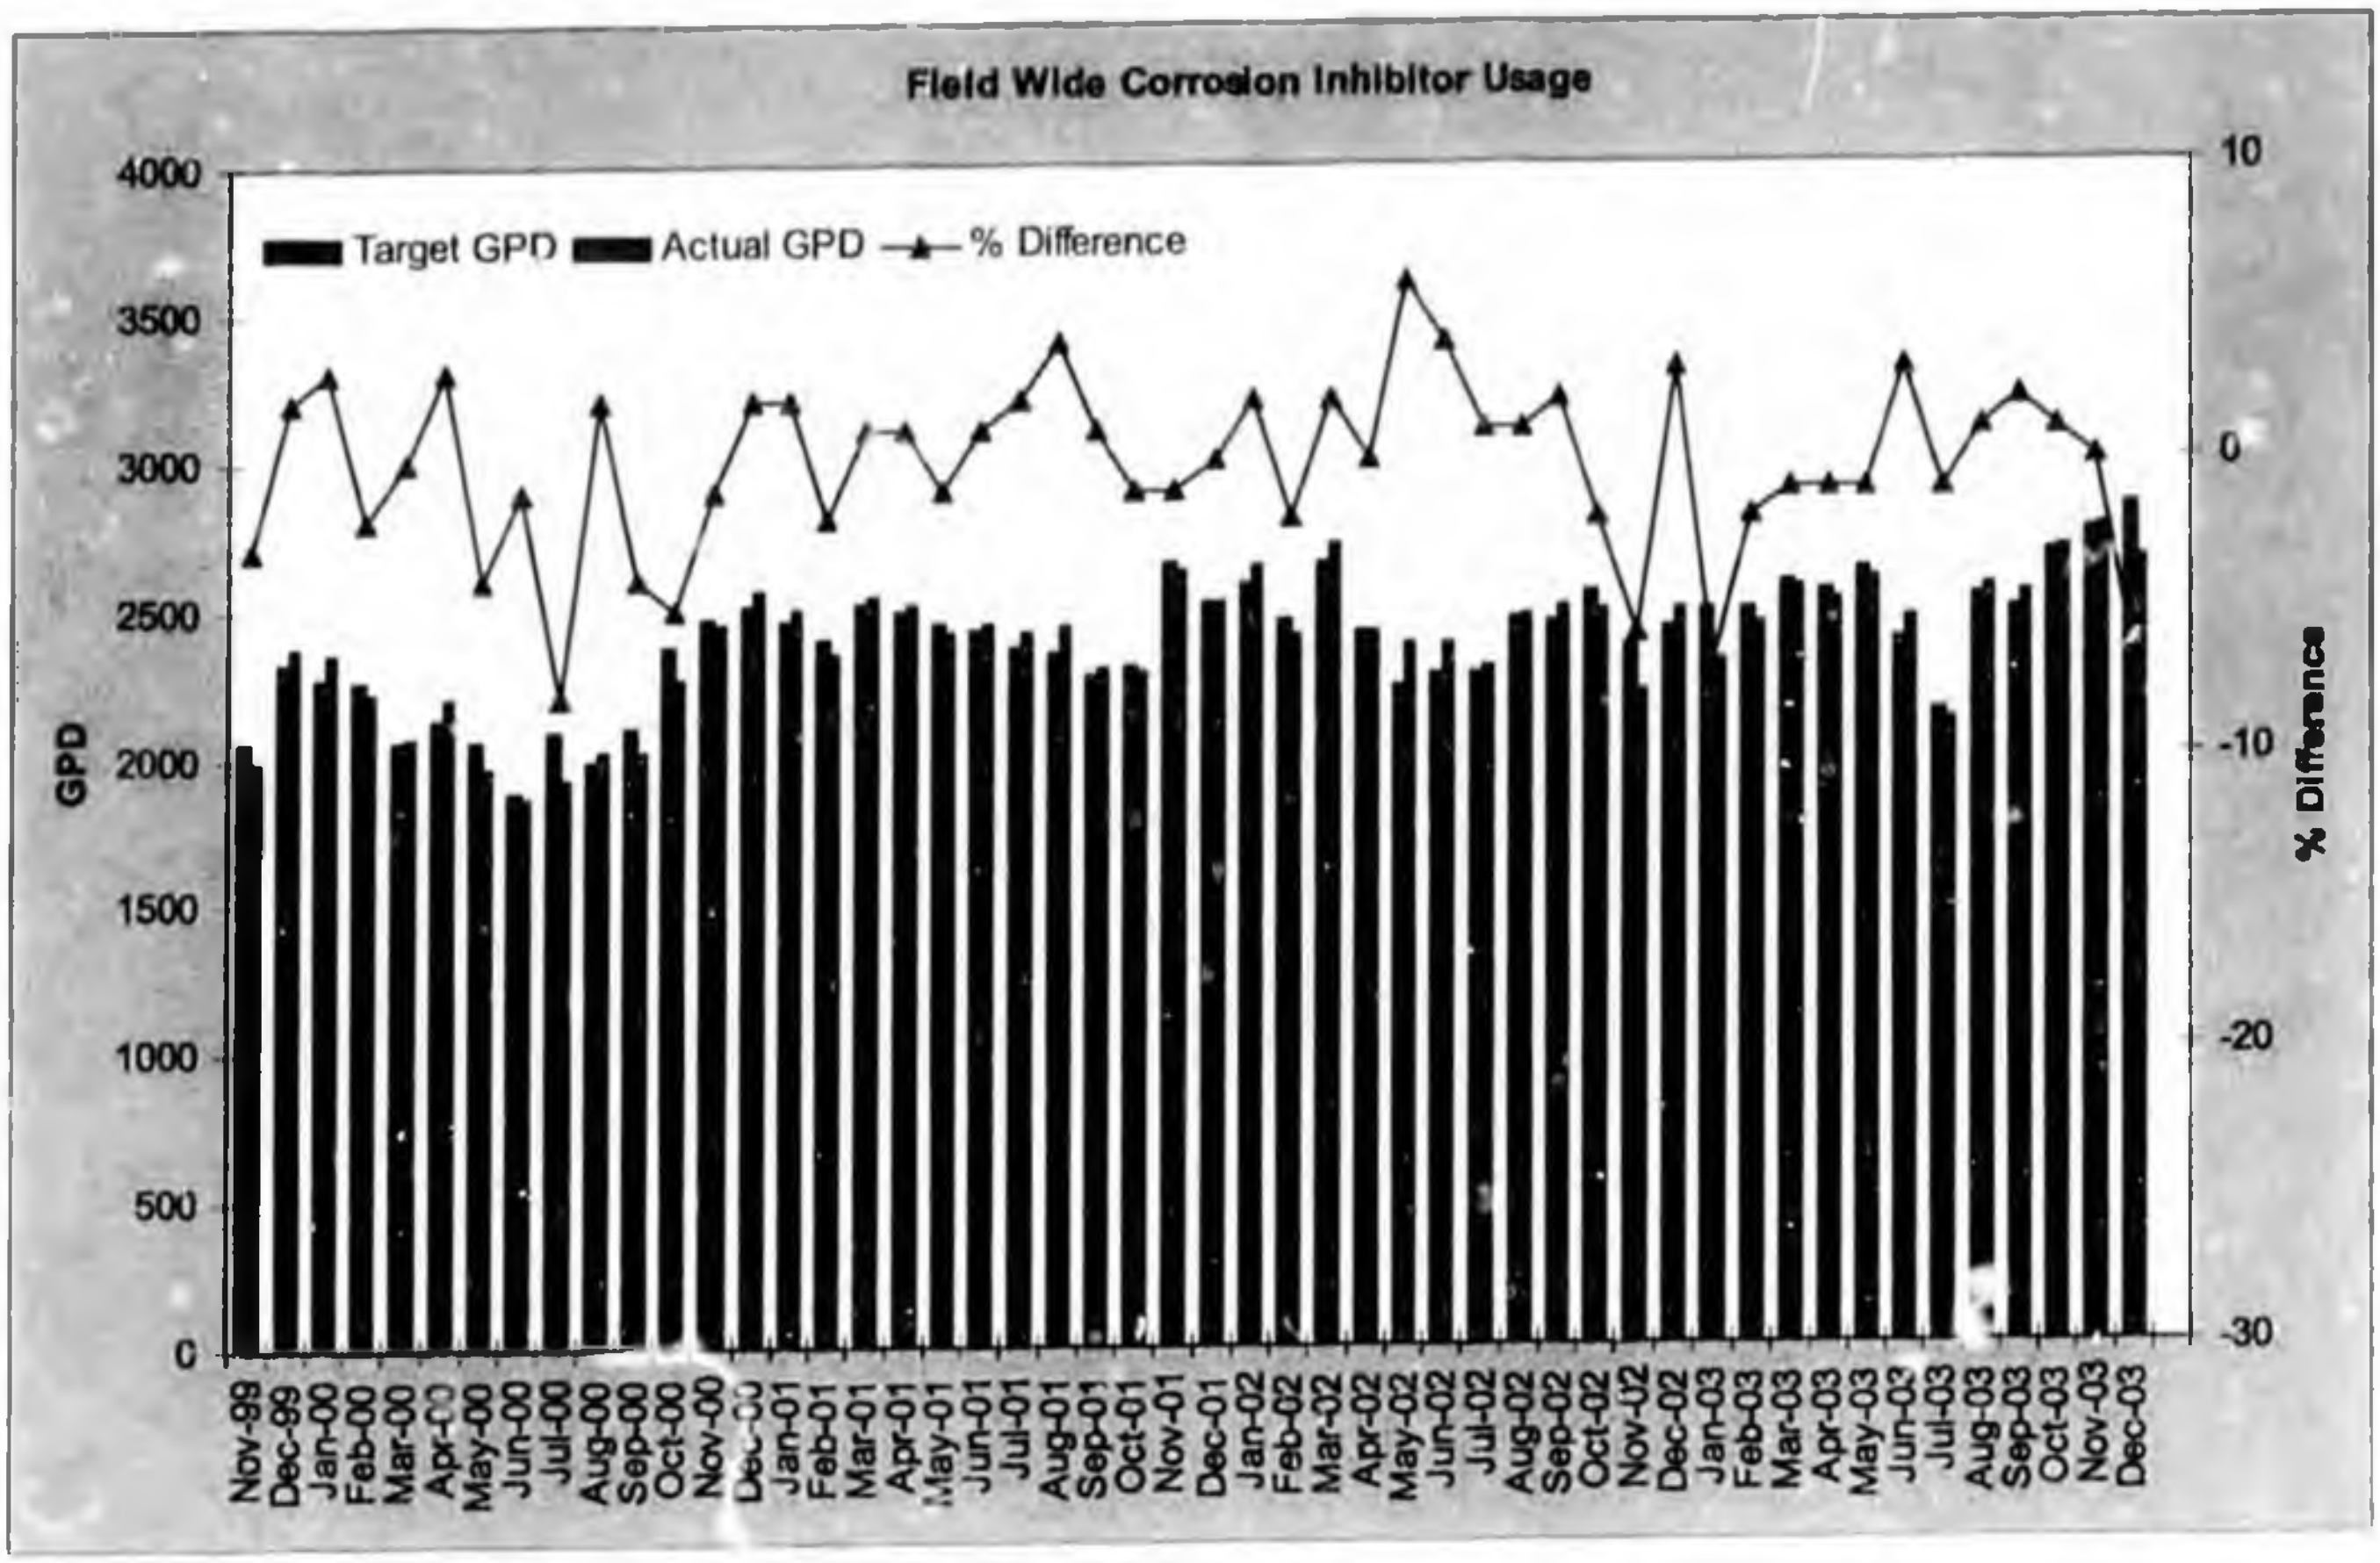
Figure 6. Field-wide Corrosion Inhibitor Use.

For the Kuparuk field, Figure 6 shows the actual number of gallons of corrosion inhibitor pumped per day, the recommended number of gallons of corrosion inhibitor per day, and the percent difference between the two. The difference fluctuated around zero percent deviation from the recommended amount of corrosion inhibitor; the average deviation for the year was −1.0%. The larger variation seen in the December 2003 data was caused by the extreme weather that caused delays in routine pump rate checks and refilling of chemical tanks.

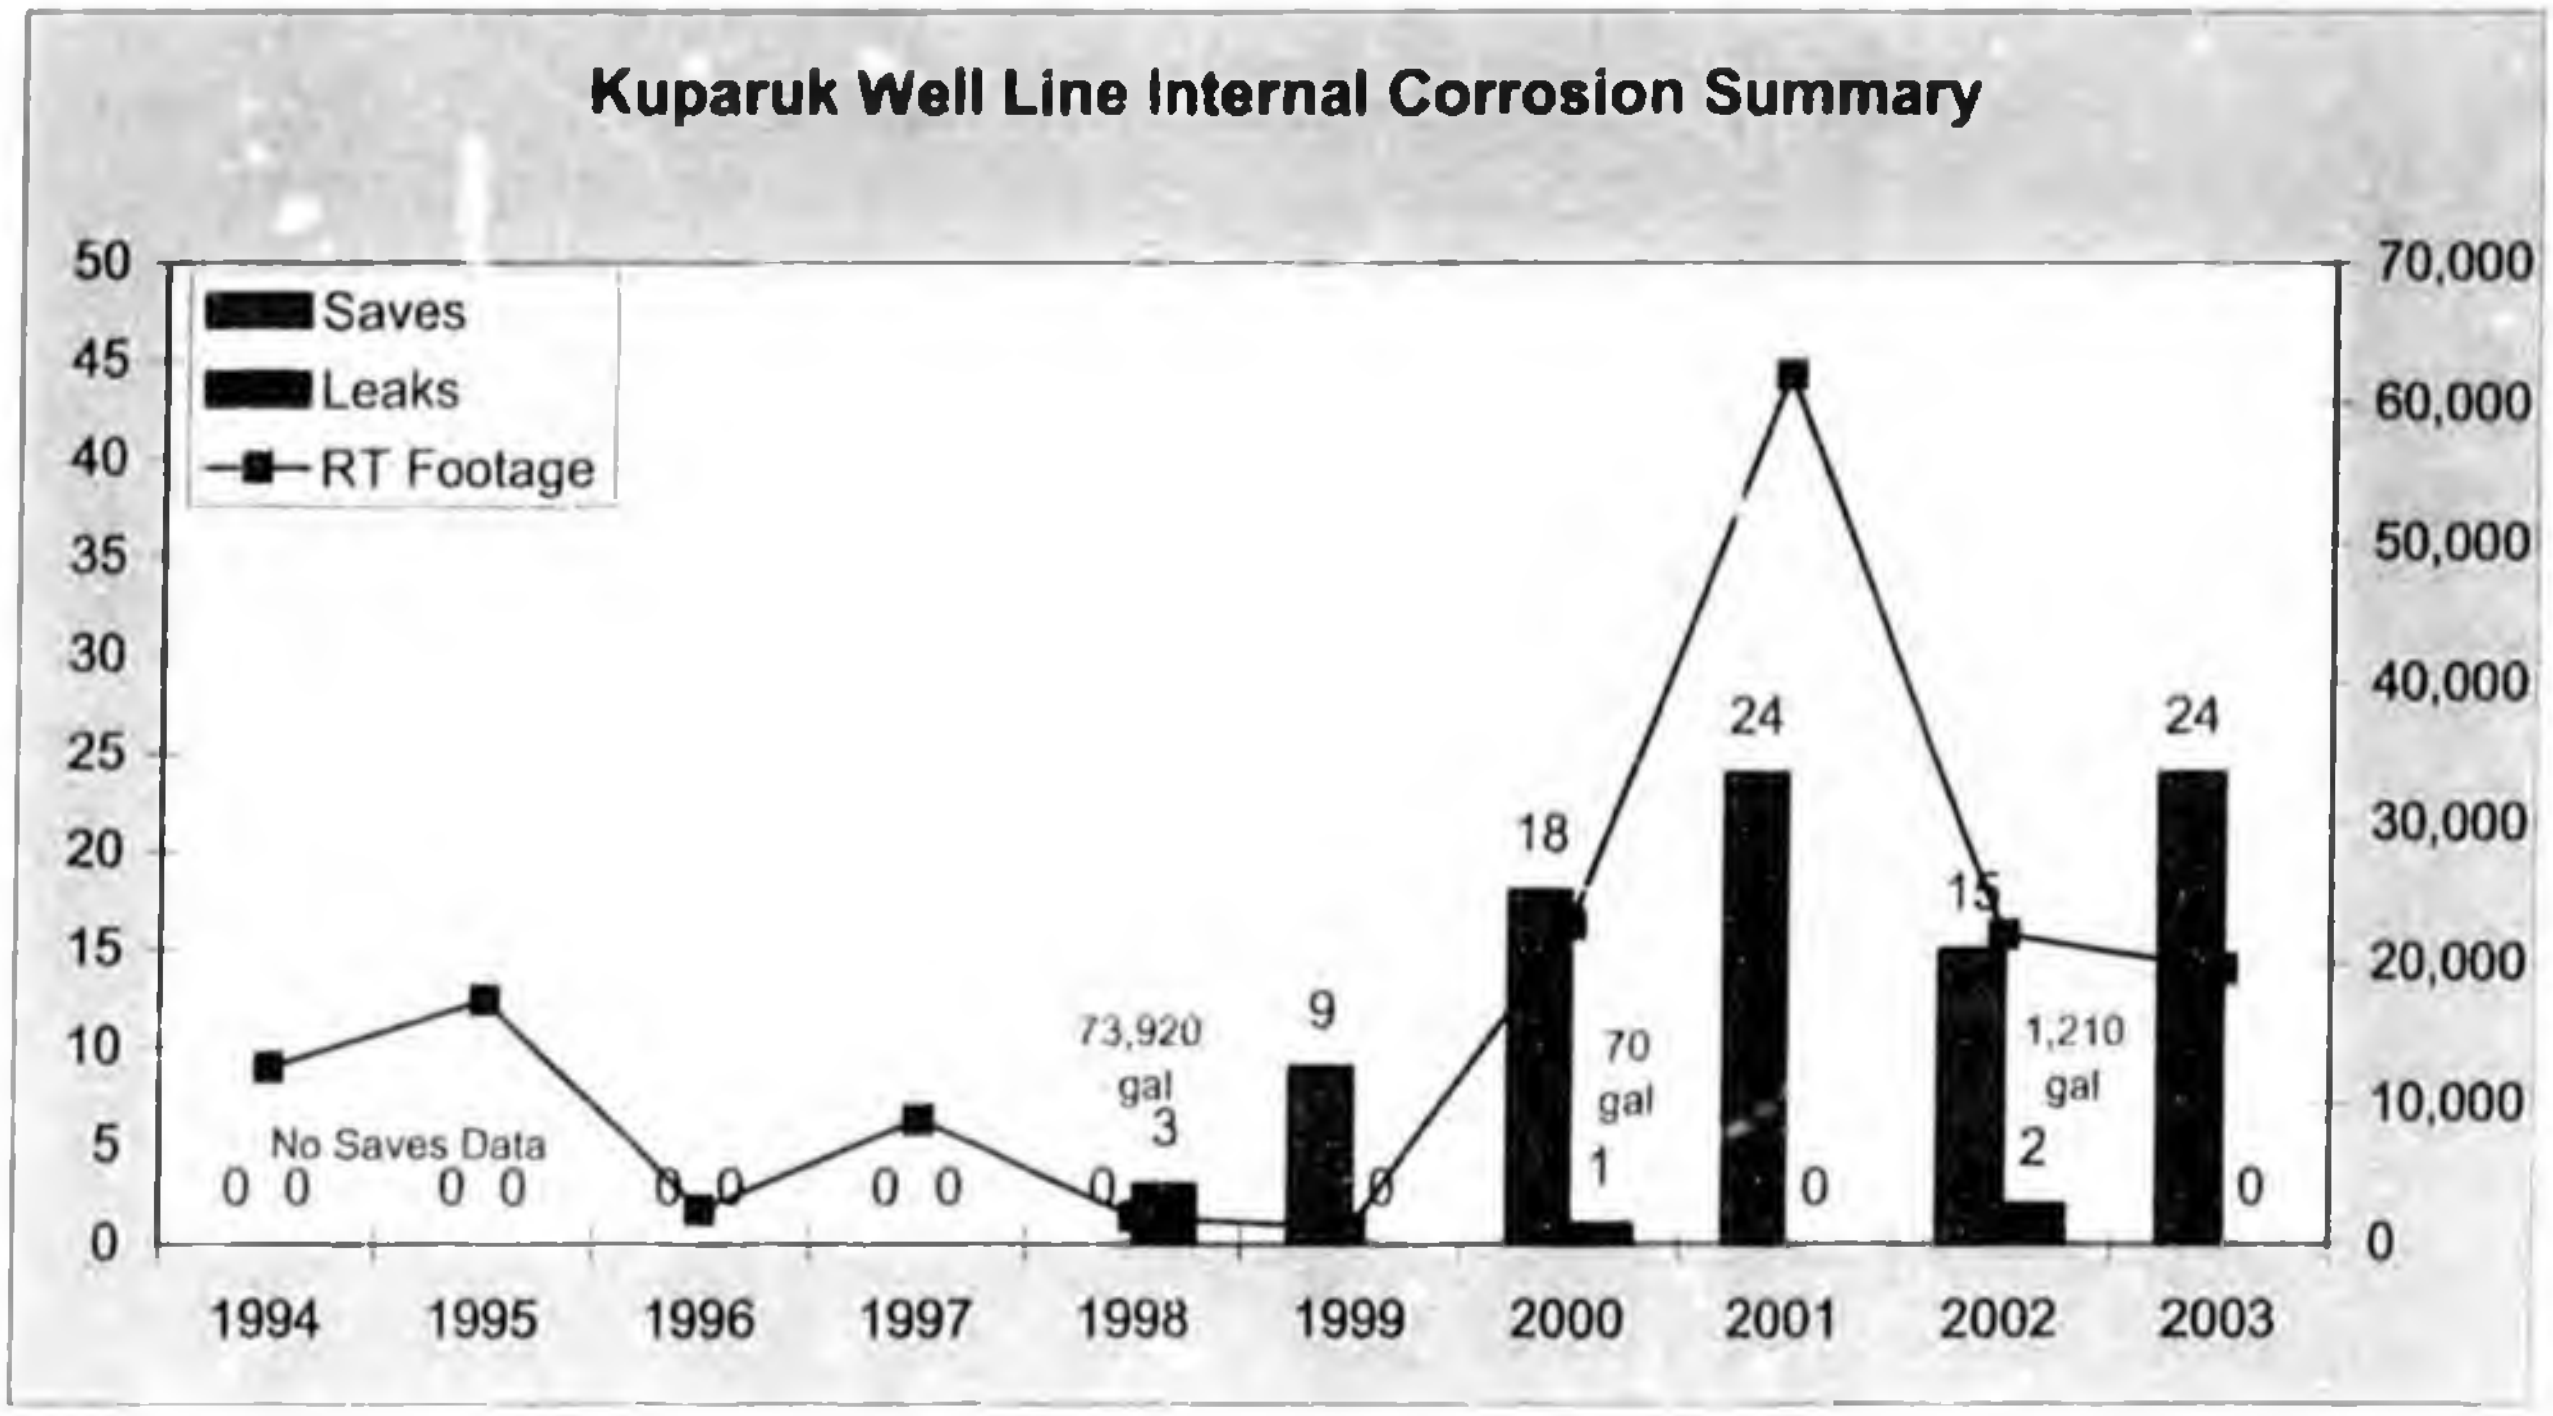
As indicated in Figure 8 below, repair recommendations were initiated on 24 lines (22 injection, 2 production) in 2003 because of internal corrosion damage. Repairs typically consist of either installing a sleeve or replacing the de-rated section of line. We met our primary 2003 goal of completing the inspection of all well lines requiring baseline inspection.

Figure 8. Summary of Well Line Internal Corrosion Inspections – RT footage, leaks, and saves as a function of time.

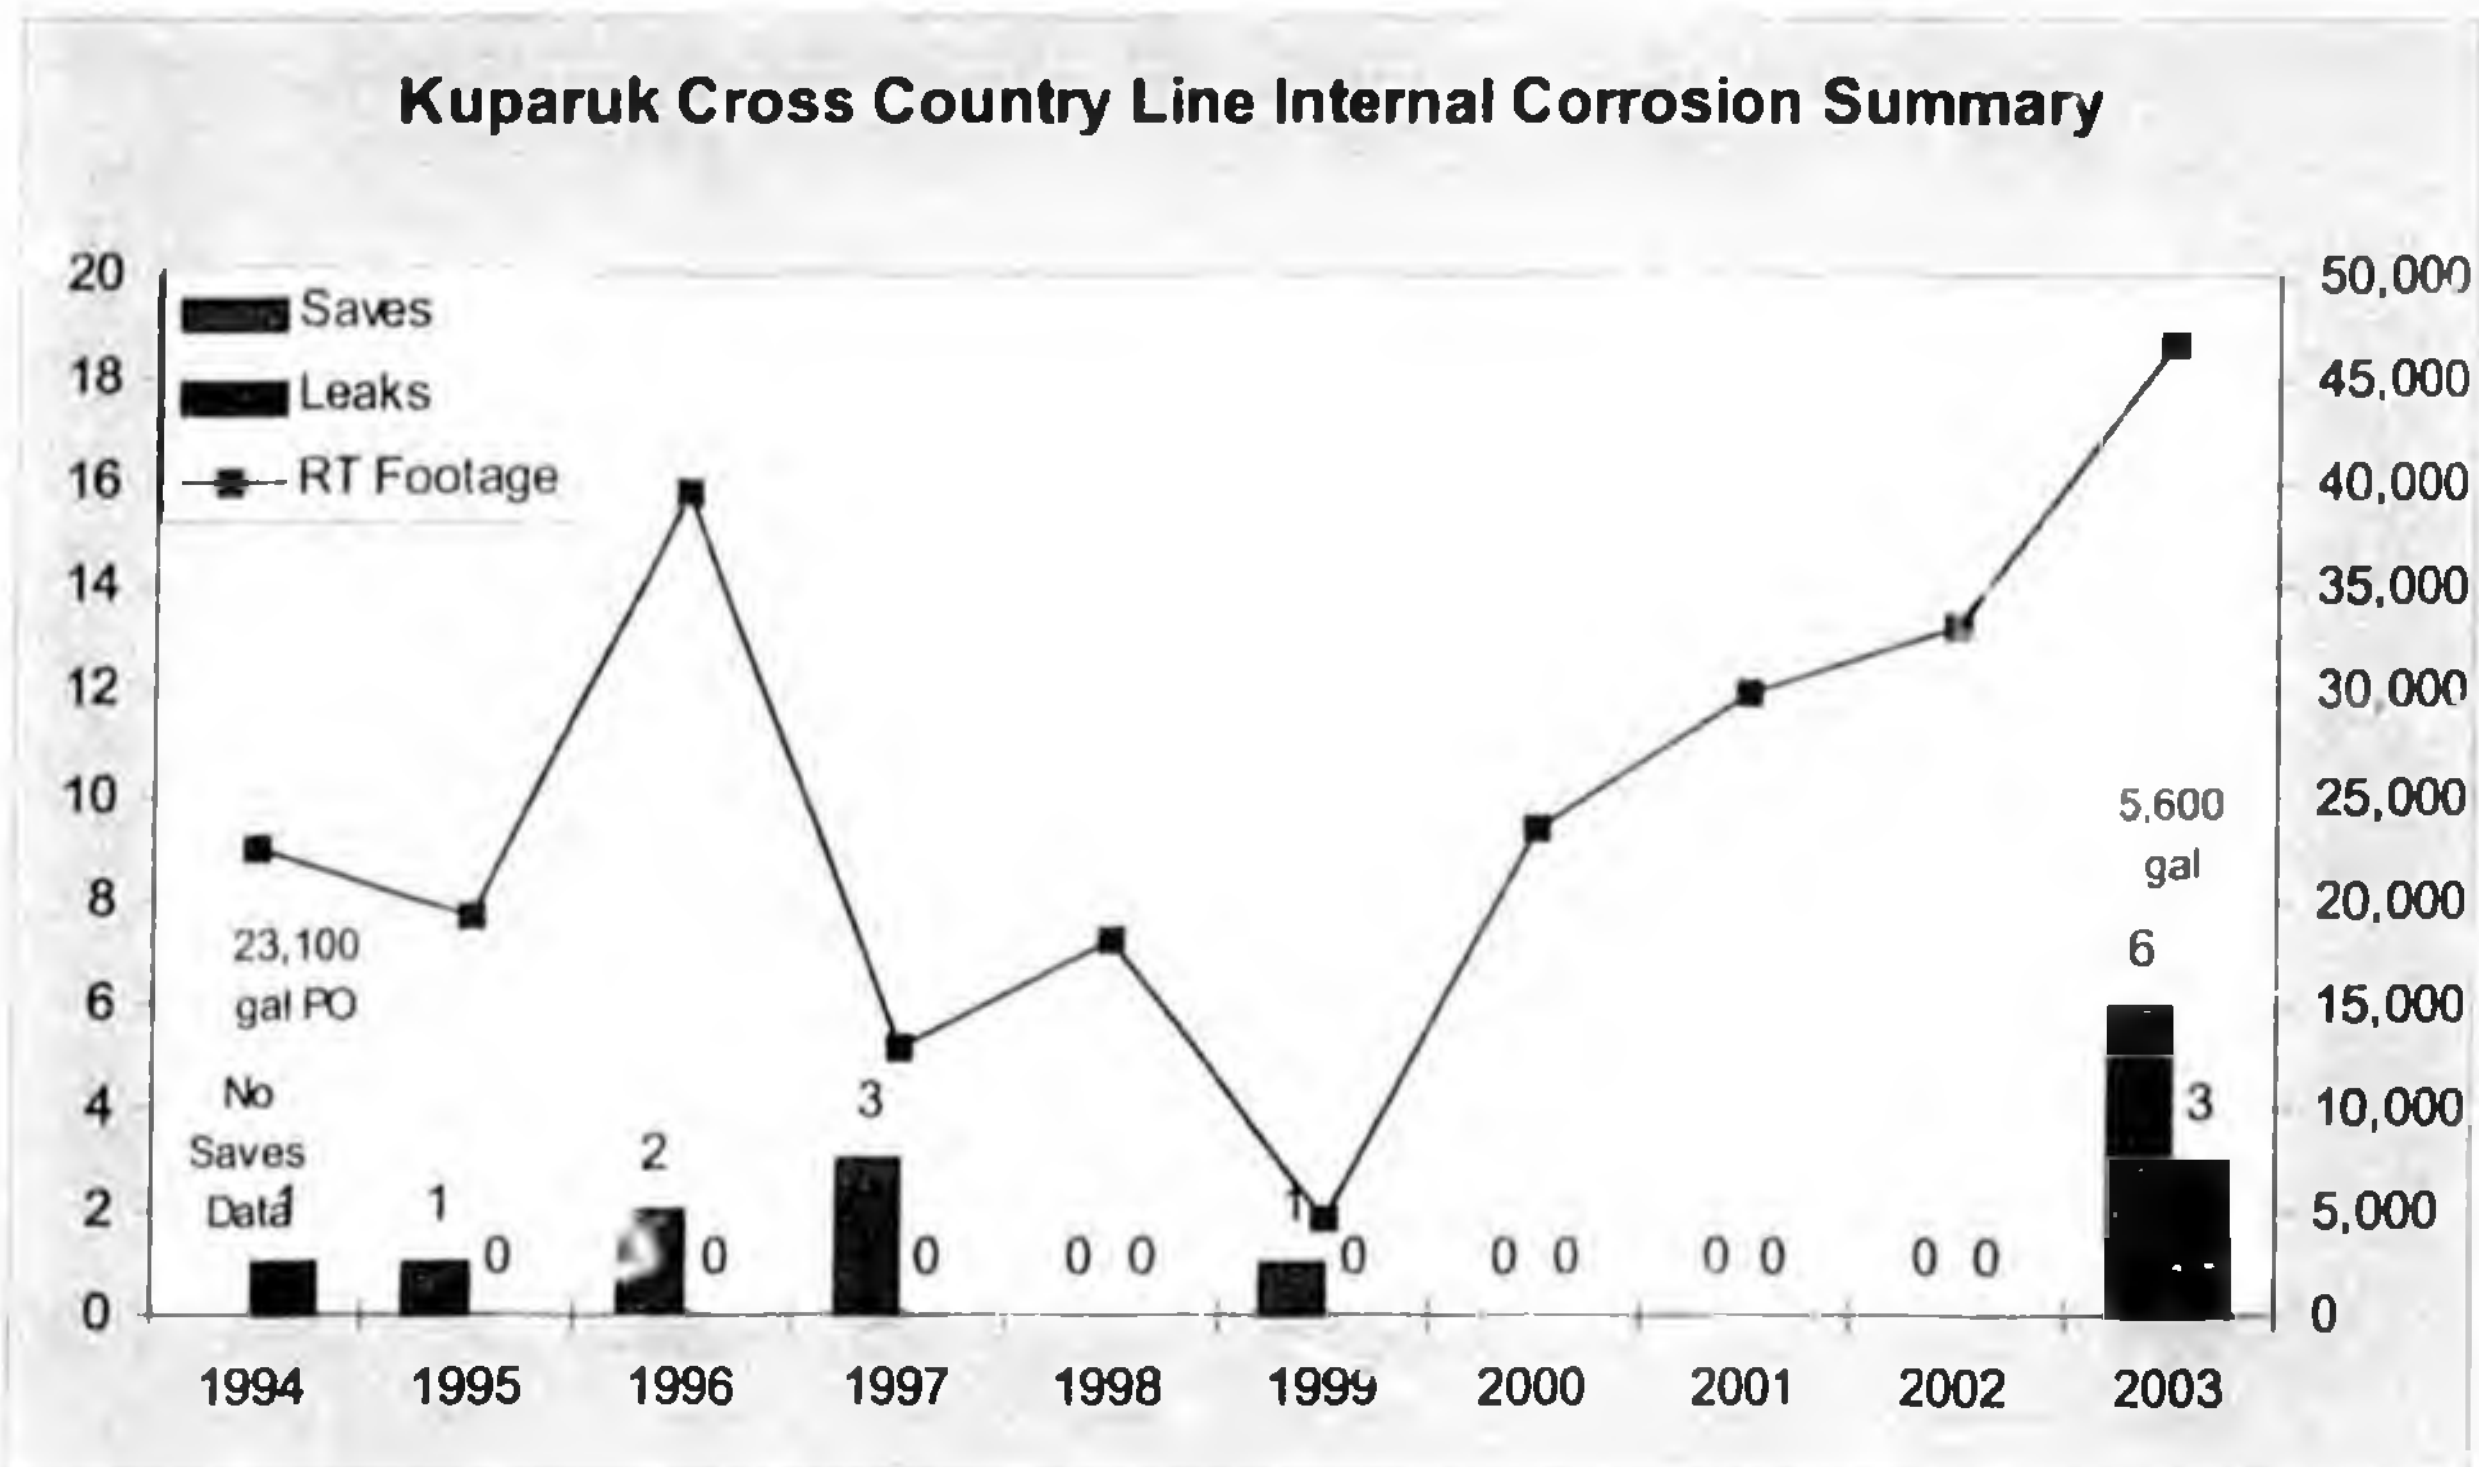
As indicated in Figure 9, nine repair recommendations were initiated on cross-country lines because of internal corrosion damage in 2003. The corrosion mechanisms were deadleg corrosion (five repairs), under deposit corrosion (three repairs) and weld attack on a flowing line (one repair). Because of large increase in repairs we will increase our inspection effort on deadlegs in 2004.

Figure 9. Summary of Cross-Country Line Internal Corrosion Inspections – RT footage, leaks, and saves as a function of time.

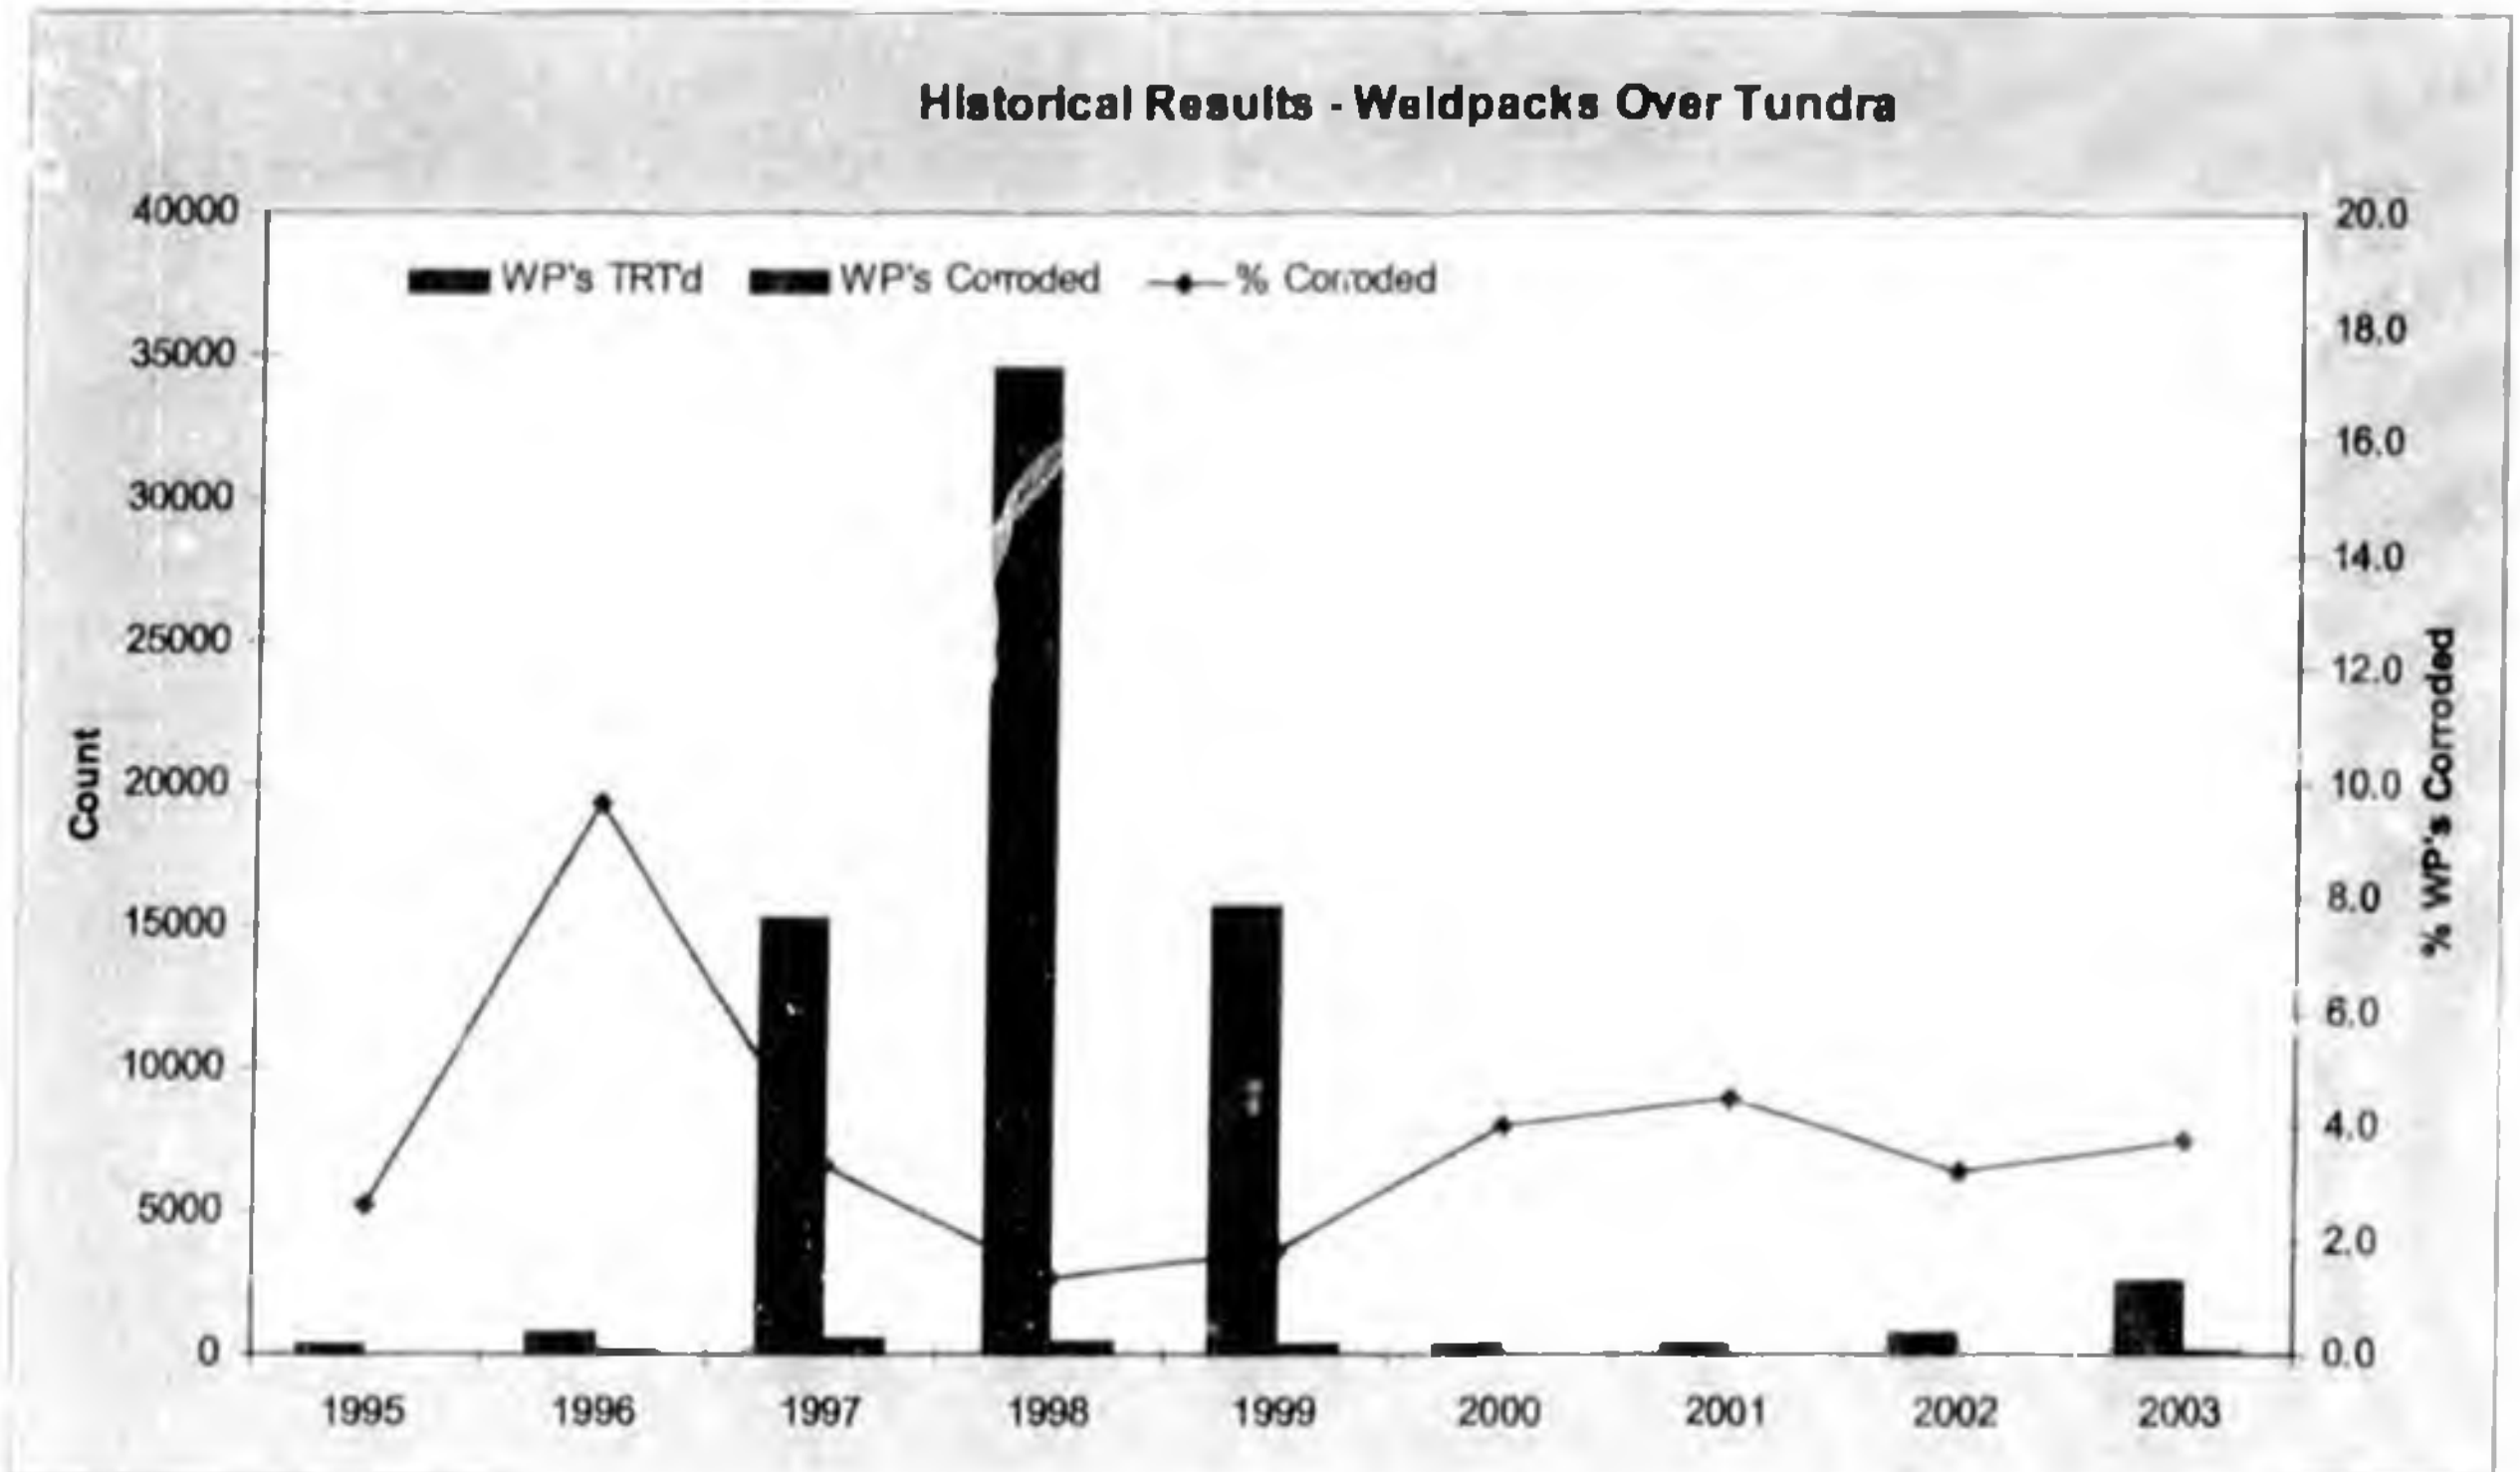
Figure 10. Summary of Weld Packs on Cross-Country Lines over Tundra (off-pad).

Figure 10 illustrates the most-complete external corrosion inspection program of the three external corrosion progı ıms. 2002 and 2003 values include re-inspections and clean-up of locations missed or not properly documented during the original base line effort.
