ALASKA LEGISLATURE COMMITTEE FILES, 2005-2006 8672
11973 SENATE RESOURCES

Greater Kuparuk Area (GKA)
Alpine Field
Corrosion Programs Overview

Commitment to Corrosion Monitoring

Prepared by
ConocoPhillips Corrosion Team

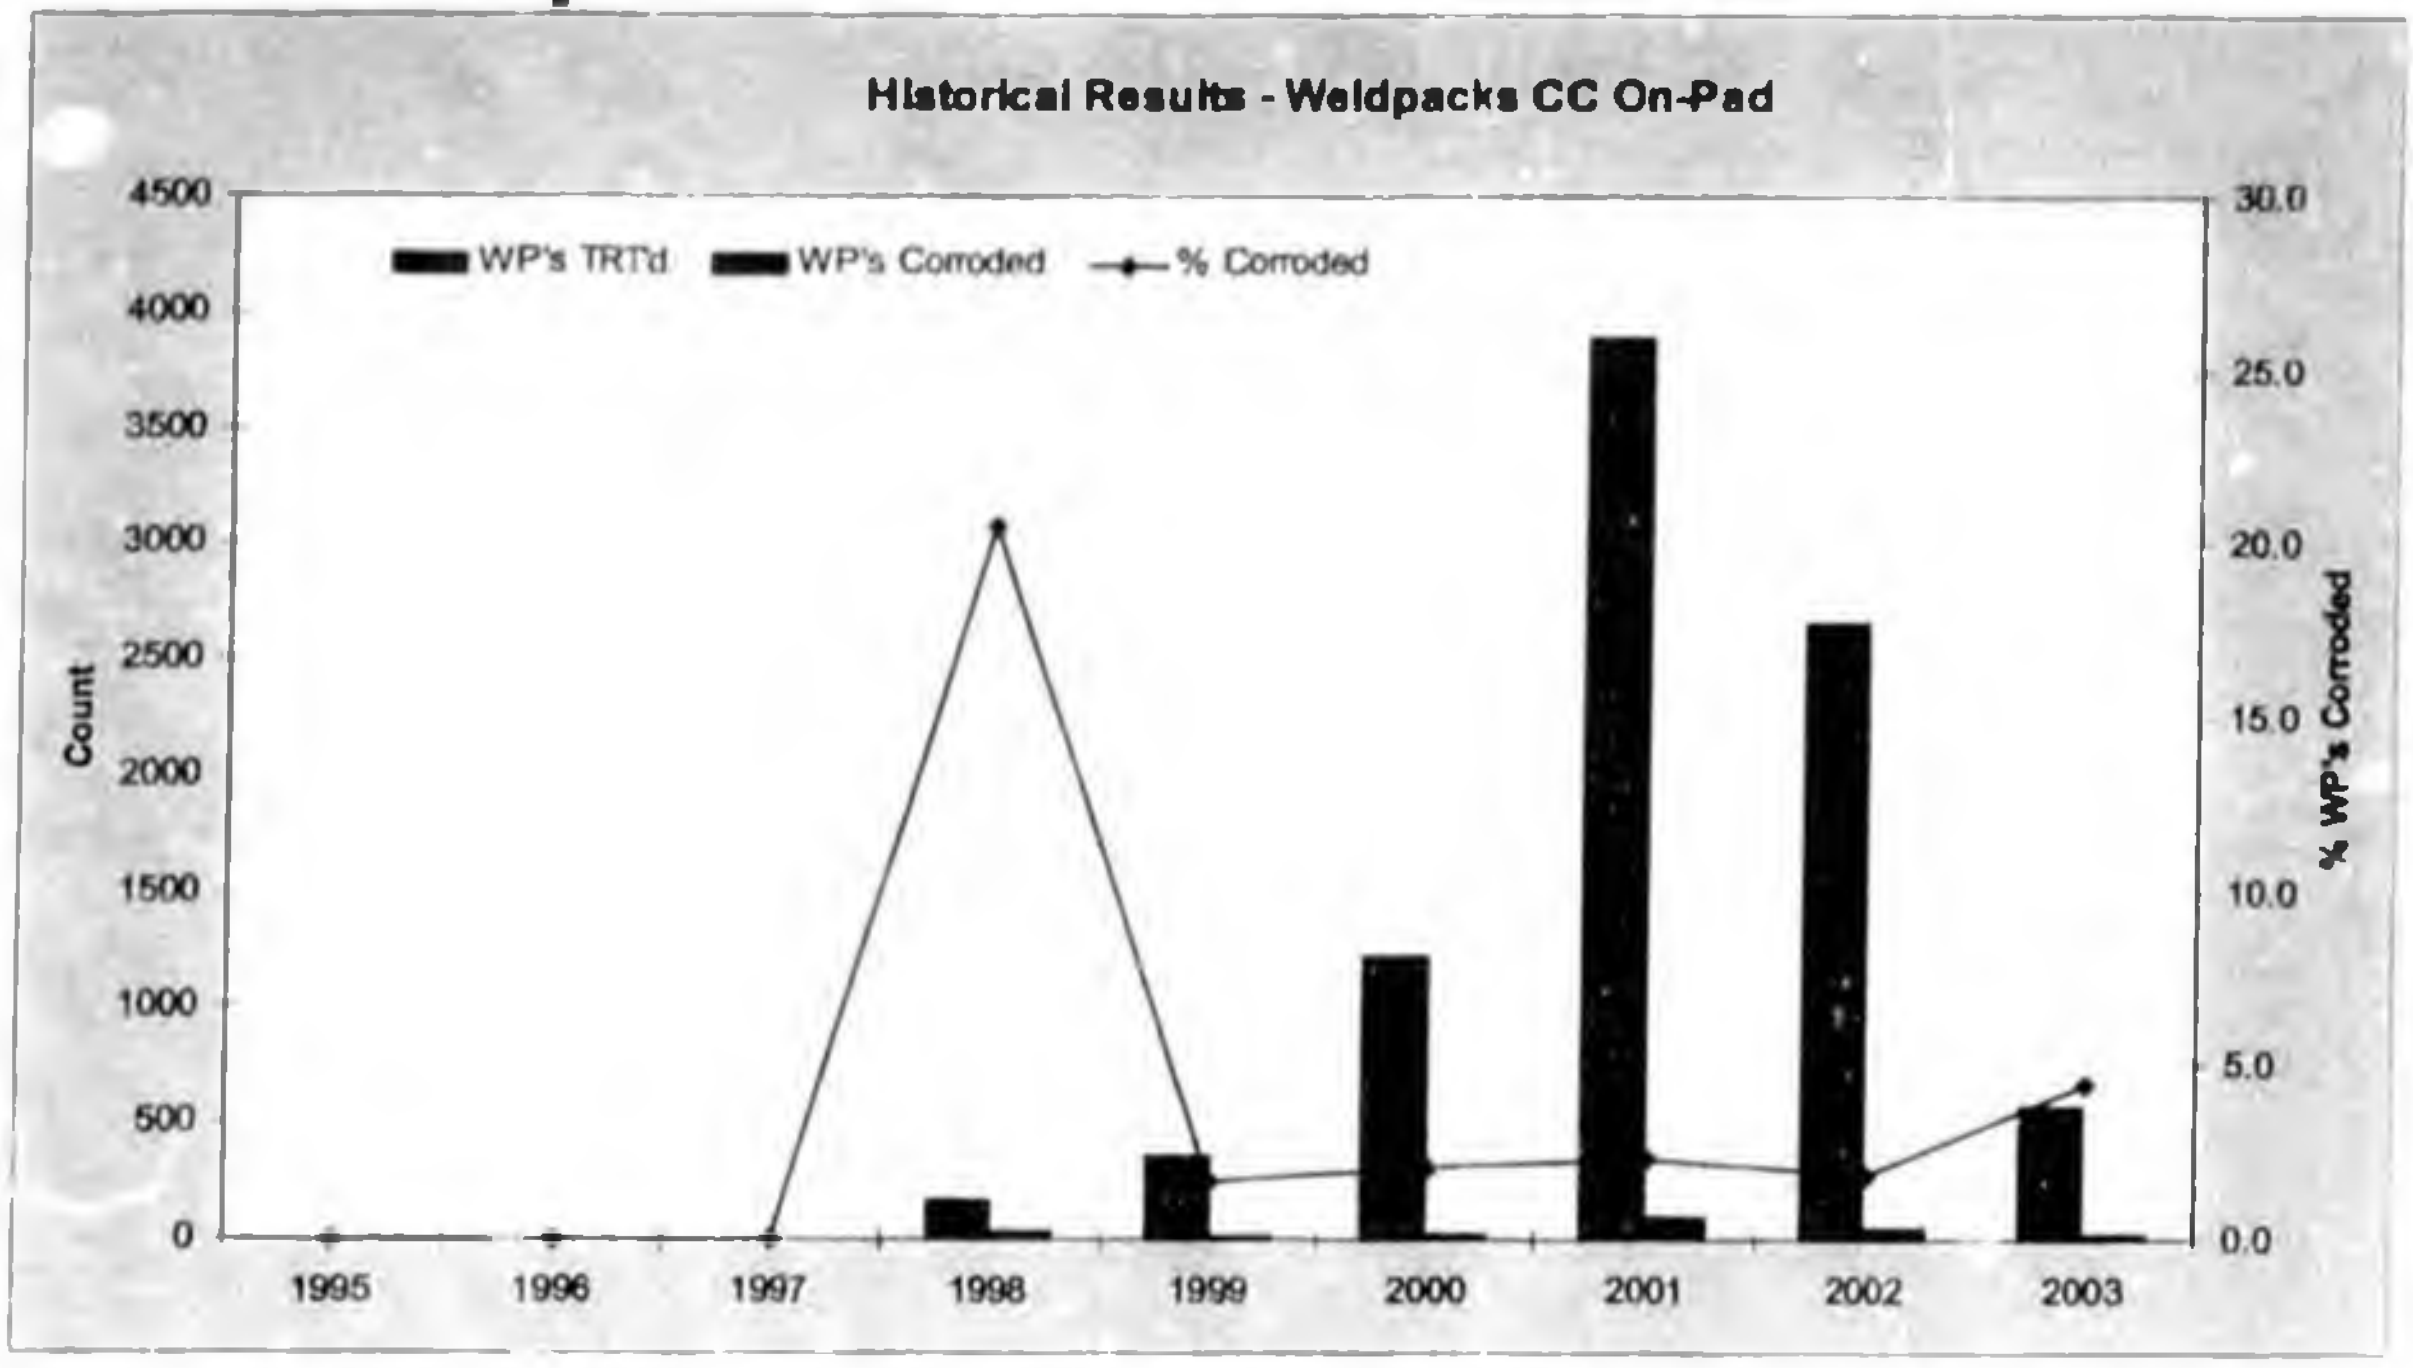
Figure 11. Summary of Weld Packs on Cross-Country Lines on Pads.

Figures 11 and 12 depict the results of the major focus of the external weld pack inspection program in 2003. The cross-country on-pad program is nearing completion and all baseline inspections should be complete by year-end 2004. The well line weld-packs were inspected using a prioritization scheme that examined the oldest, the hottest, and the thinnest-walled lines first. As of year-end 2003, 96% of the cross-country on-pad weld-packs and 91% of the well line weld-packs have received their baseline TRT inspections.

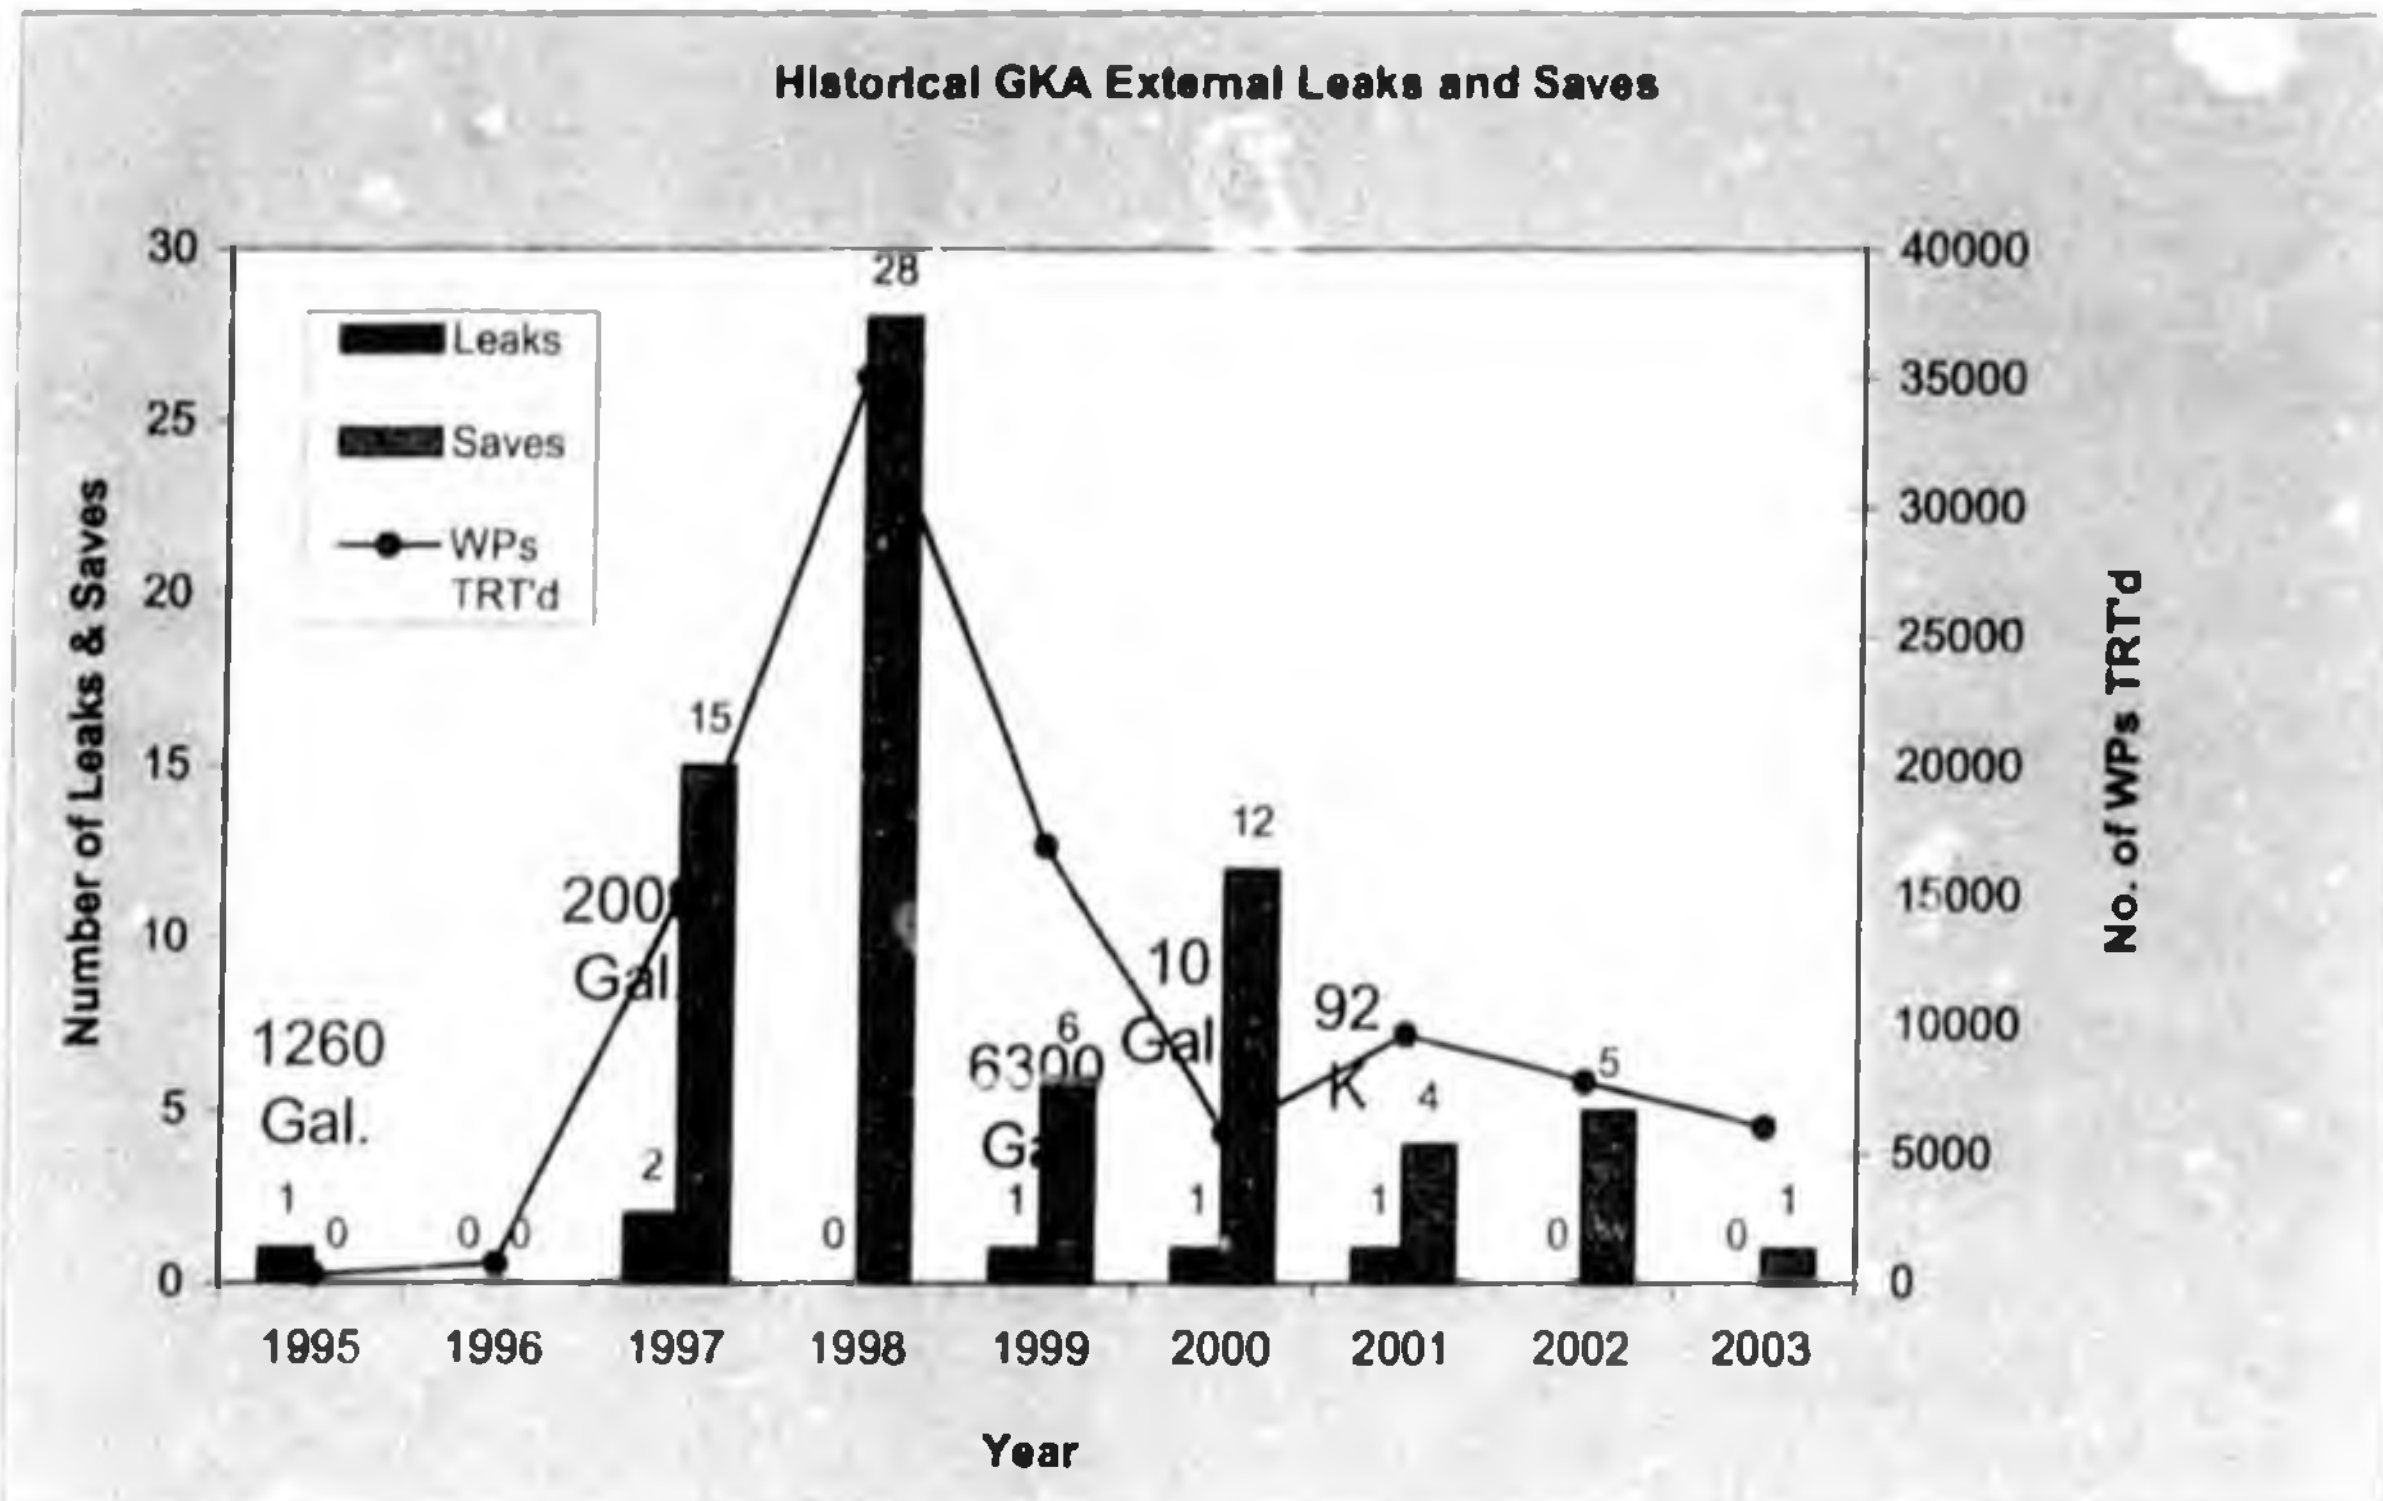
Figure A1. Leaks, saves, number of weld packs inspected with TRT, and volumes of leaks as a function of time.

Note: The leak in 2001 due to external corrosion was located in a weld pack in a below-grade piping segment, and as such, would not have been detected by the TRT inspection program. The location had not yet received PTI/TWI inspection.

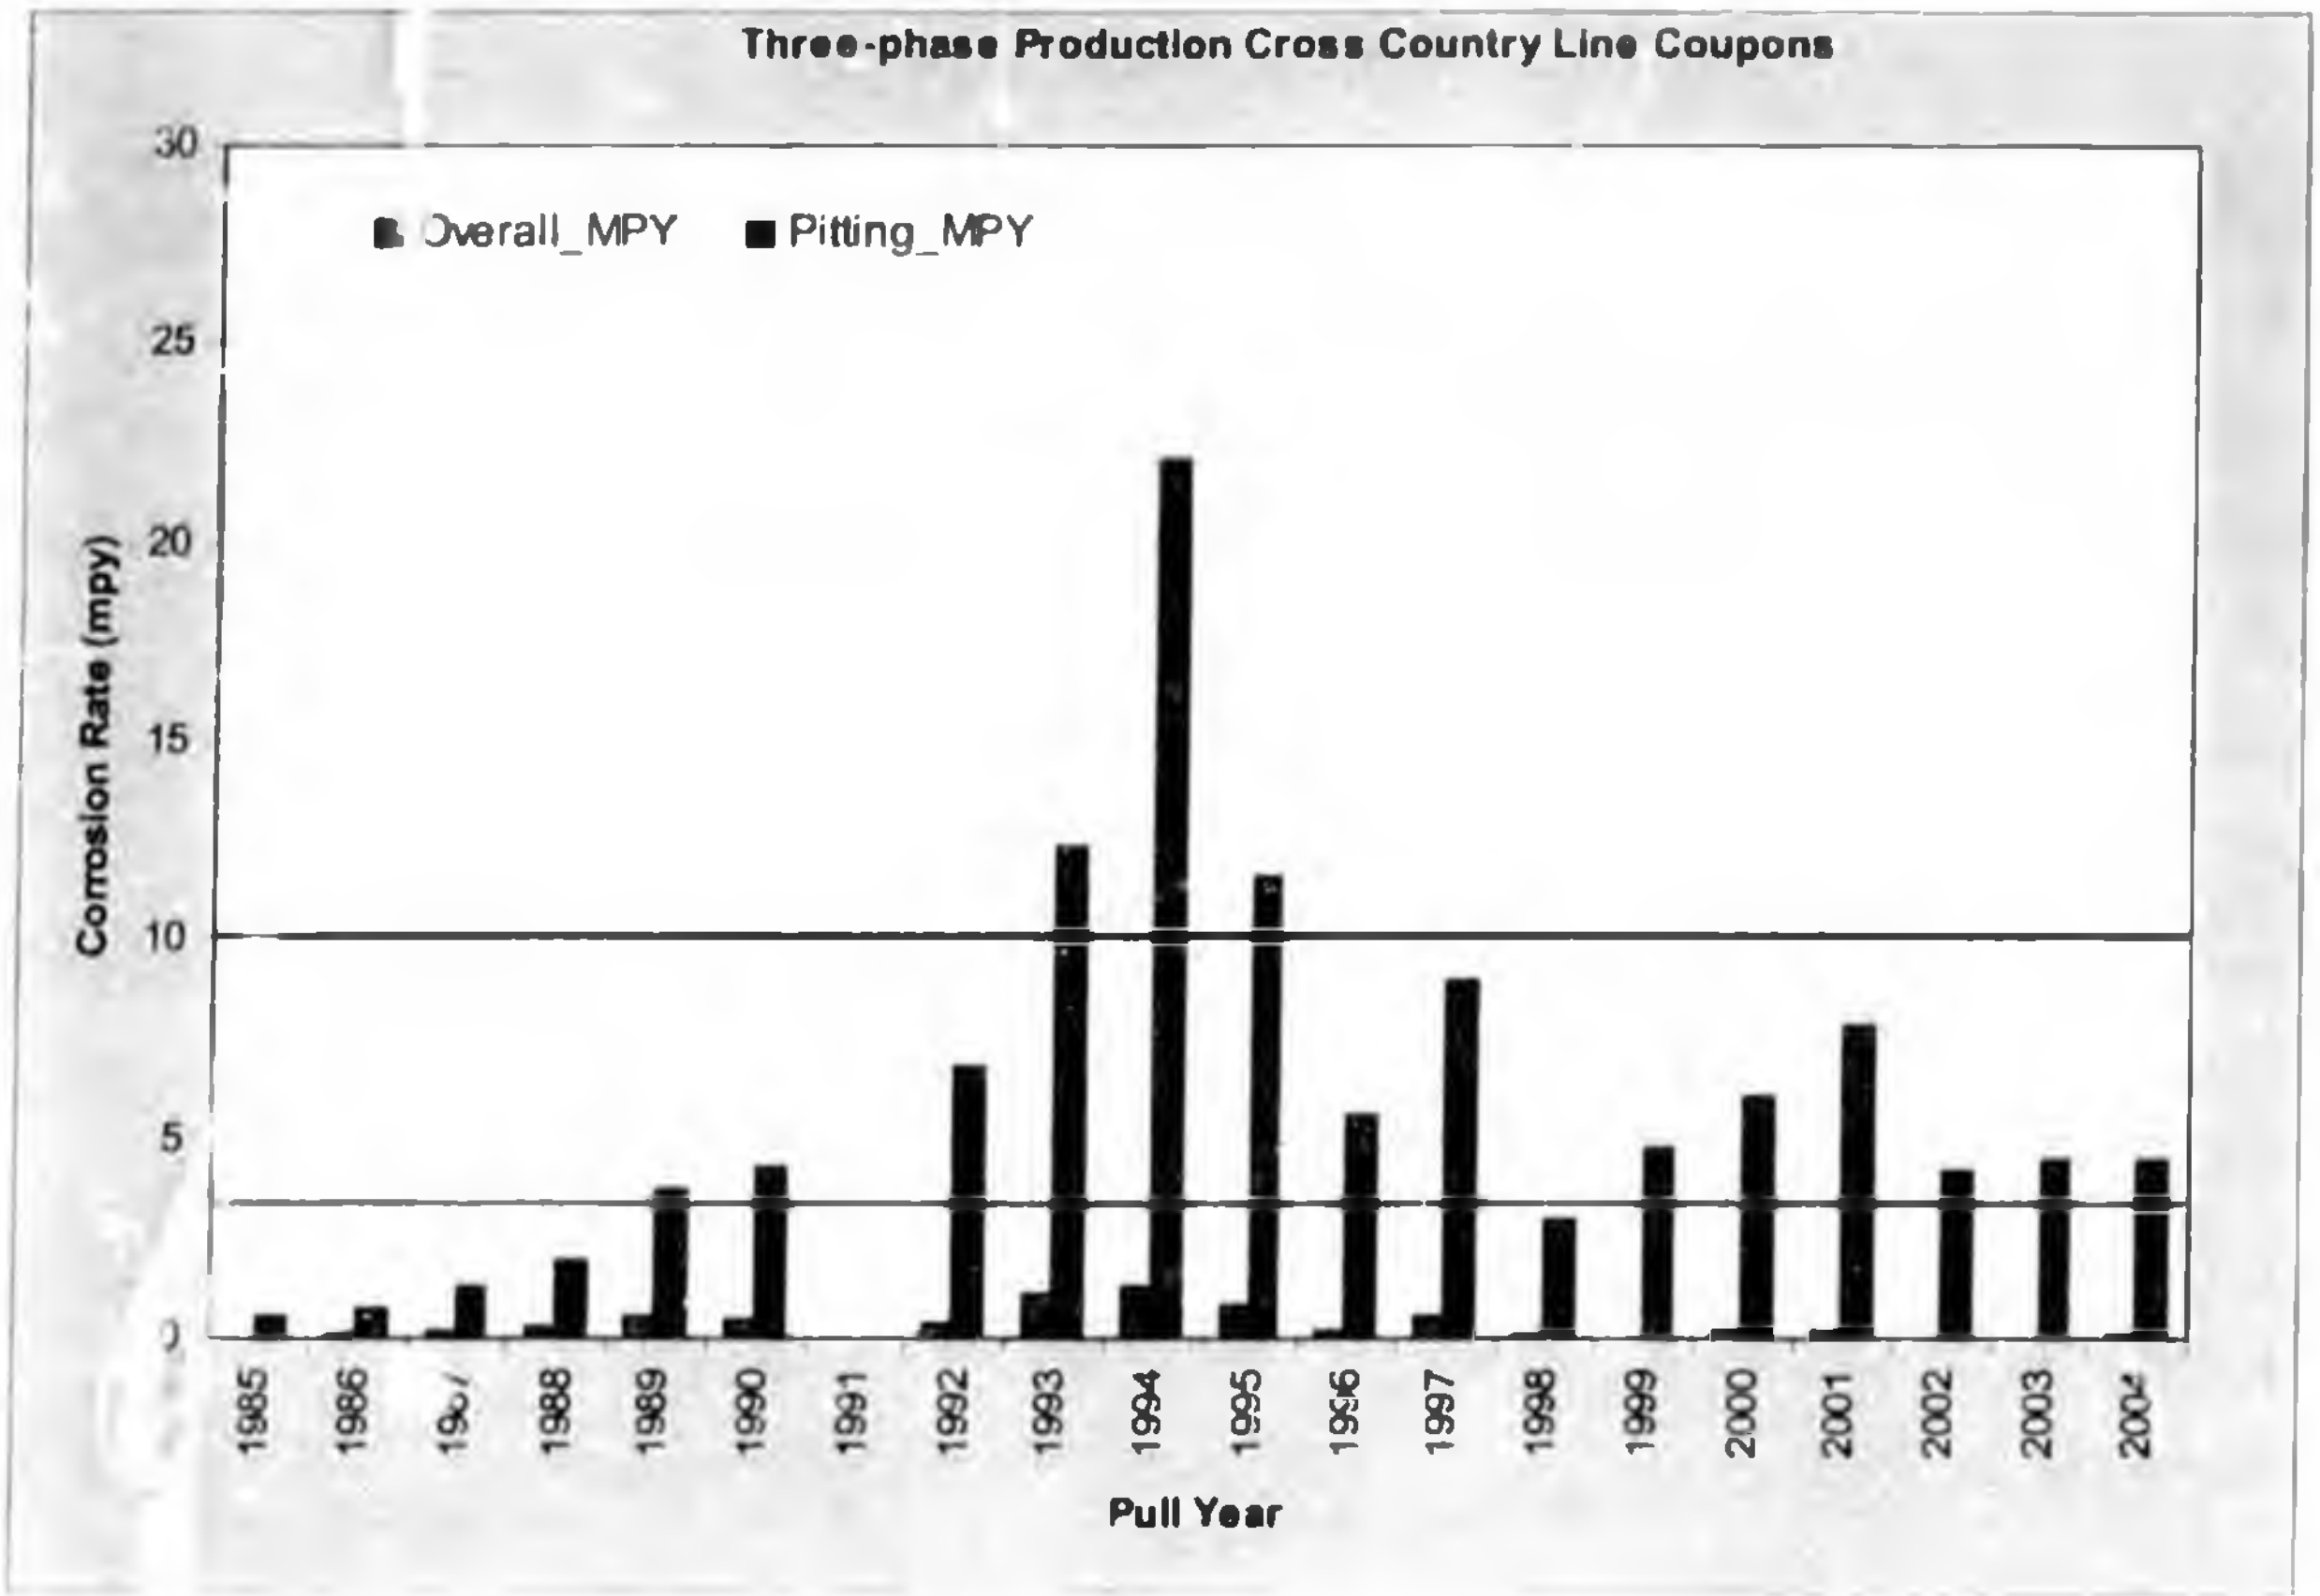
Figure 1. Three-phase Production Cross-Country Line Coupons – general and pitting corrosion rates as a function of time.

Three-phase Production Cross-Country Lines: The monitoring data summarized in Kuparuk Tables 1 and 2 and presented in Figure 1 suggest that general corrosion is under control. The data presented in the Tables 1 and 2 and in Figure 1 include corrosion coupon data from the wet oil lines starting at CPF3 and going to CPF1 and CPF2.

Where corrosion rates exceeded targets, corrosion inhibitor concentrations were increased and/or the amount of inspection was increased excluding: one corrosion inhibitor test location (2WUVPO); and one location that had increased inspection damage over a 12-month period and that had its corrosion inhibitor concentration increased at the end of 2003 (1L10PO). In 2004, coupon or probe corrosion rates exceeded targets on fifteen lines and action was taken on all fifteen of these lines. In 2004, inspection results indicated minor corrosion had occurred on six lines; corrosion inhibitor concentrations were increased in four of these lines. A complete listing of the lines with coupon/probe corrosion rates that exceeded targets and/or where inspection indicated increased damage is given in Table 3.

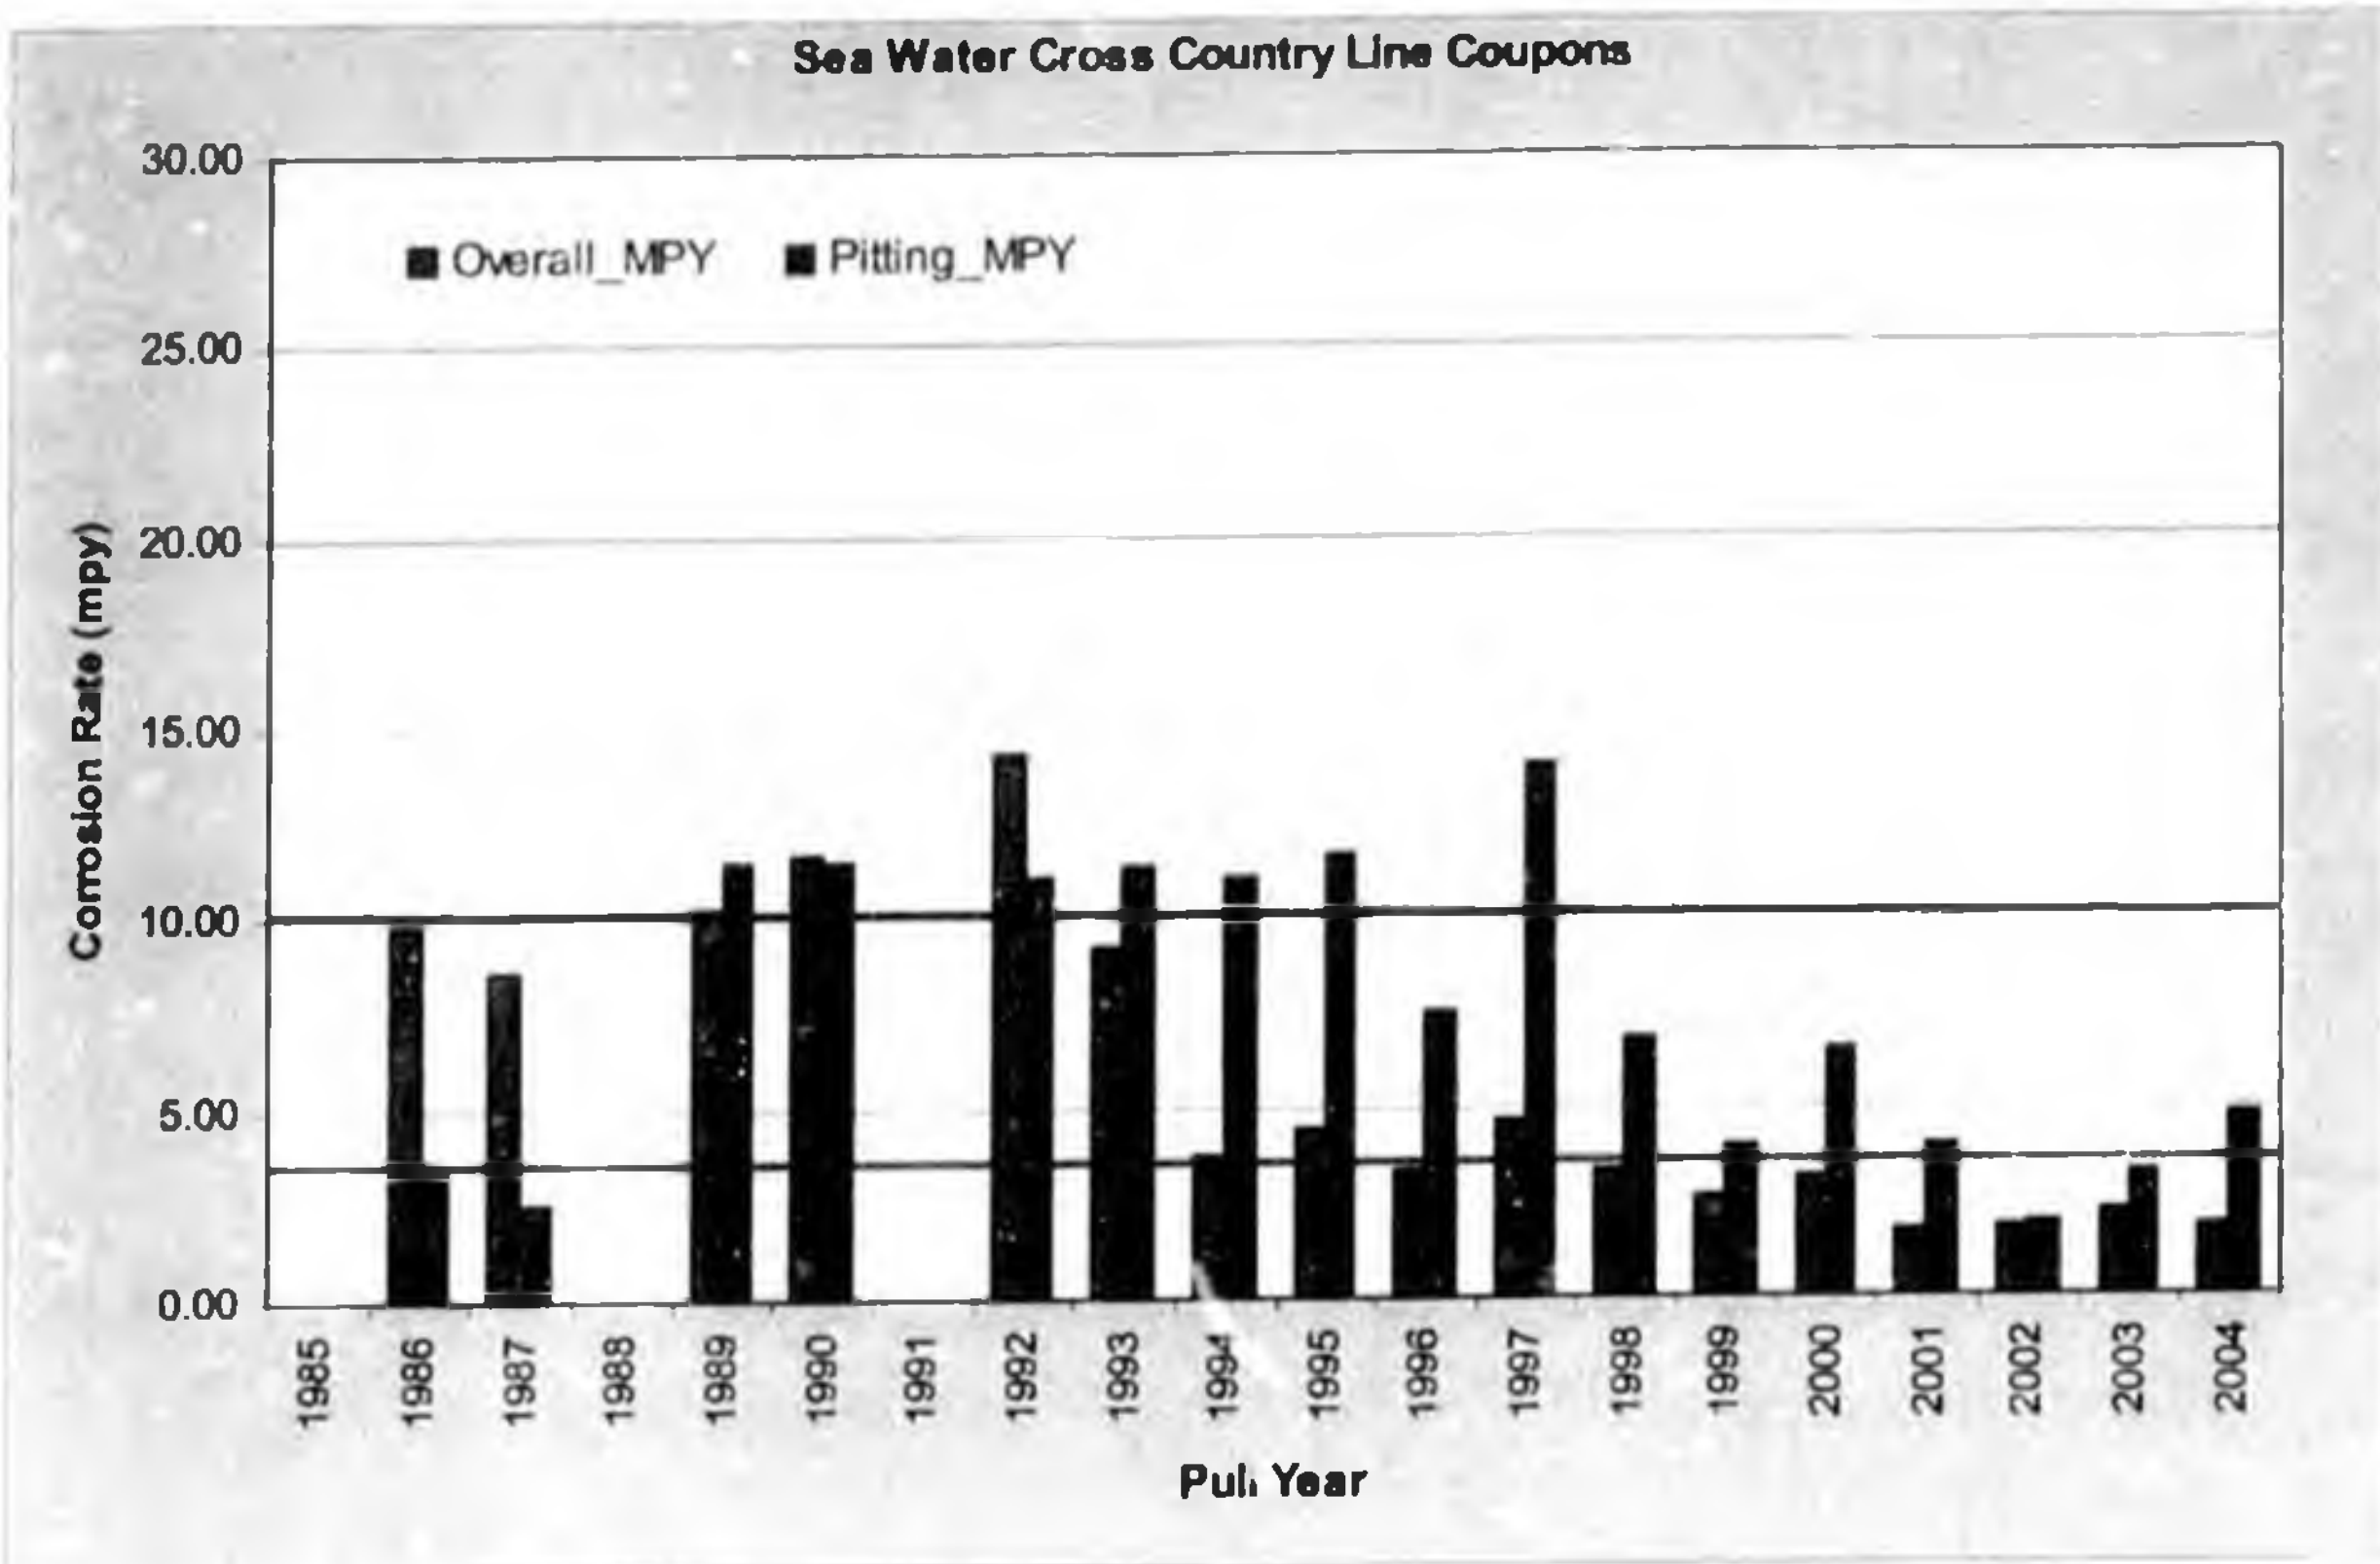
Figure 2. Seawater Cross-Country Line Coupons – general and pitting corrosion rates as a function of time.

Sea Water Cross-Country Lines: The monitoring data summarized in Kuparuk Tables 1 and 2 and presented in Figure 2 above, shows the average corrosion rates for the sea water cross-country line coupons remained under thresholds in 2004.

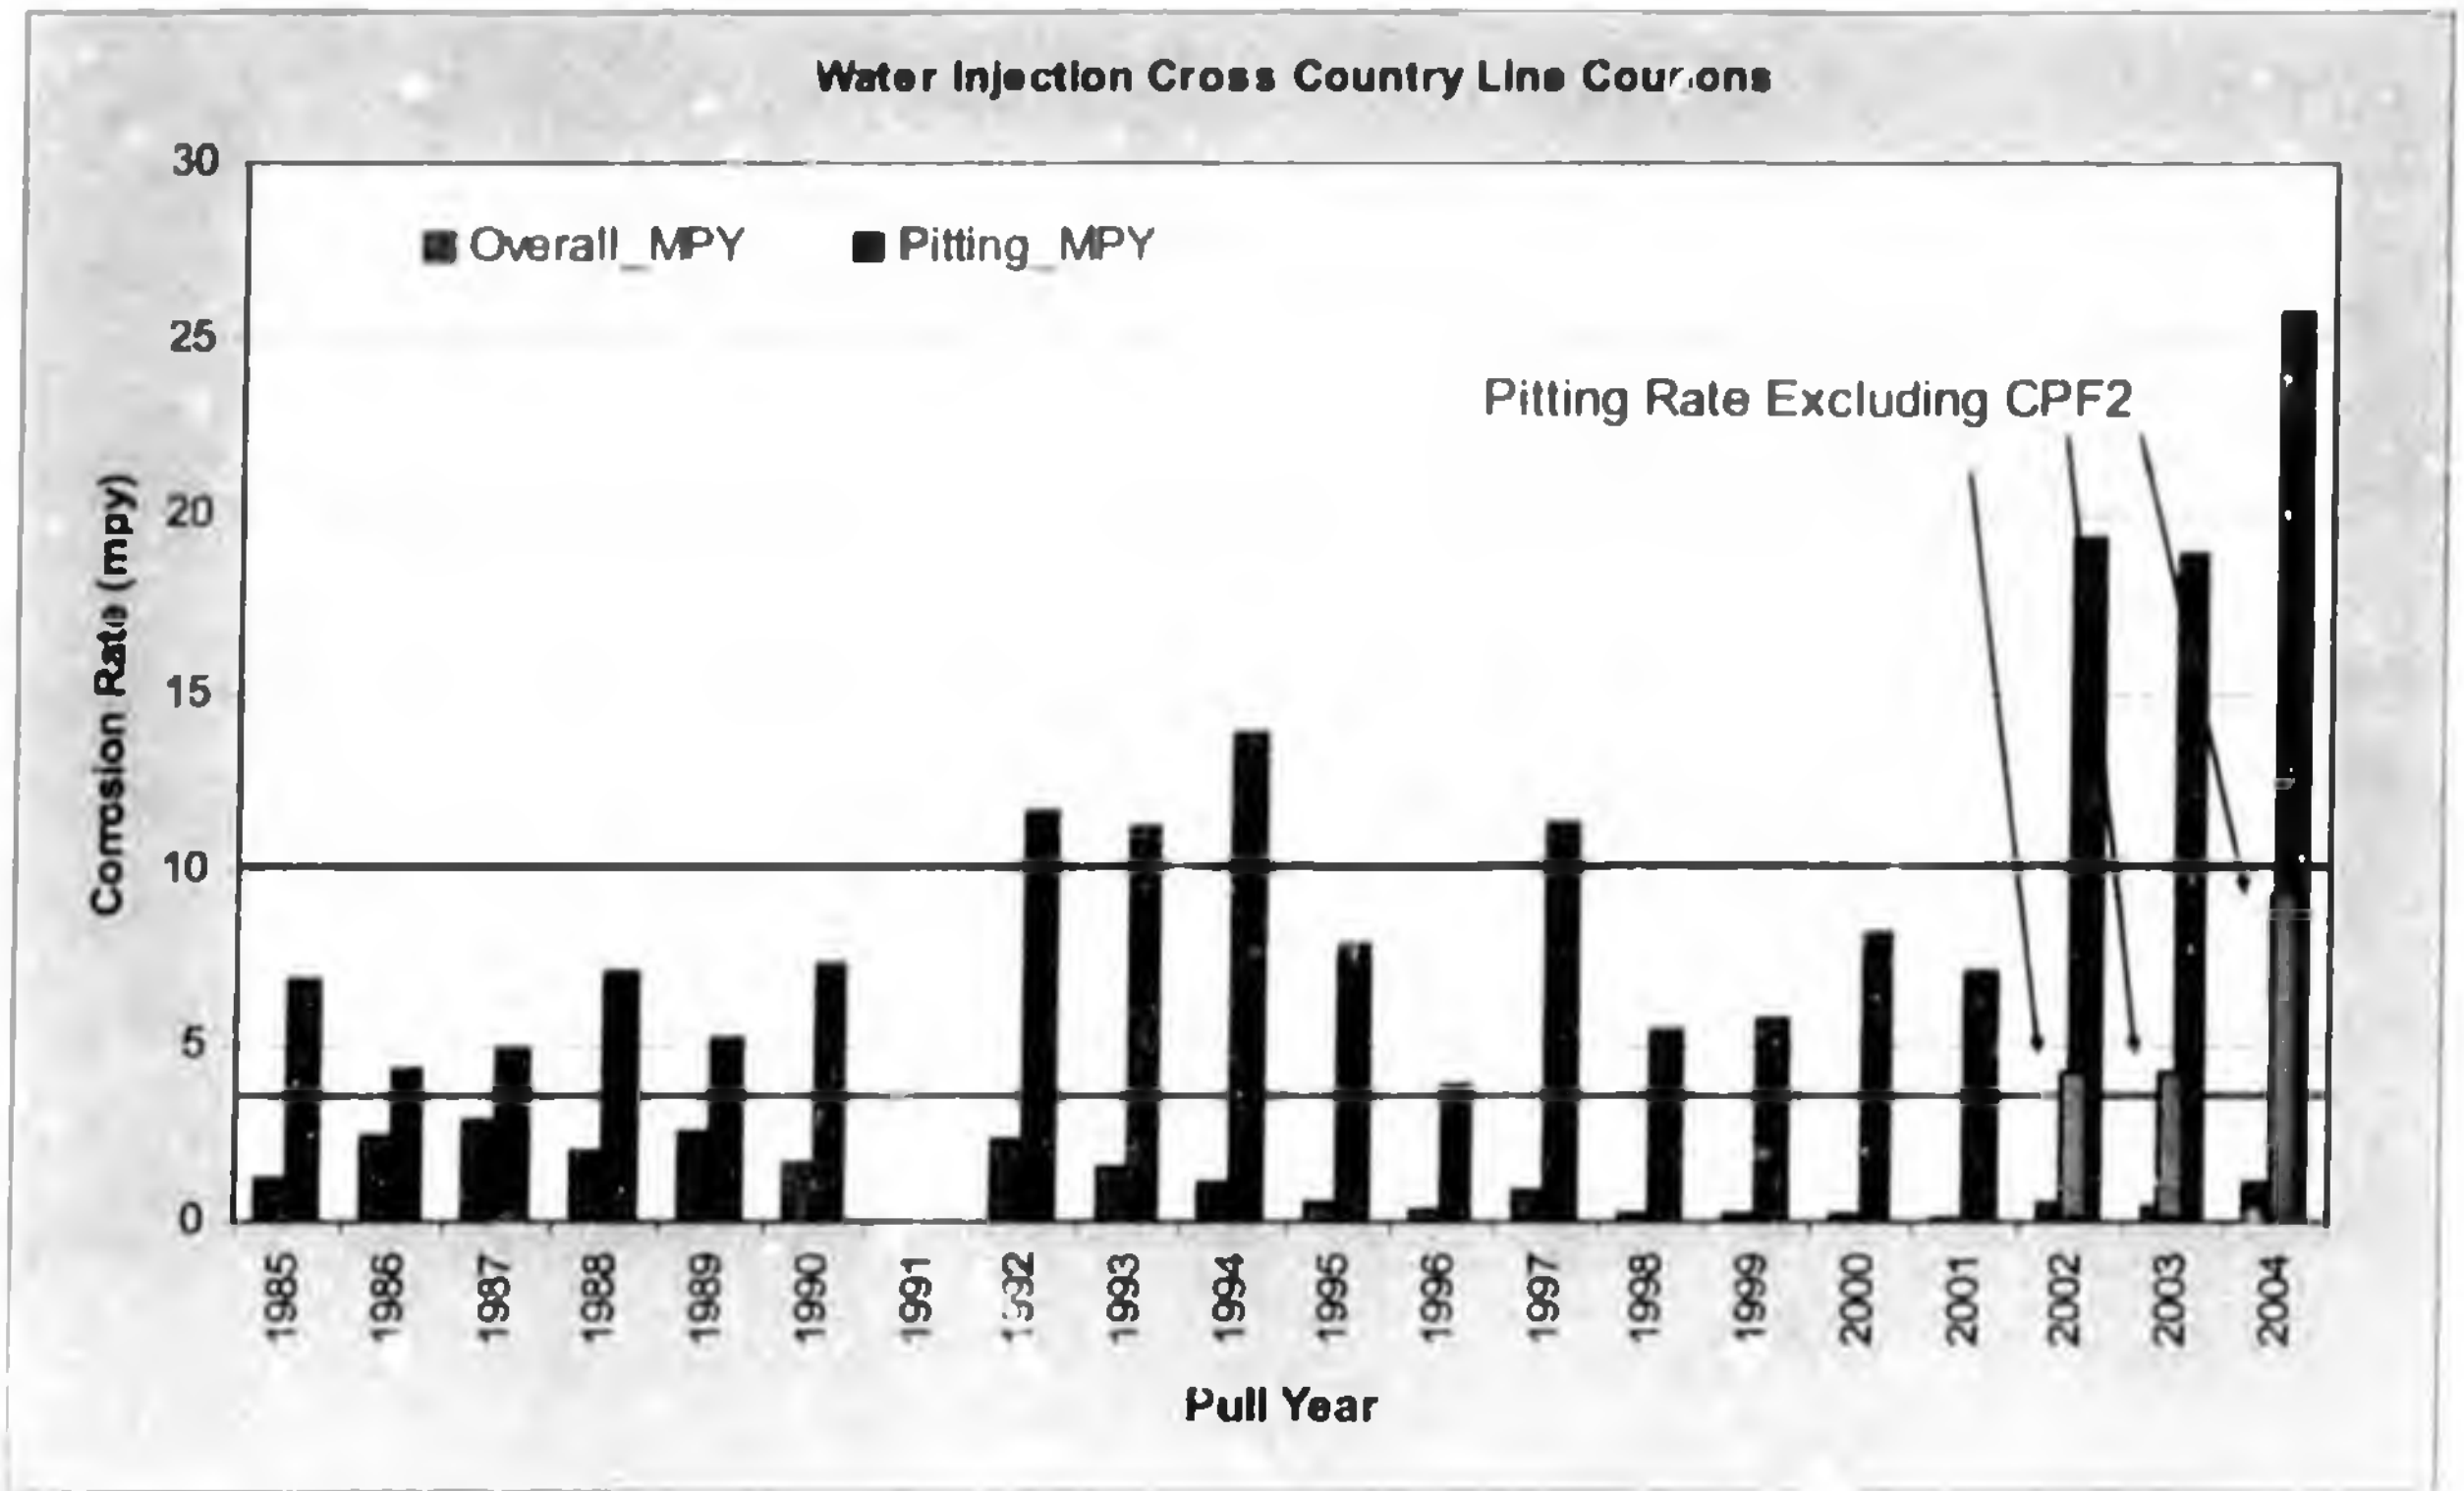
Figure 3. Water Injection Cross-Country Line Coupons – general and pitting corrosion rates as a function of time.

Mixed Water Injection Cross-Country Lines: The monitoring data summarized in Kuparuk Tables 1 and 2 and presented in Figure 3 show that average general corrosion rates are below the threshold, but that pitting rates for the field are above the threshold. Closer analysis of the data shows that the average pitting rate excluding CPF2 locations is under the threshold. Coupon results are used to prioritize inspection efforts. During the second half of 2004, equipment was installed and procedures were implemented to provide enhanced biocide treatments at CPF2. The first quarter 2005 coupon pulls from CPF2 show that pitting rates are lower than the 2004 average, but are still above threshold. In addition to the biocide treatment enhancements, an additional 80K BWPD of SW has been added to CPF2. This will increase line velocities and is anticipated to help reduce the under-deposit corrosion seen on many of these coupons.

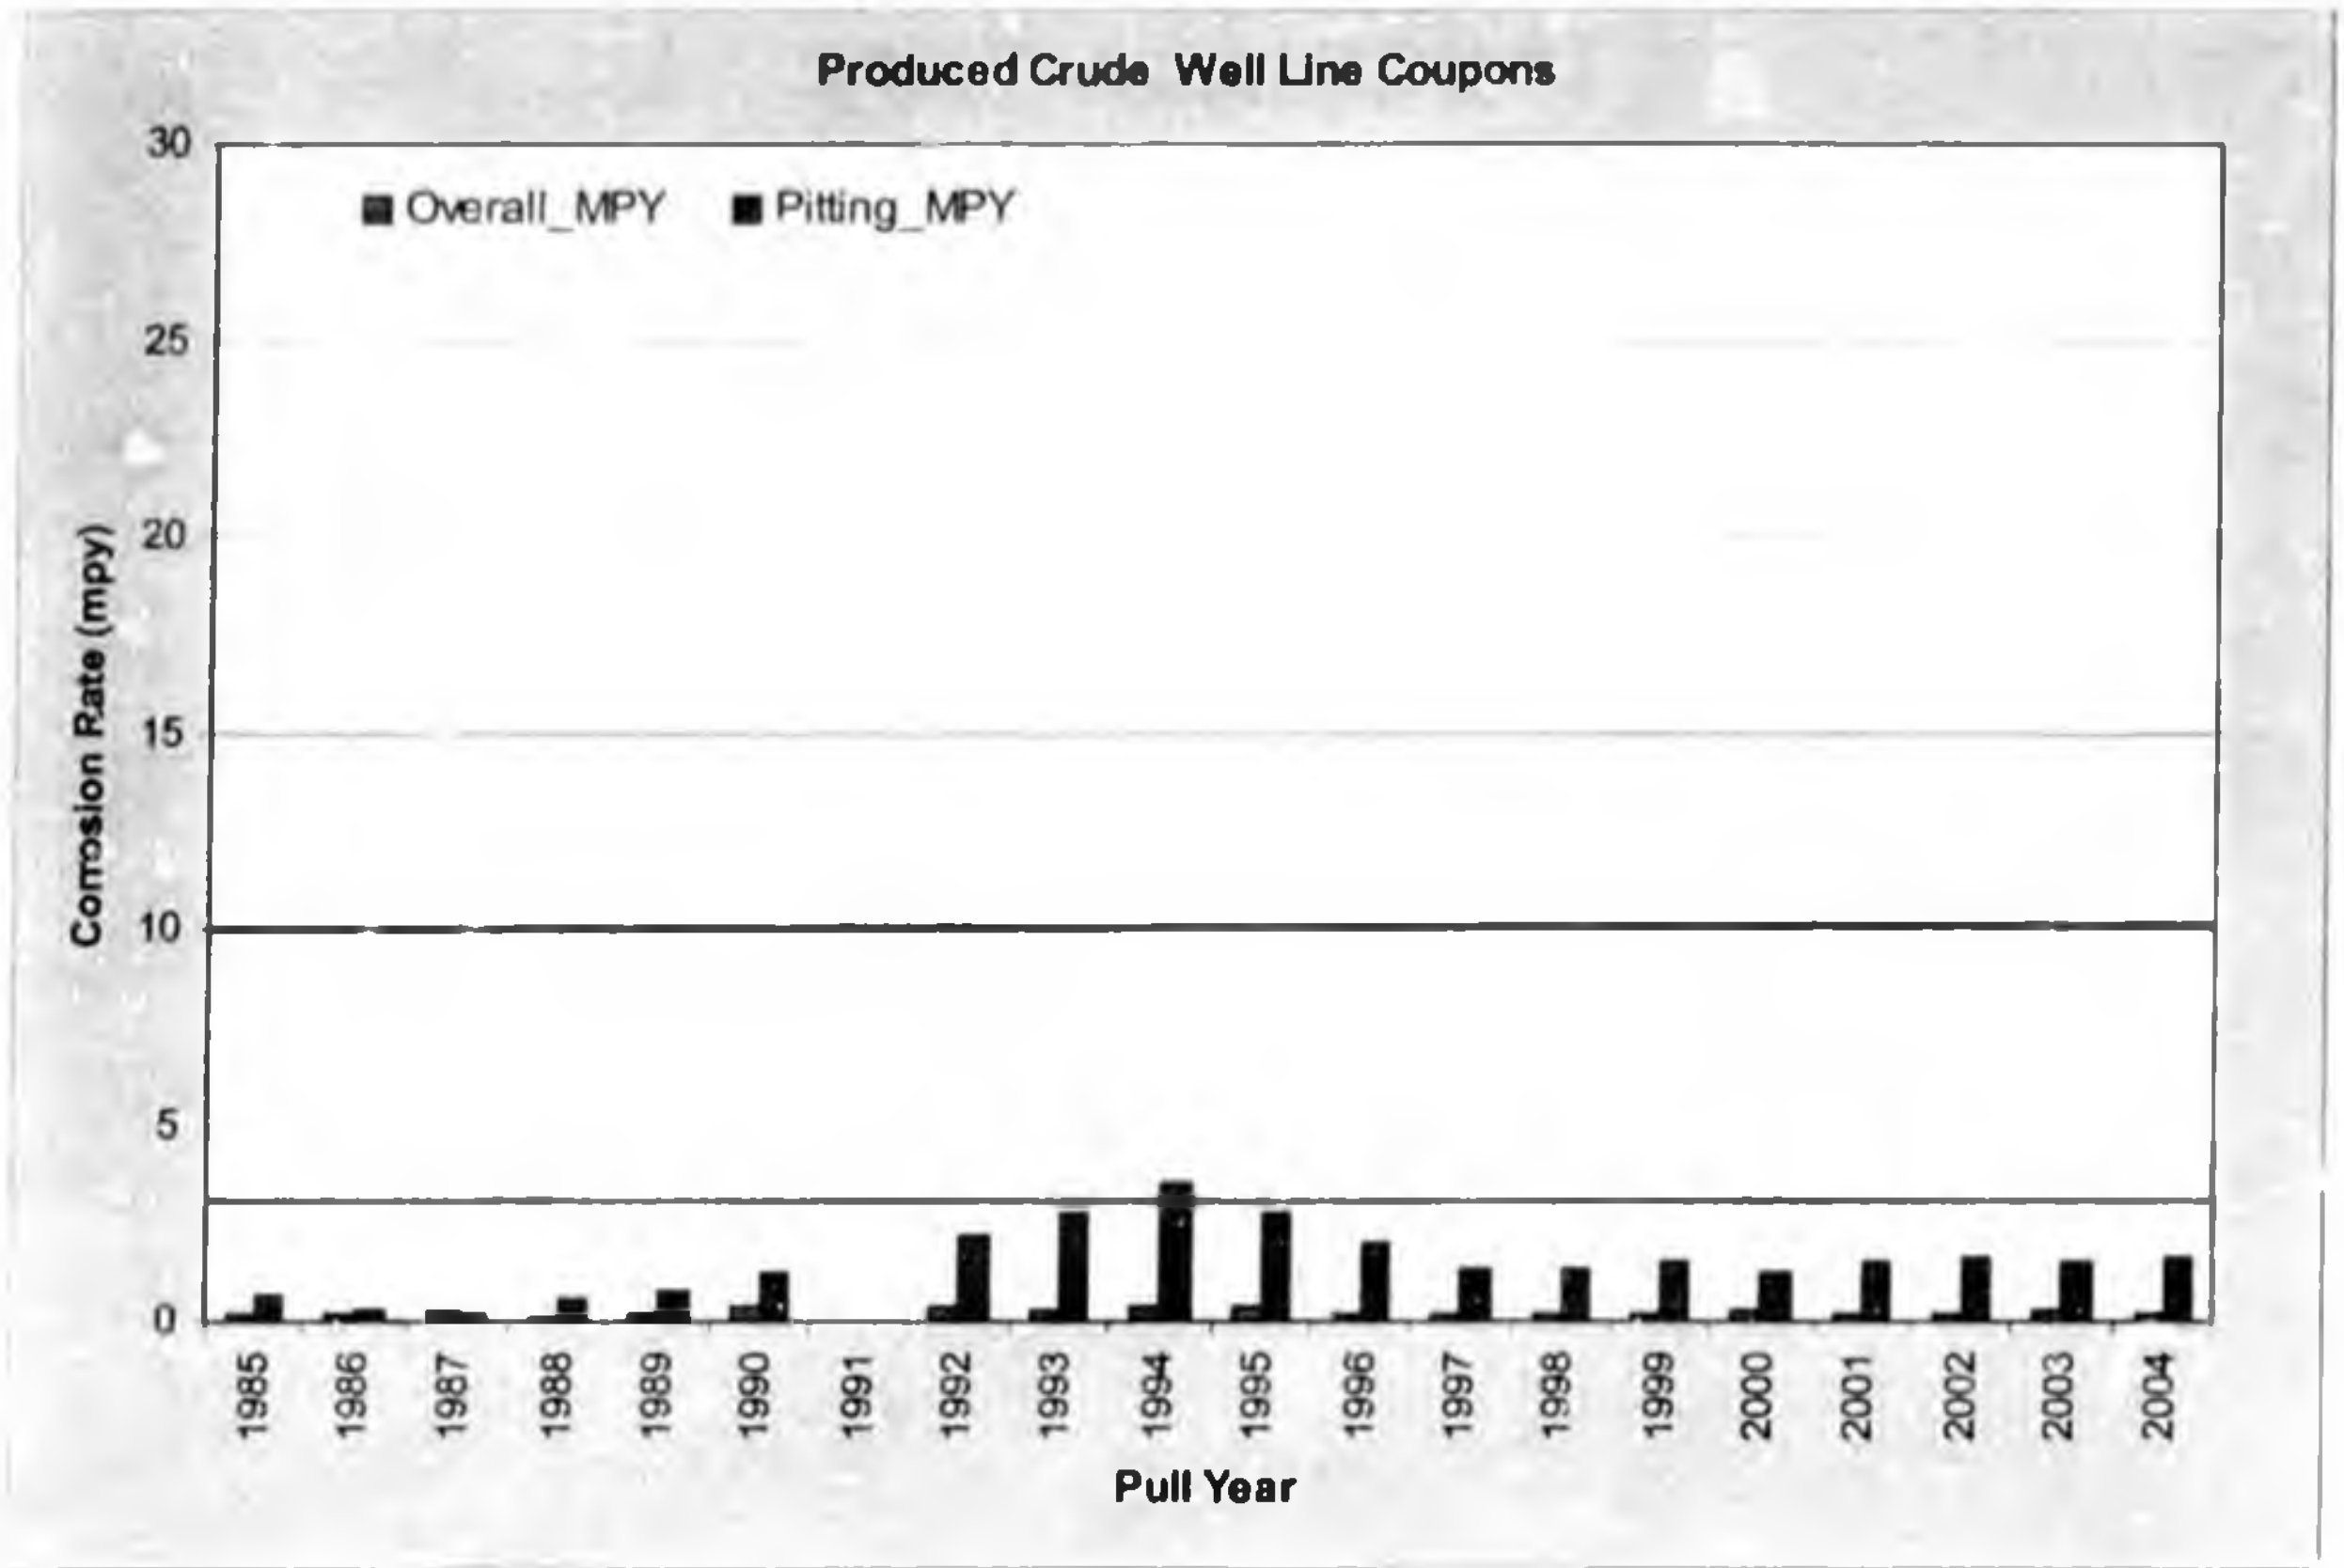
Figure 4. Three-phase Production Well Line Coupons – general and pitting corrosion rates as a function of time.

Three-phase Production Well Flow Lines: While the monitoring data summarized in Kuparuk Tables 1 and 2 and presented in Figures 4 and 5 suggest that corrosion rates are below targets, inspection data indicate that higher corrosion rates have been experienced historically. The well line inspection data are discussed in section 3.1.b below, and are a good example of why monitoring data alone cannot be relied upon to characterize corrosion in a given system. For three-phase production, coupons monitor free flowing fluid and have not shown the predominant, under-deposit corrosion mechanism.
