ALASKA LEGISLATURE COMMITTEE FILES, 2005-2006 8672
11973 SENATE RESOURCES

Greater Kuparuk Area (GKA)
Alpine Field
Corrosion Programs Overview

Commitment to Corrosion Monitoring

Prepared by
ConocoPhillips Corrosion Team

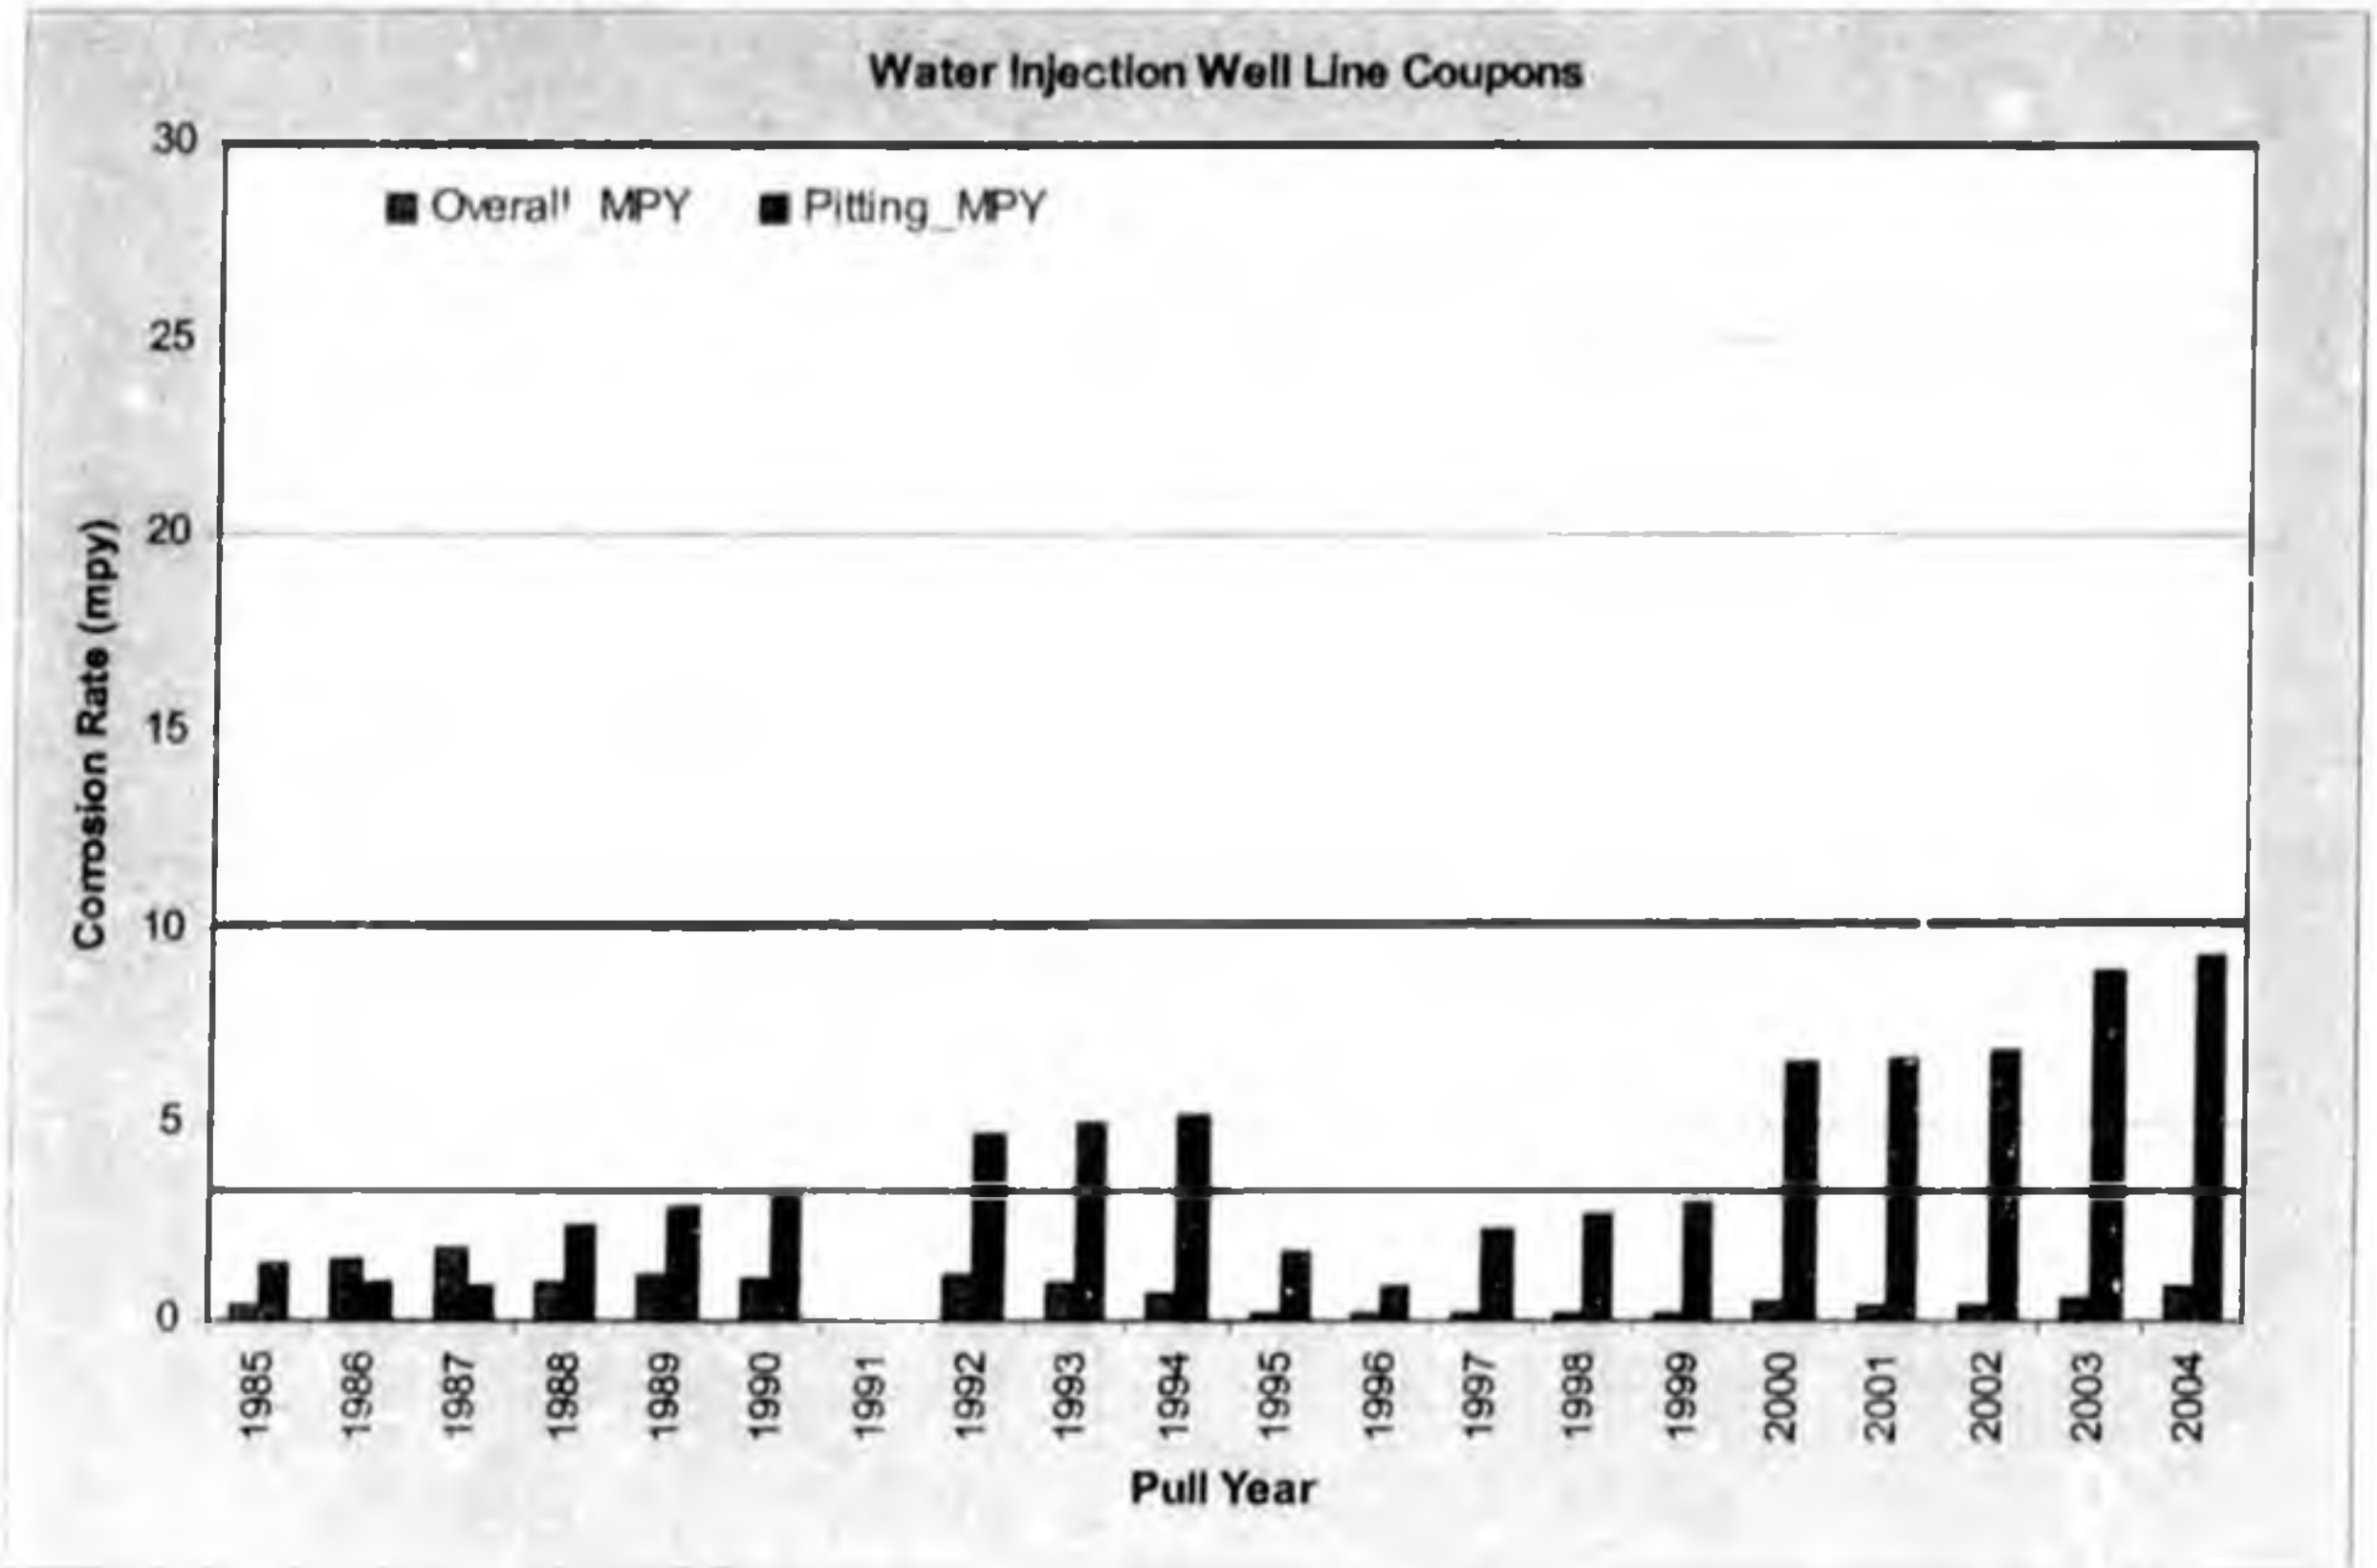
Figure 5. Water Injection Well Line Coupons - general and pitting corrosion rates as a function of time.

Water Injection Well Flow Lines: As discussed in section 3.1.b below, the well line inspection data on water injectors show that there are a significant number of corrosion related repairs. The water feeding this system is treated at the facilities with biocide and is discussed under Figure 3 - Water Injection Cross-Country Line Coupons.

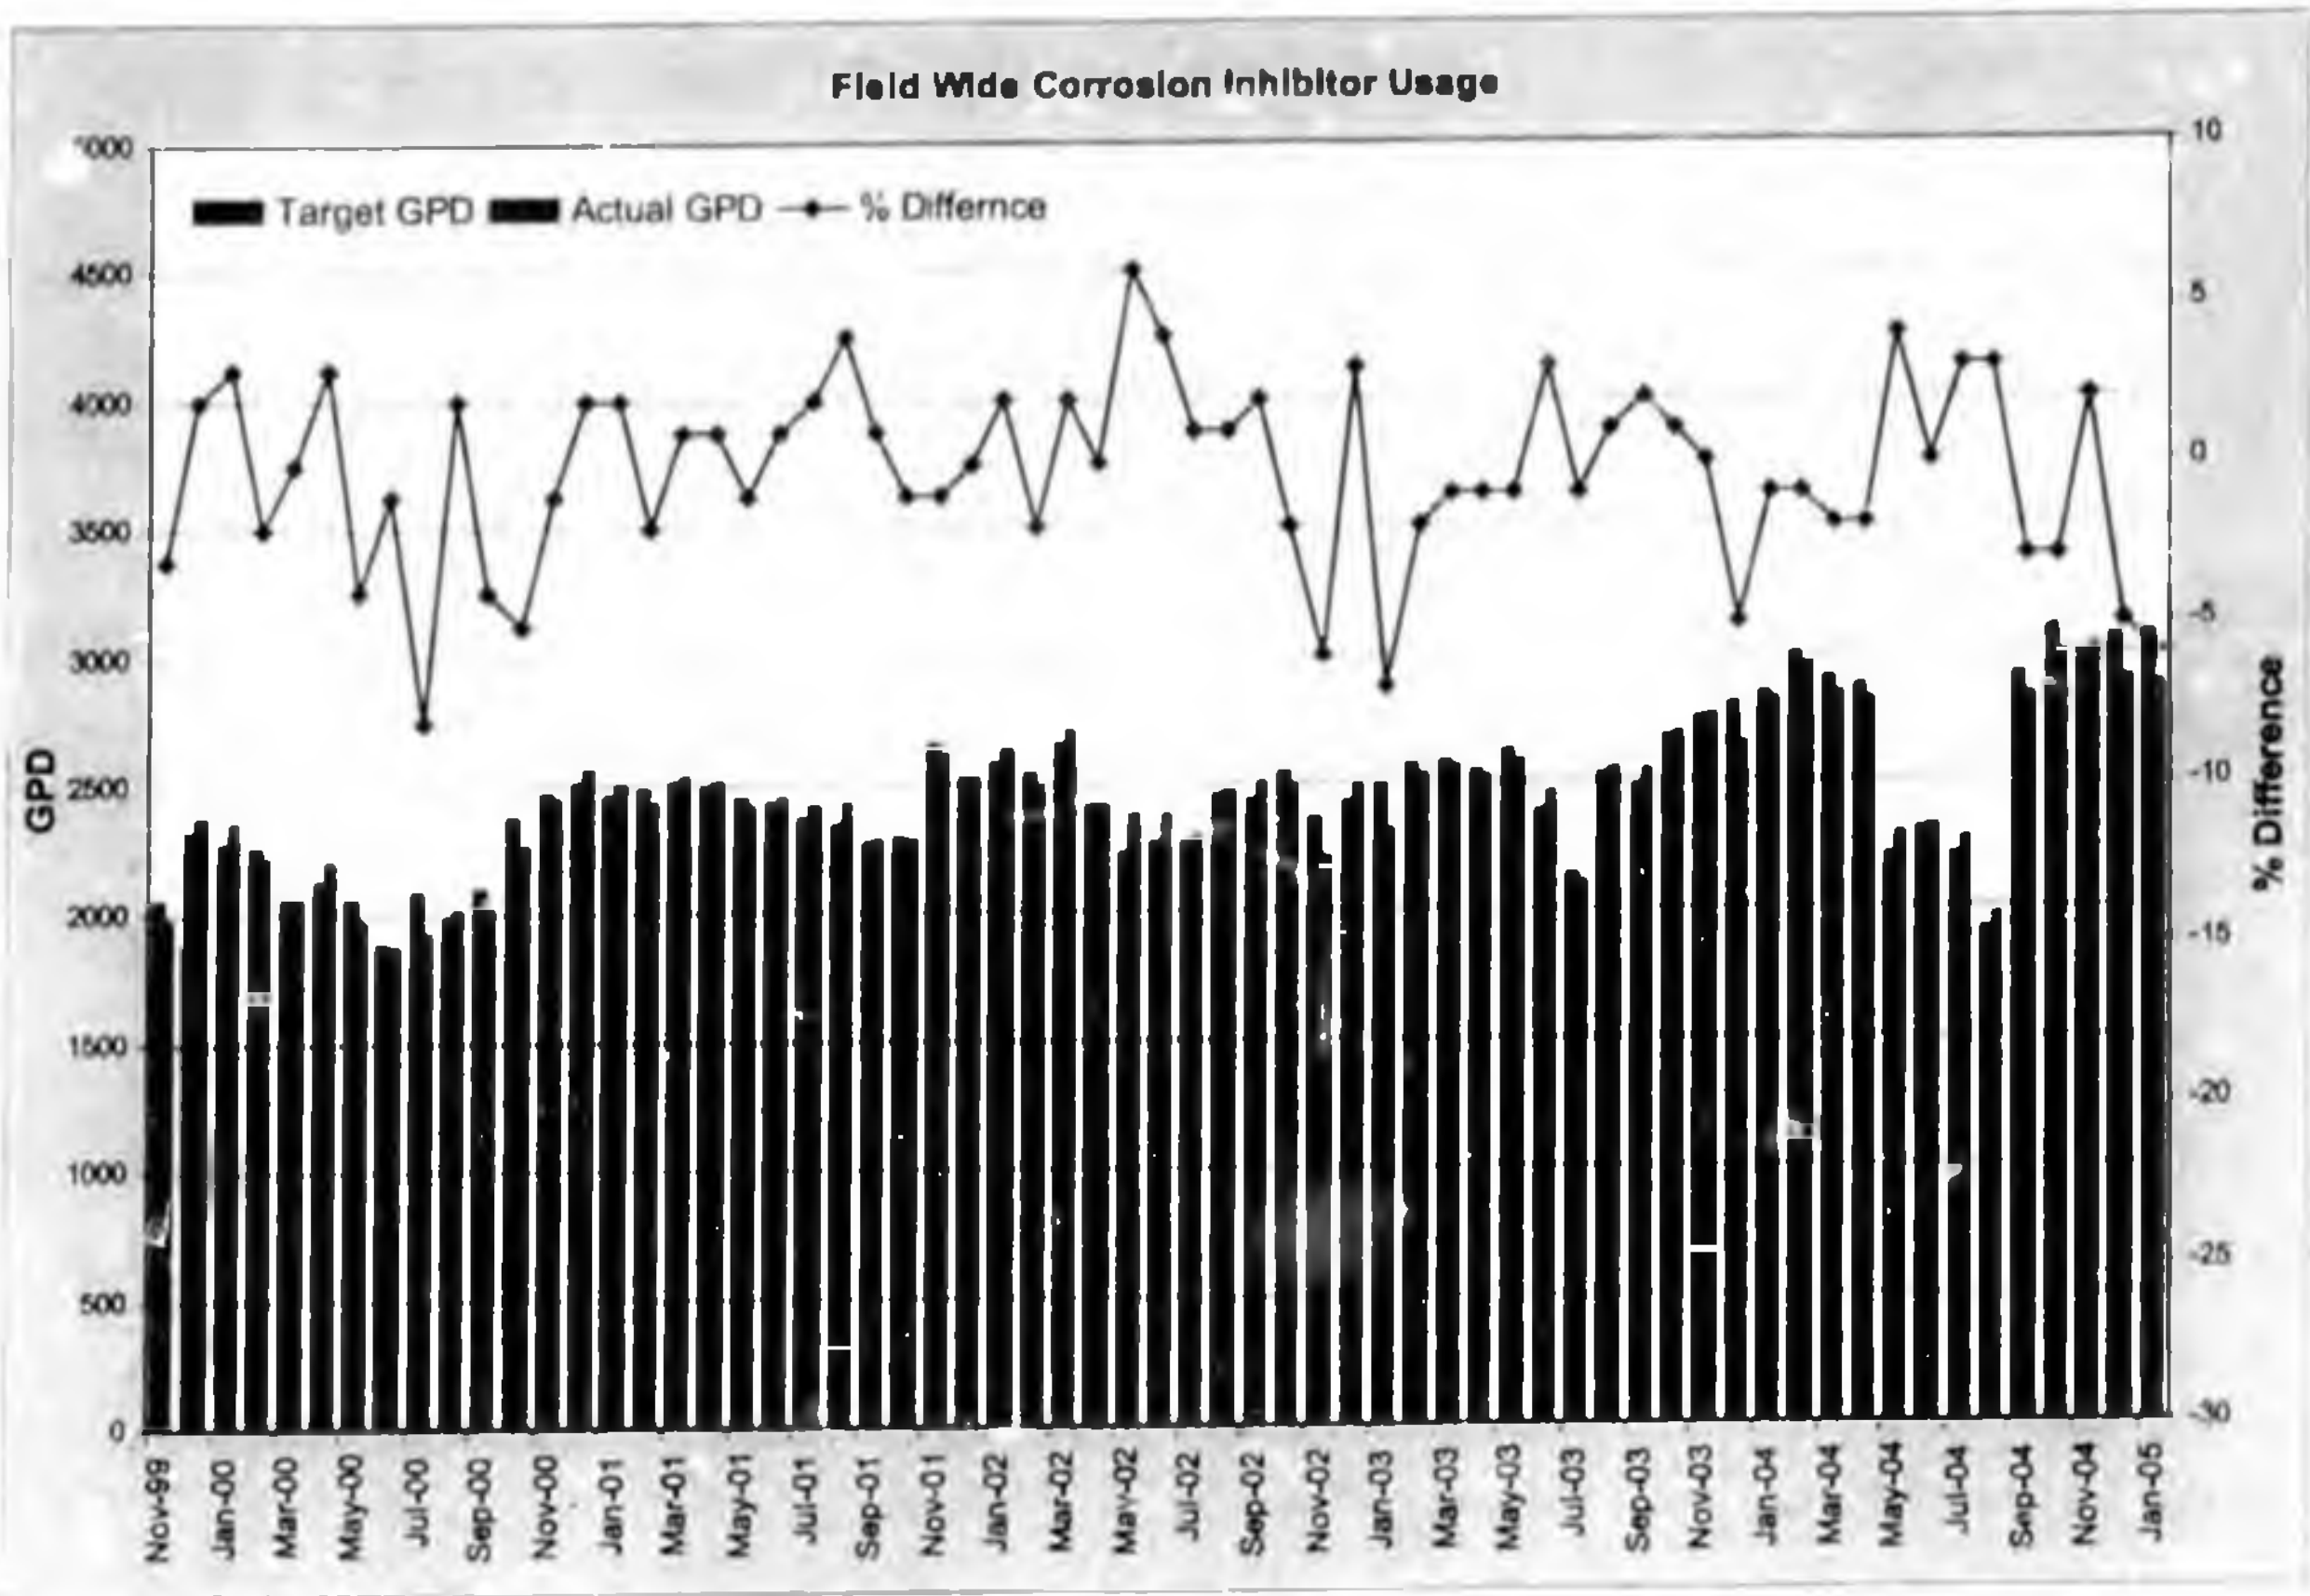
Figure 6. Field-wide Corrosion Inhibitor Use.

For the Kuparuk field, Figure 6 shows the actual number of gallons of corrosion inhibitor pumped per day, the recommended number of gallons of corrosion inhibitor per day, and the percent difference between the two. The average deviation for the year was –0.85%. The larger variation seen in the November and December 2004 data was caused by the extreme weather. The lower usage seen in May through August was due to pumping a more concentrated blend of the same field-wide corrosion inhibitor (the concentration of active components in both blends is the same).

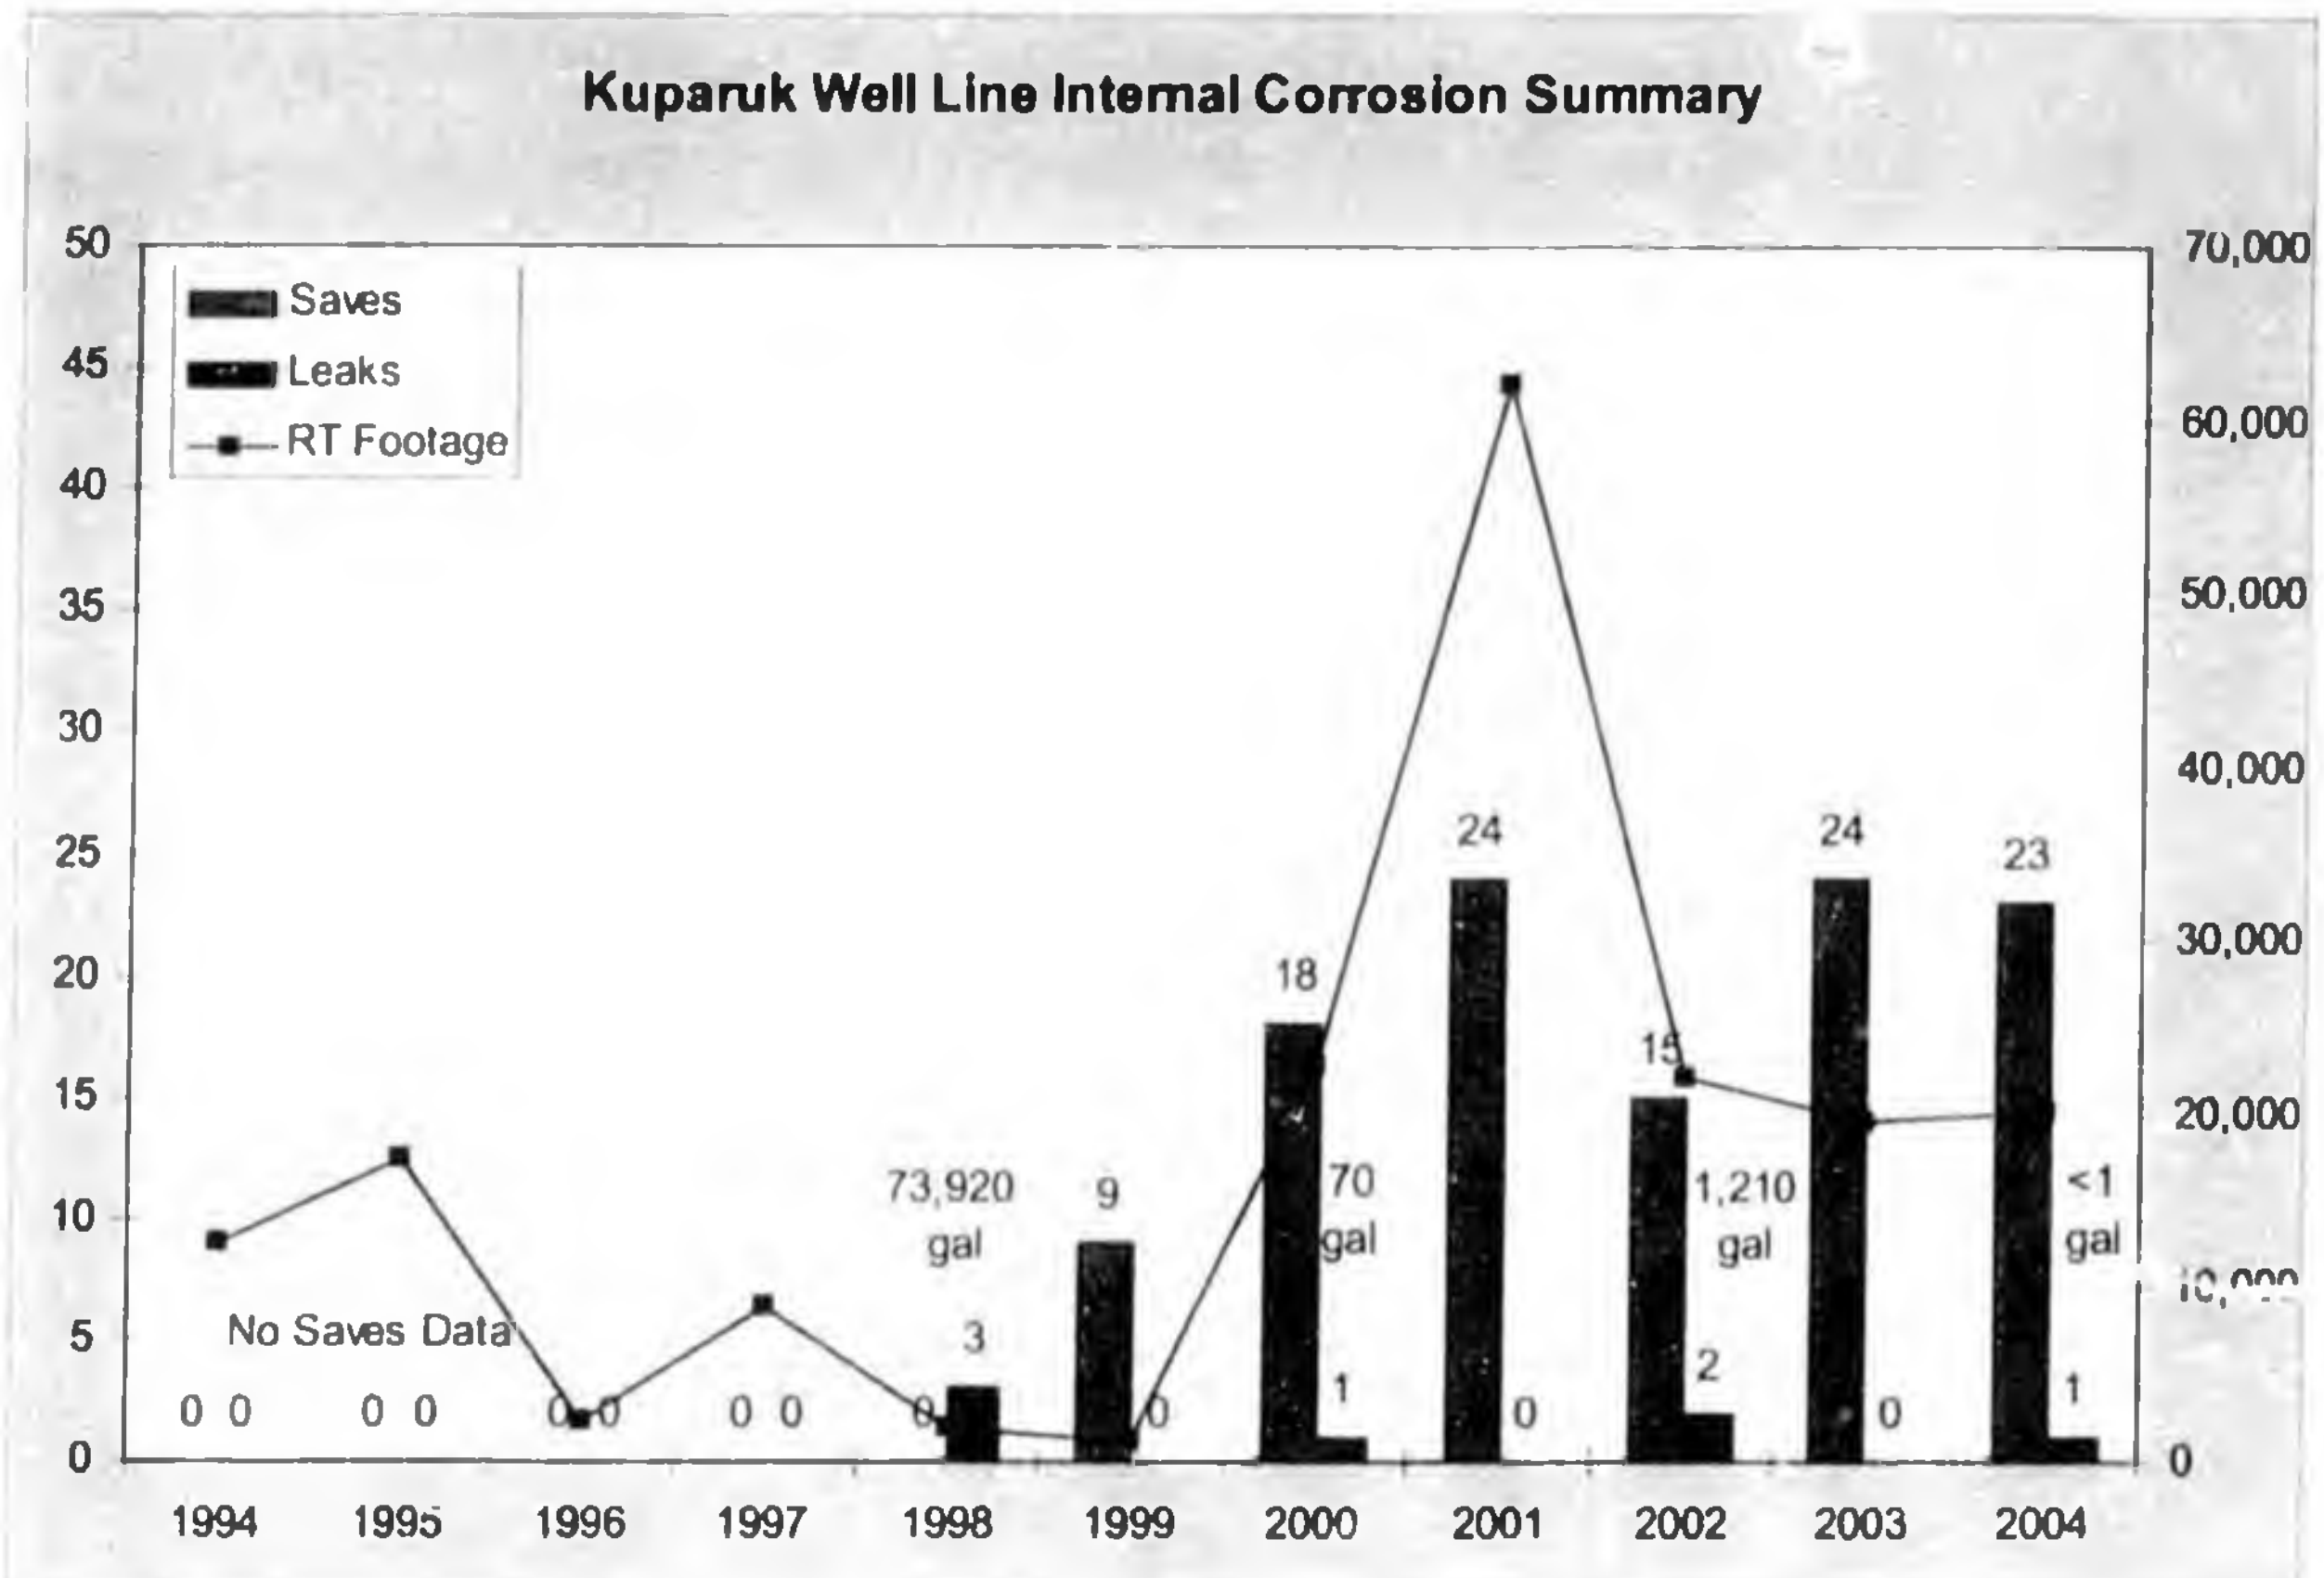
As indicated in Figure 8 below, repair recommendations were initiated on 24 lines (16 water injection, 8 production) in 2004 because of internal corrosion damage. Except for the leak, the corrosion mechanisms were all underdeposit corrosion. The leak, determined not to be an ADEC-reportable spill, was in a water injection line and was caused by erosion associated with a straightening vane pack. More information on the leak can be found in section 3.1.g.

Figure 8. Summary of Well Line Internal Corrosion Inspections – RT footage, leaks, and saves as a function of time.
