# **INVESTIGATION OF RECLAIMED DRILL SITES, PEBBLE PROSPECT, 2016**

**Center for Science in Public Participation  
*for*  
United Tribes of Bristol Bay  
304 Main Street  
Dillingham, AK 99576  
November 3, 2016**

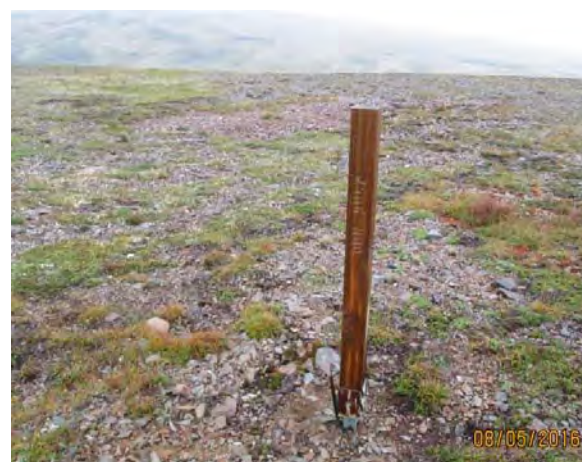
**Figure 4. Monument marker.** A wooden post with the drill hole number is commonly placed where the drill casing has been removed.

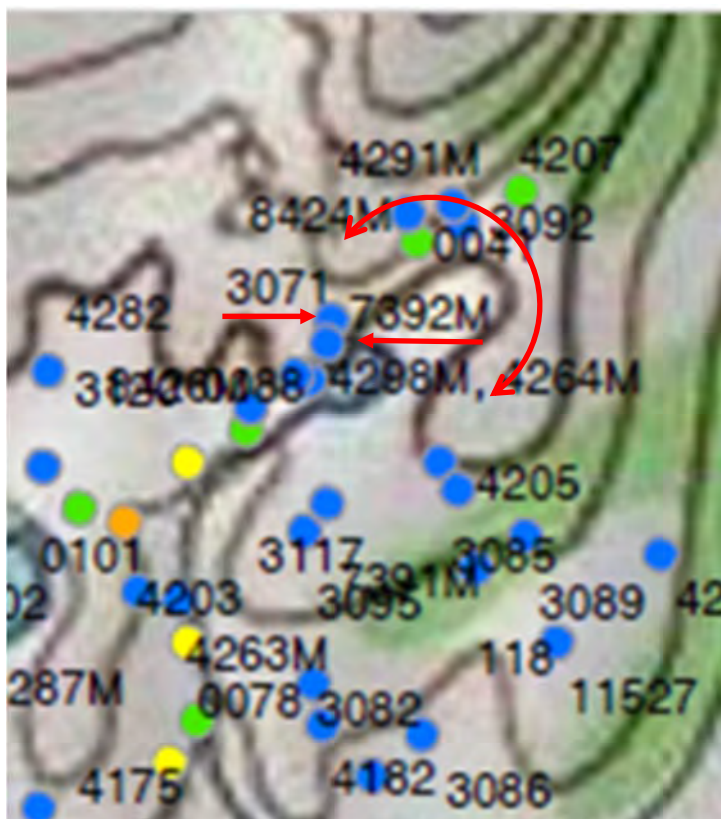
The site PB041, the discovery outcrop soil sample collected by USGS in 2007, is on a ridge west of and overlooking the main camp (Figure 9). This ridge is the site of at least six former drill sites, and rims a gulley that contains two abandoned drill sites, including DDH 7392 which has an open drill casing and has flushed a thick layer of drill cuttings along the gulley floor (Figure 8).

**Figure 9. Topographic map of ridge and gulley.** Drill sites 3071 and 7392M are in the bottom of the gulley. Multiple drill sites surround them along a horseshoe shaped ridge.

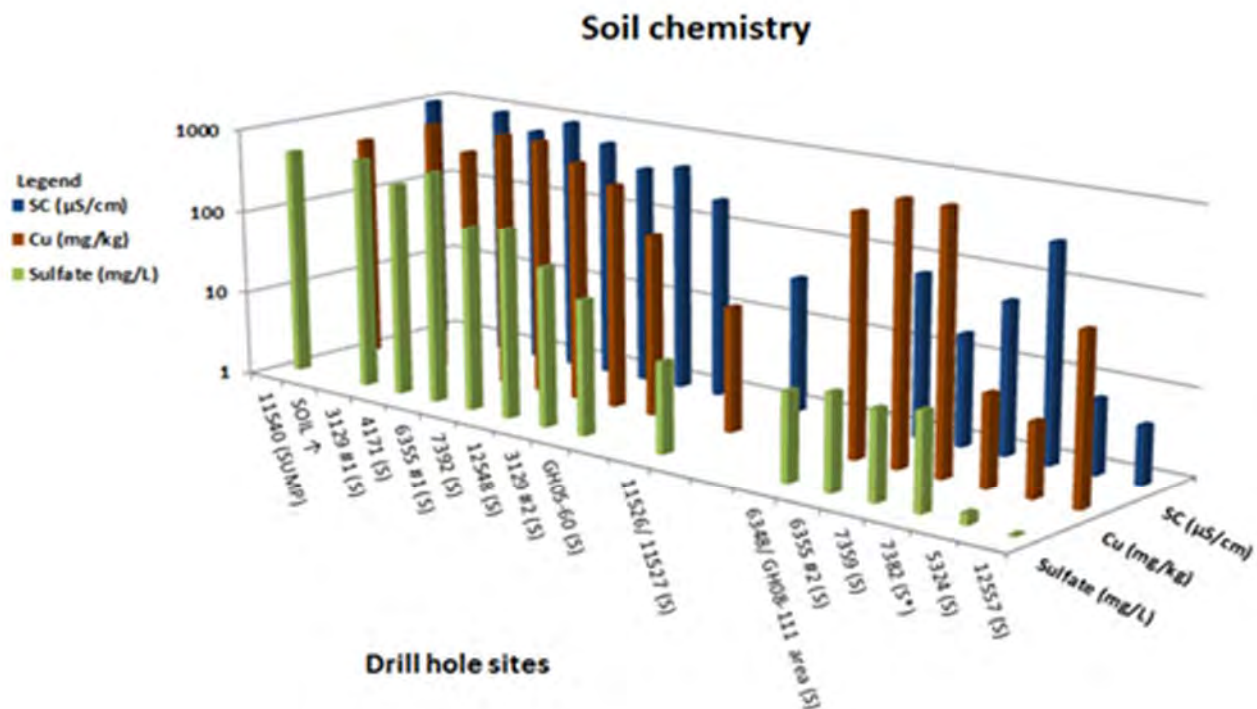
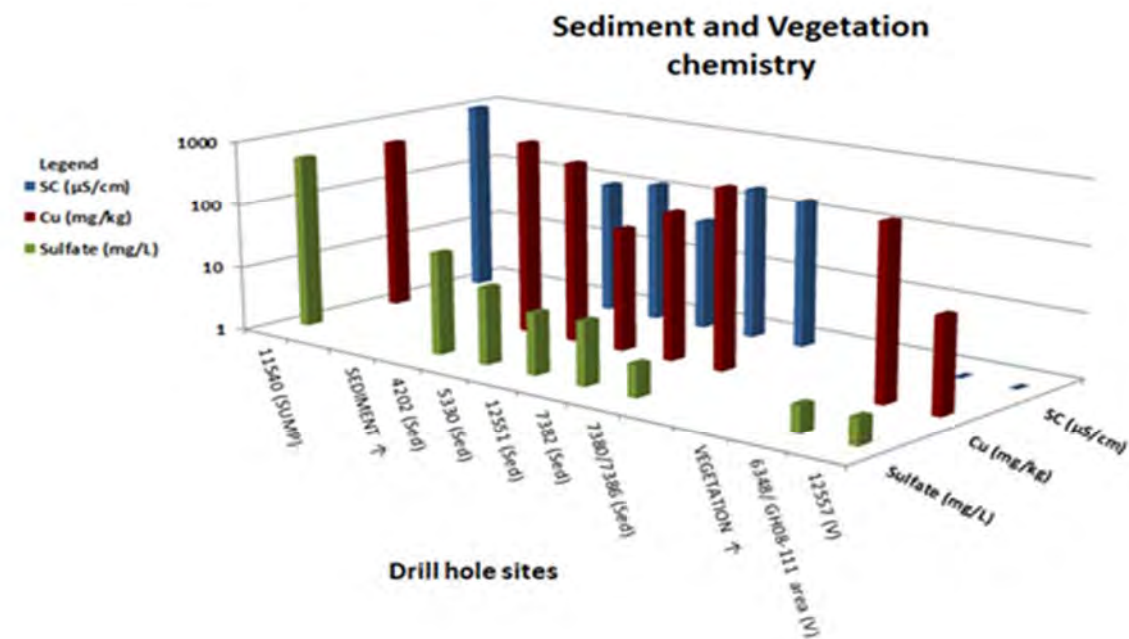
**Figure 12. Soil, sediment, and vegetation chemistry.** The chemistry associated with drill cuttings can be represented by the pattern of the drill sump material. (Top, label furthest to the left) Drill pit sump material is elevated in sulfate, copper, and specific conductance. Sites with drill cuttings have similar chemistry. The most dissimilar are sites on the far right. The sample of the upper 2" of soil from site DDH 6355 had a different profile than the sample from the upper 4". Site GH08-111, although in an area of drilling discharge, was a sample of grey material. The profile of sediment and vegetation (bottom), not impacted by drill cuttings, is different from soil in the upper figure. Drill sump material is shown on the far left of both charts for comparison.

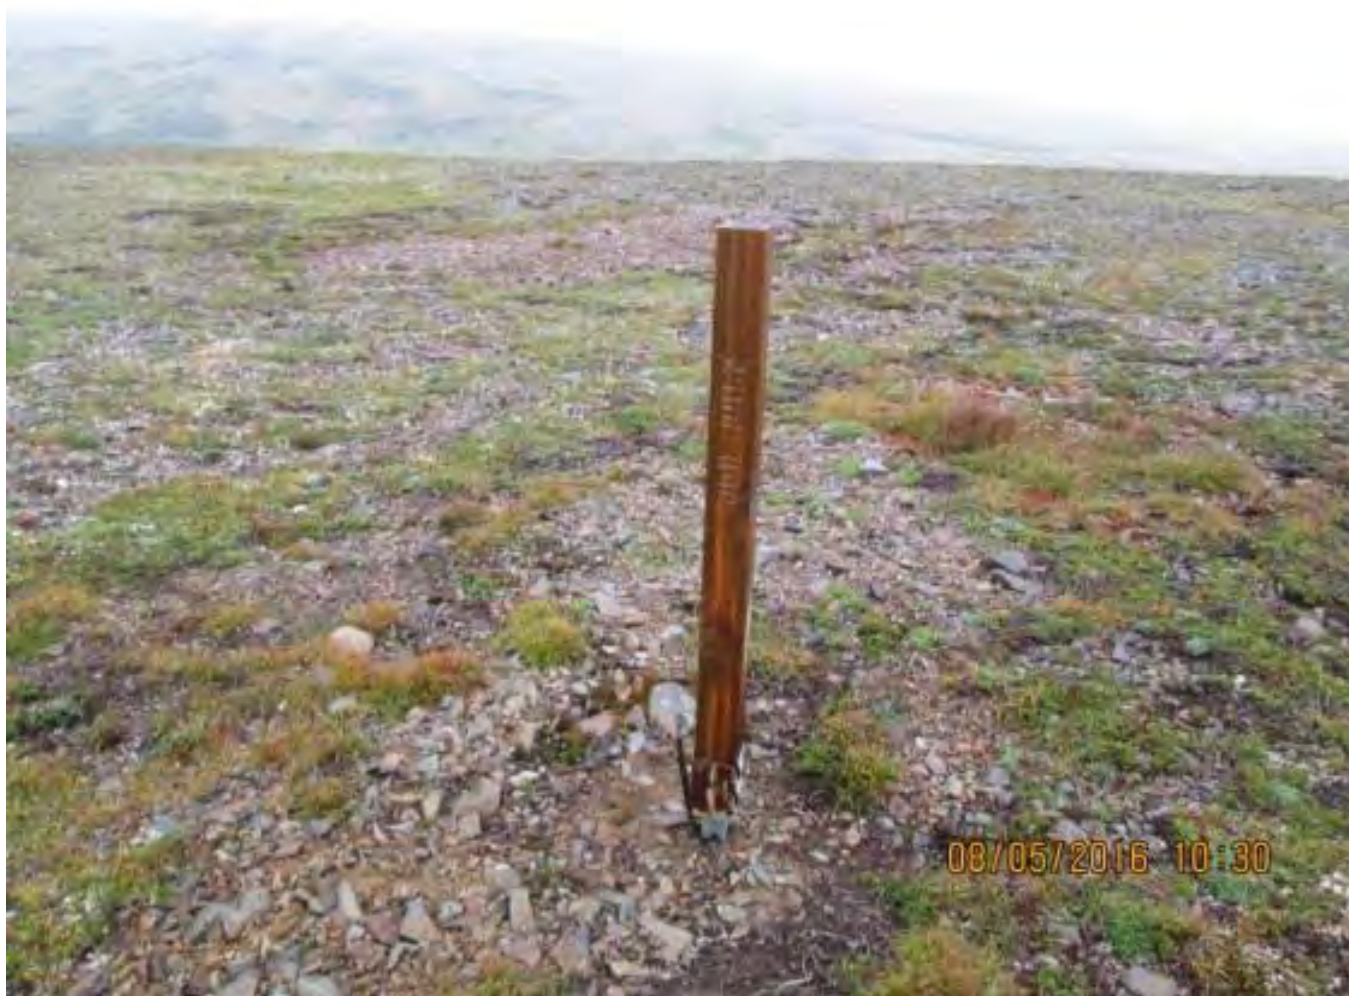
***DDH 9452***

**This is an example of a fully reclaimed site with no apparent issues. No water was on the site.**

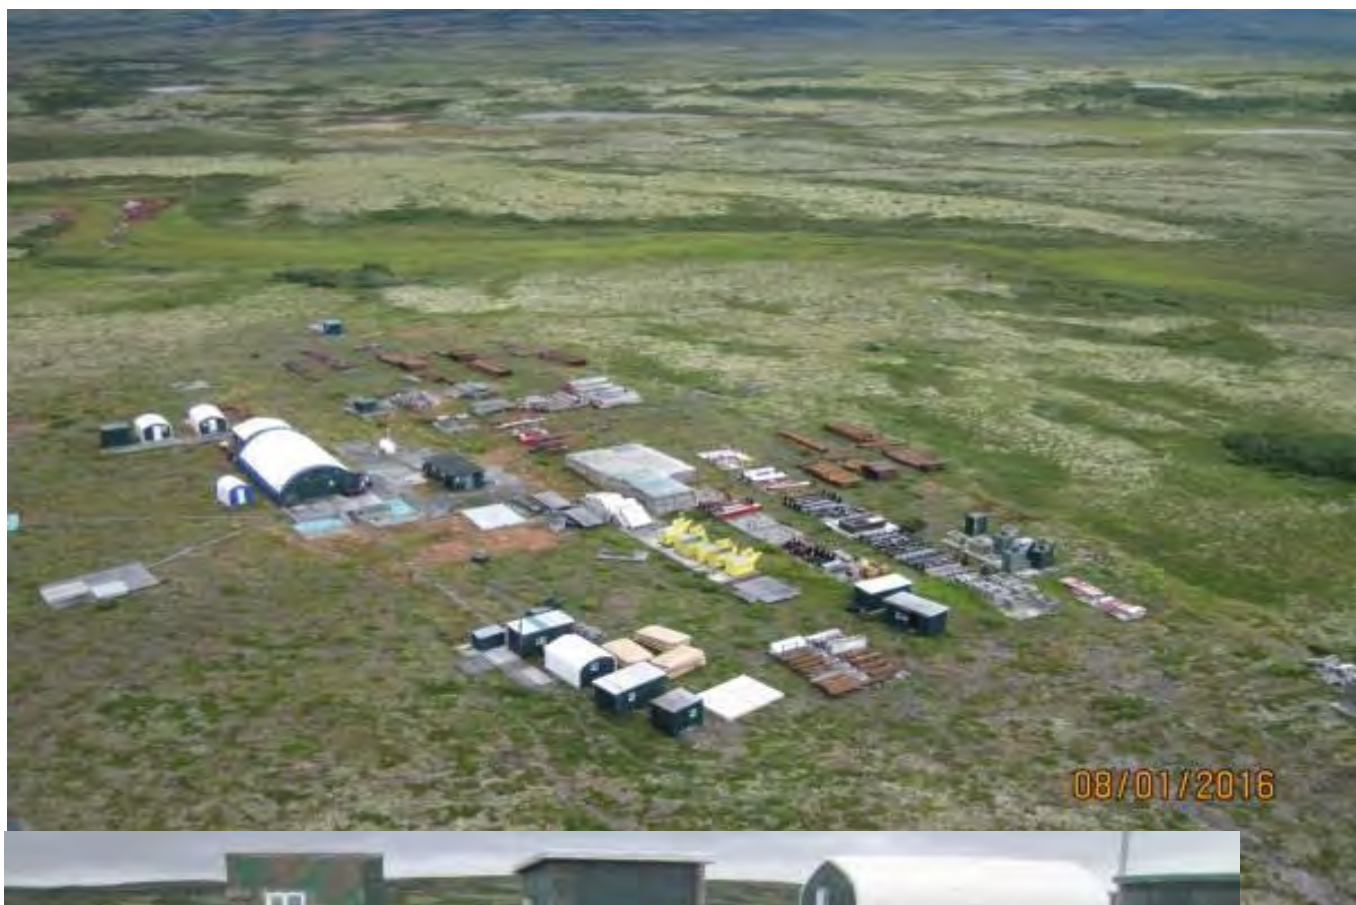
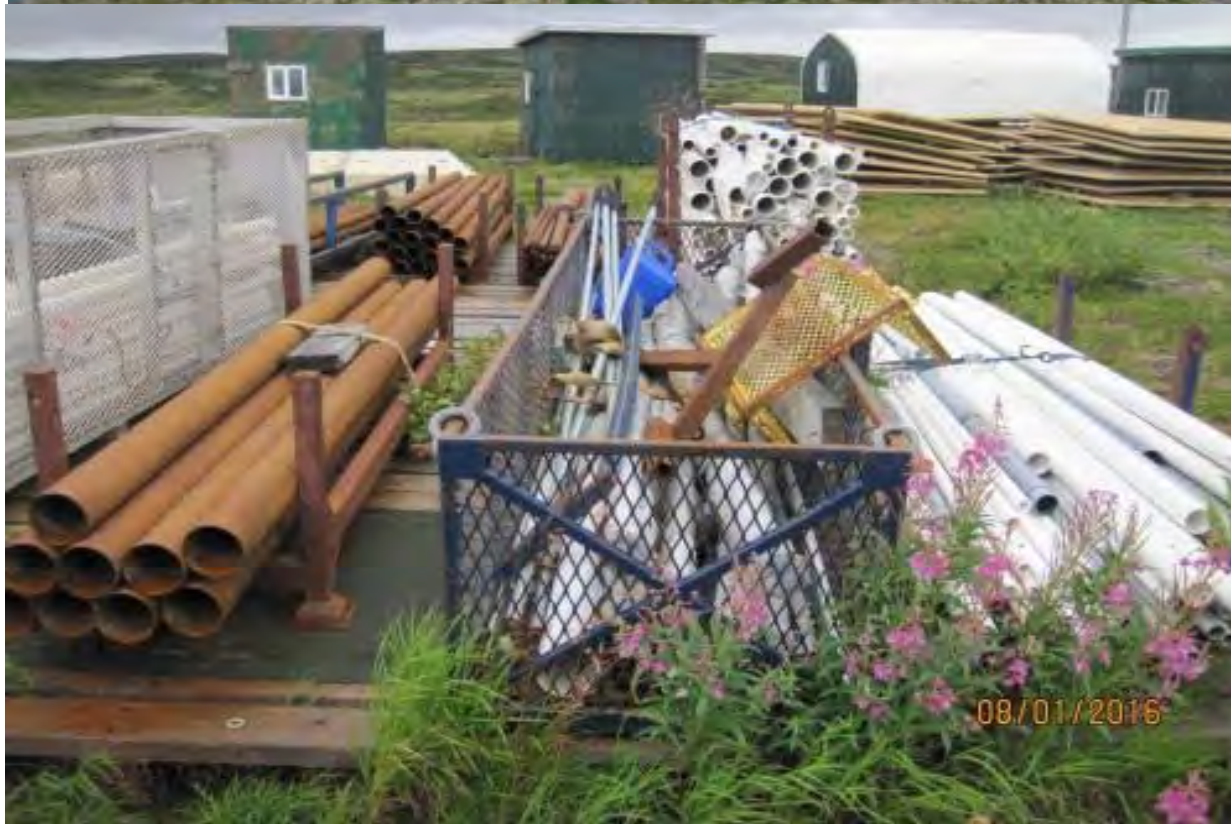
## *Main camp*

The main camp contains drill pipe, buildings, tanks, and other supplies.
