State of Alaska 30th Legislature House Resources Committee

RE: Cook Inlet Offshore Update

Middle Ground Shoal - "A" Pipeline

Anna Platform & Pipeline

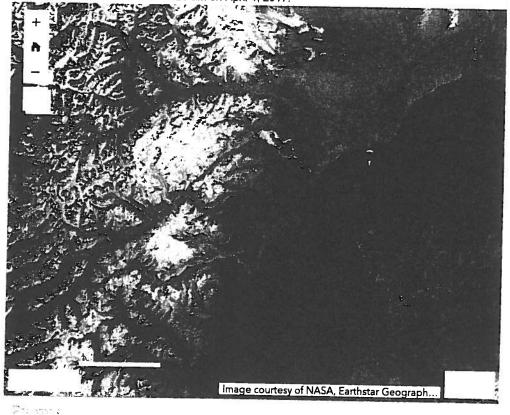
Anna Platform 9-inch

Cause Hilcorp was unable to determine the cause of the spill until recently

when ice conditions allowed divers to access the site. A large rock, approximately 3 feet by 10 feet, was identified as causing a breech on

position due to wear from a rock. Measurement shows the pipe is 1/8"

April 21 Dive crew was able to get the temporary repair clamp properly

torqued to seal properly, stopping the leak.
