Risks and Impacts from a Tailings Dam Failure at the Proposed Pebble Mine

April 1, 2019

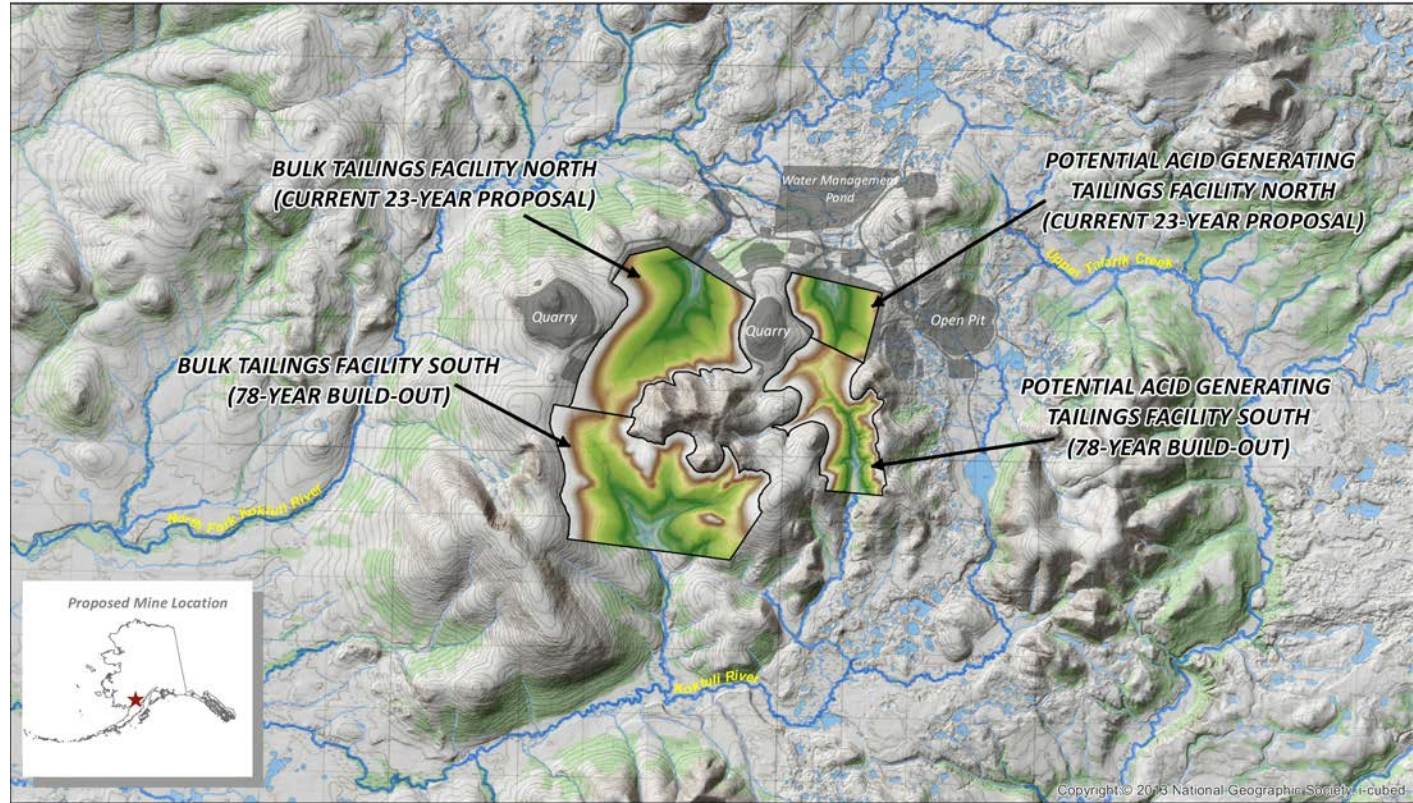
PROPOSED TAILINGS STORAGE FACILITIES FOR THE PEBBLE MINE - CURRENT PROPOSAL AND POTENTIAL 78-YEAR BUILD-OUT

“Based upon the economic assumptions made in the 2011 [Wardrop] assessment, the EIS mine plan...is likely to have a strongly negative net present value (NPV)”

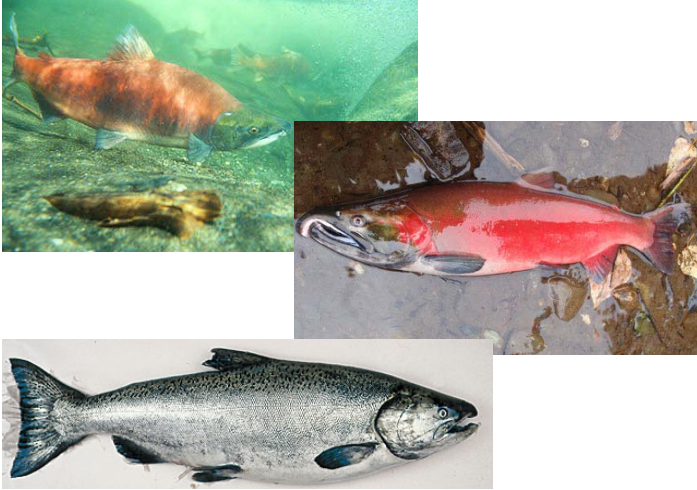
Salmon Habitat Impacts – Anadromous Waters

- Tailings would directly impact >219 miles of anadromous waters
