**PRUDHOE  
BAY  
CORROSION  
CRISIS,  
8/18/06  
(FILE 9)**

**ConocoPhillips Alaska  
Commitment to Corrosion Monitoring  
Annual Reports 2000 – 2005**

# **Greater Kuparuk Area (GKA) Corrosion Programs Overview**

***Commitment to Corrosion Monitoring***  
***1<sup>st</sup> Annual Report to the Alaska Department of Environmental Conservation***

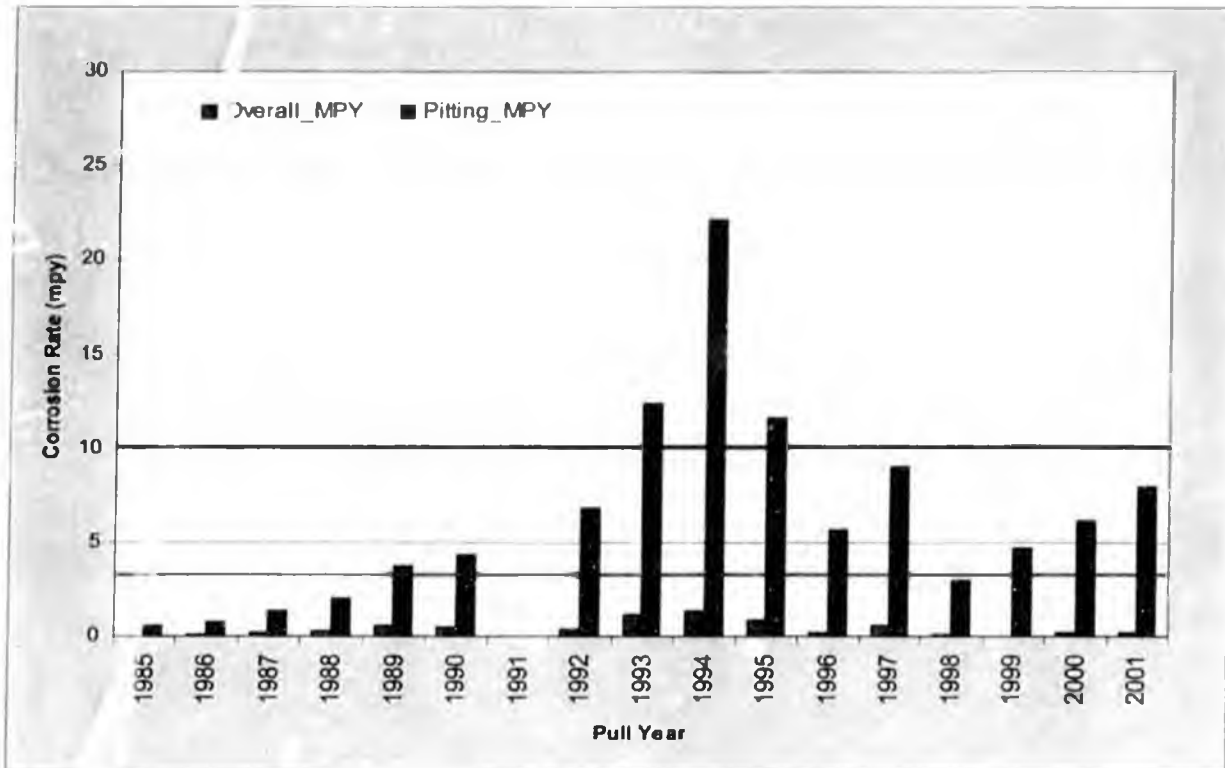
Figure 1. Three-phase Production Cross-Country Line Coupons – general and pitting corrosion rates as a function of time.

*Three-phase Production Cross-Country Lines:* The monitoring data summarized in Tables 1 and 2 and presented in Figure 1 suggest that general corrosion is under control. The data presented in the Tables 1 and 2 and in Figure 1 include corrosion coupon data from the wet oil lines.

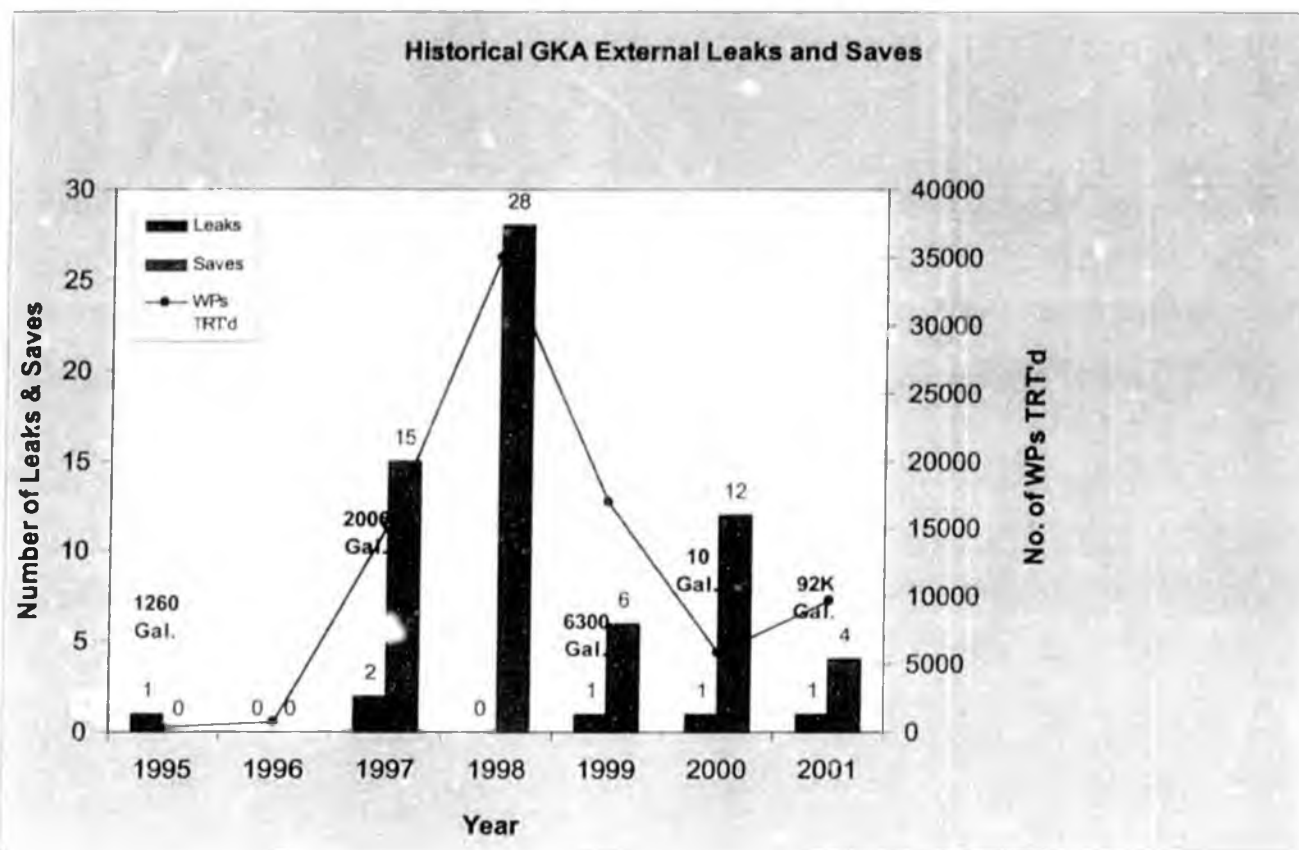
Figure A1. Leaks, saves, number of weld packs inspected with TRT, and volumes of leaks as a function of time.

Note: The leak in 2001 due to external corrosion was located in a weld pack in a below-grade piping segment, and as such, would not have been detected by the TRT inspection program. The location had not yet received PTI/TWI inspection.

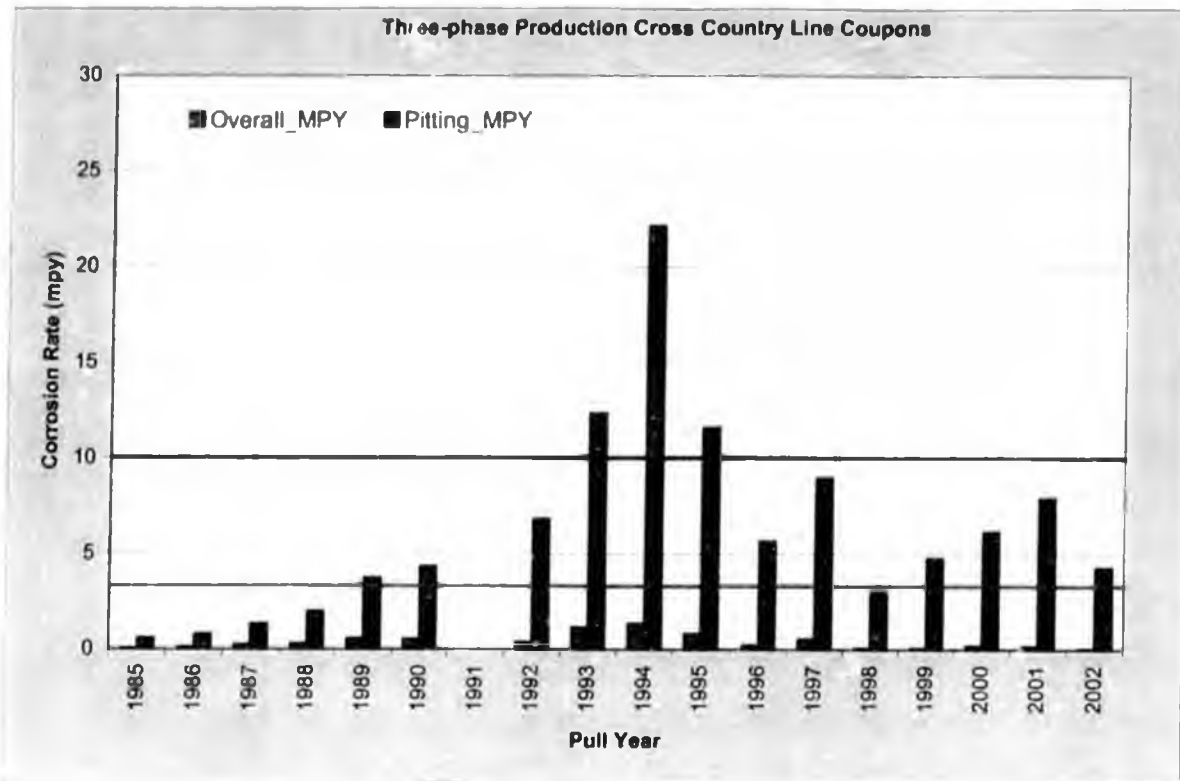
Figure 1. Three-phase Production Cross-Country Line Coupons – general and pitting corrosion rates as a function of time.

*Three-phase Production Cross-Country Lines:* The monitoring data summarized in Kuparuk Tables 1 and 2 and presented in Figure 1 suggest that general corrosion is under control. The data presented in the Tables 1 and 2 and in Figure 1 include corrosion coupon data from the wet oil lines.

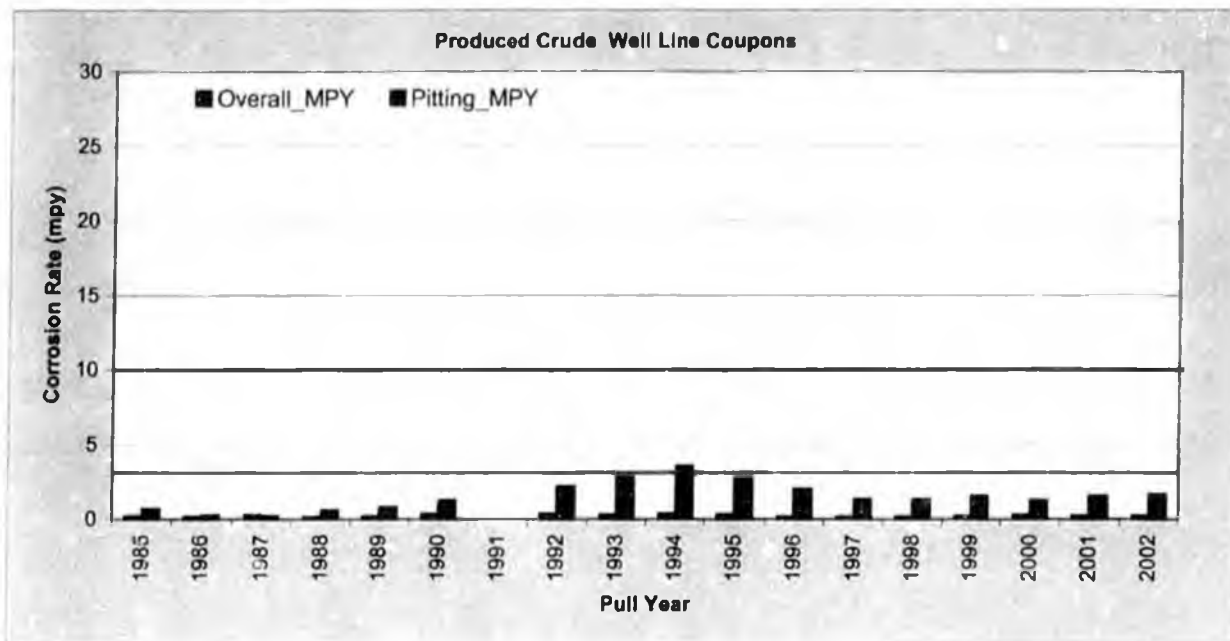
Figure 4. Three-phase Production Well Line Coupons – general and pitting corrosion rates as a function of time.

*Three-phase Production and Mixed Water Injection Well Flow Lines:* While the monitoring data summarized in Kuparuk Tables 1 and 2 and presented in Figures 4 and 5 suggest that corrosion rates are below targets, inspection data indicates that higher rates are actually being experienced. The well line inspection data are discussed in section 3.1.b below, and are a good example of why monitoring data alone cannot be relied upon to characterize corrosion in a given system.

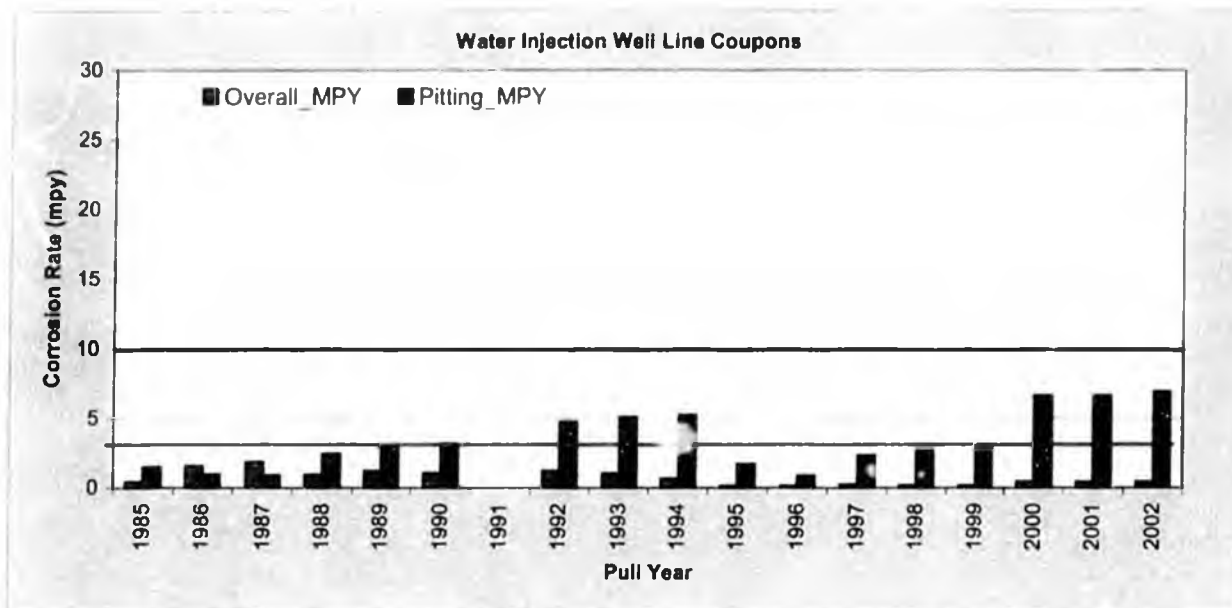
Figure 5. Water Injection Well Line Coupons – general and pitting corrosion rates as a function of time.

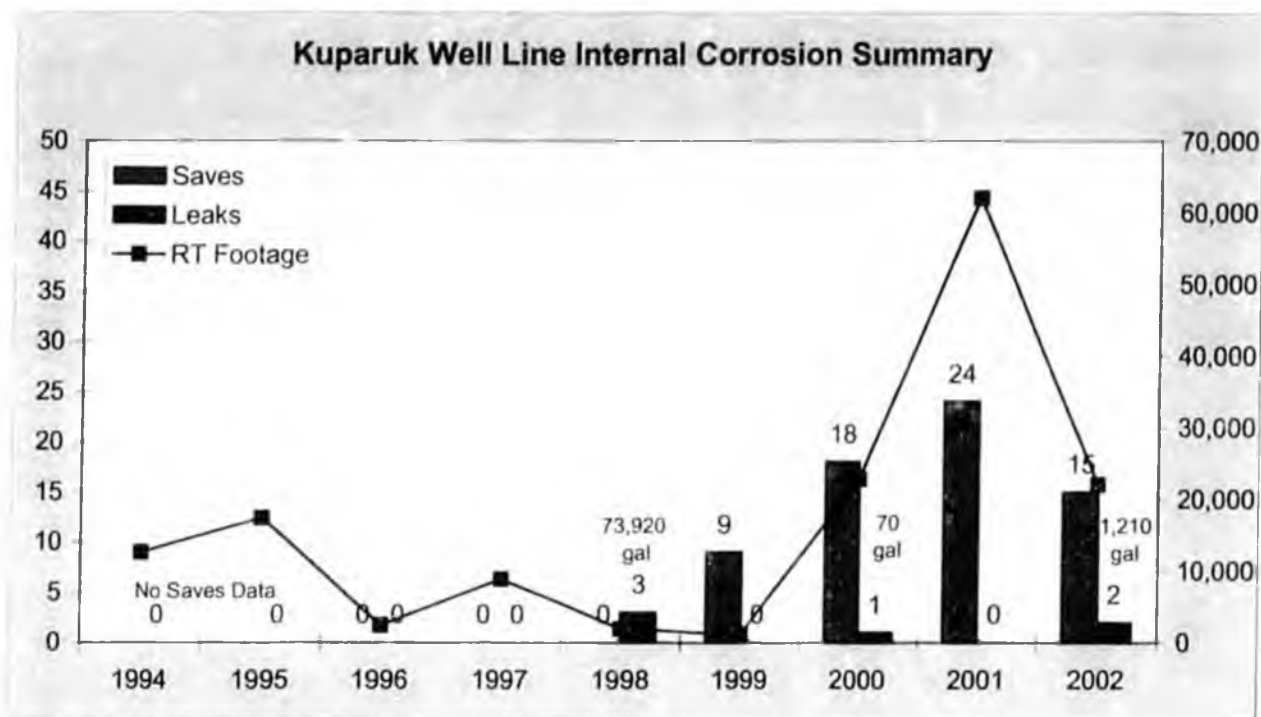
As indicated in Figure 8 below, repair recommendations were initiated on 17 lines (8 injection, 9 production) in 2002 because of internal corrosion damage. The two leaks were on production lines. Repairs typically consist of either sleeving or replacing the de-rated section of line. The graph indicates a decrease in inspection footage from 2001 to 2002. This was the first year we encountered well lines with obstructions that did not allow efficient use of the RTR crawler. As a result, these lines required manual RT as the primary inspection method. We met our primary 2002 goal of inspecting all well lines with a 0.312" nominal pipe wall thickness.

Figure 8. Summary of Well Line Internal Corrosion Inspections – RT footage, leaks, and saves as a function of time.

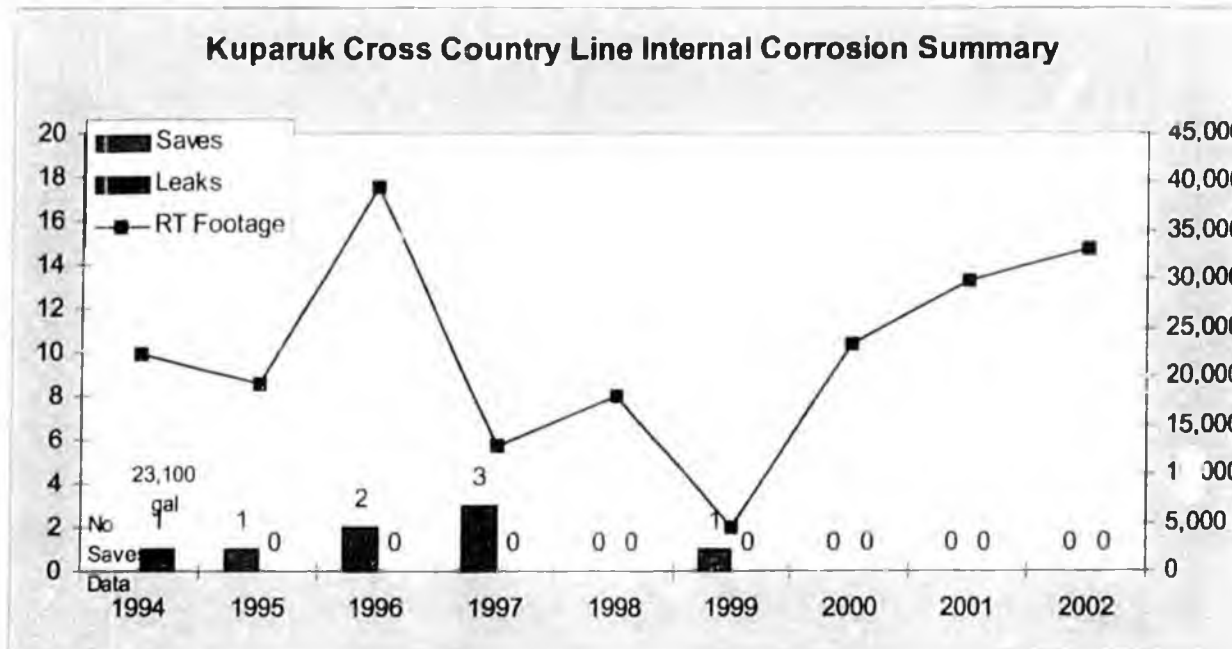
As indicated in Figure 9, no (0) repair recommendations were initiated on cross-country lines because of internal corrosion damage in 2002. Inspection results in Figure 9 indicate that the corrosion mitigation programs are adequately protecting the three-phase lines and the water injection lines.

Figure 9. Summary of Cross-Country Line Internal Corrosion Inspection - RT footage, leaks, and saves as a function of time.

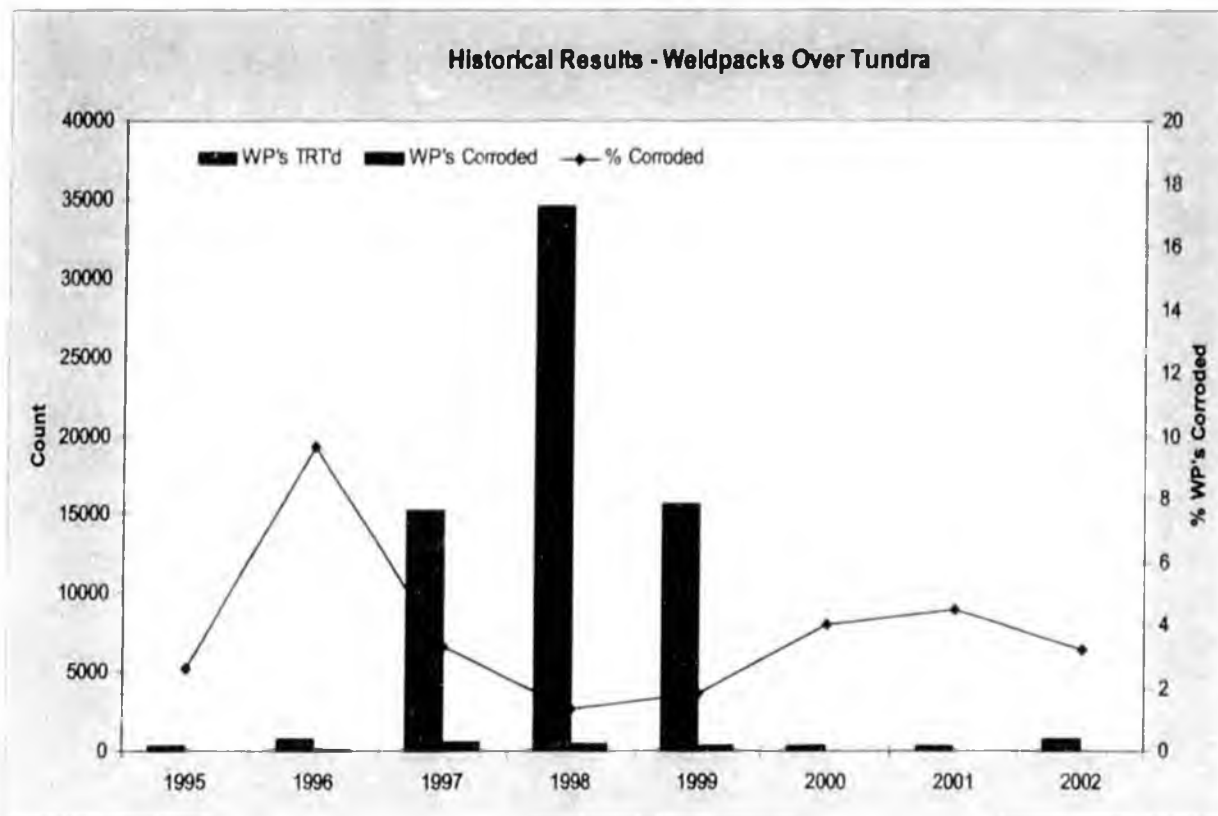
Figure 10. Summary of Weld Packs on Cross-Country Lines over Tundra (off-pad) – number of weld packs inspected, number of weld packs corroded, and percent of weld packs corroded.

Figure 10 illustrates the most-mature external corrosion inspection program of the three external corrosion programs. A review of results, obtained early in this program was initiated in 2002. A larger recur inspection program for these weld packs is scheduled to begin in 2003.

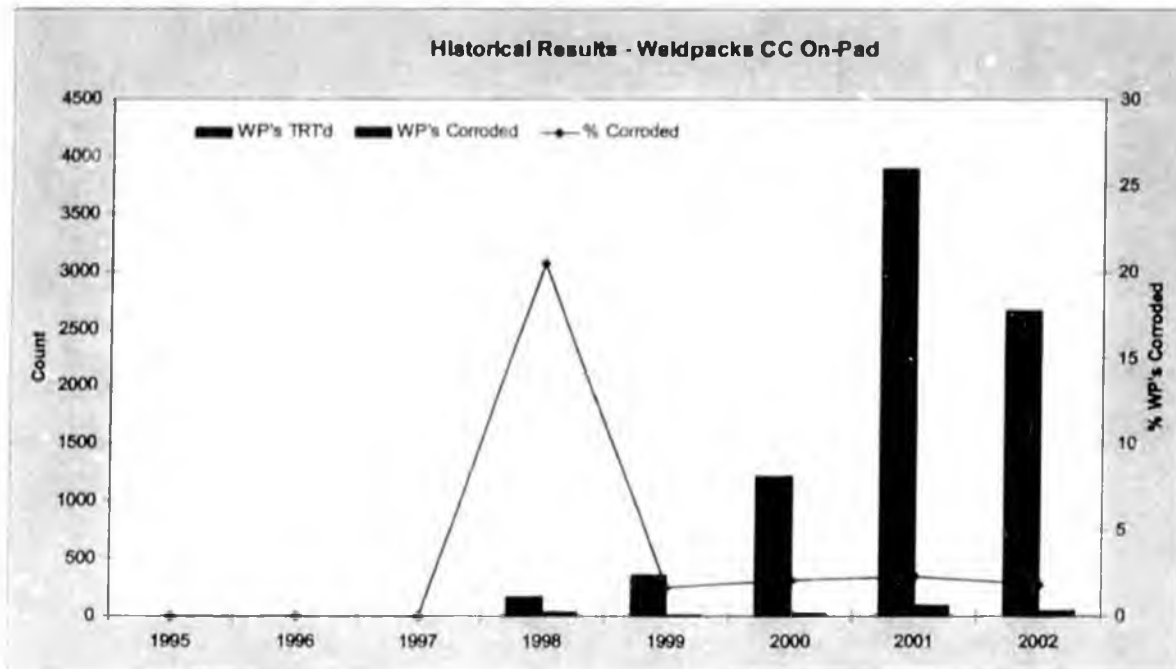
Figure 11. Summary of Weld Packs on Cross-Country Lines on Pads – number of weld packs inspected, number of weld packs corroded, and percent of weld packs corroded.

Figures 11 and 12 depict the results of the major focus of the external weld pack inspection program in 2002. The cross-country on-pad weld packs were inspected using a prioritization scheme based on the historical corroded-to-wet ratios of the over-tundra portions of the cross-country lines. The well line weld-packs were inspected using a prioritization scheme that examined the oldest, the hottest, and thinnest-walled lines first. As of year-end 2002, 92% of the cross-country on-pad weld-packs and 60% of the well line weld-packs have received their baseline TRT inspection.

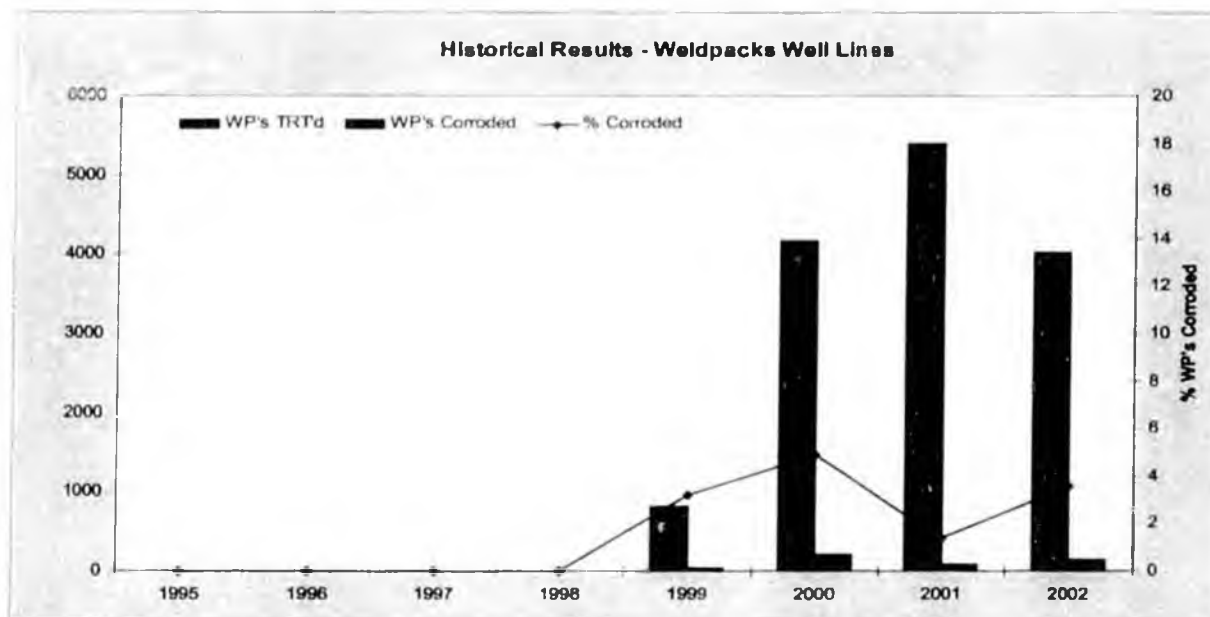
Figure 12. Summary of Weld Packs on Well Lines – number of weld packs inspected, number of weld packs corroded, and percent of weld packs corroded.

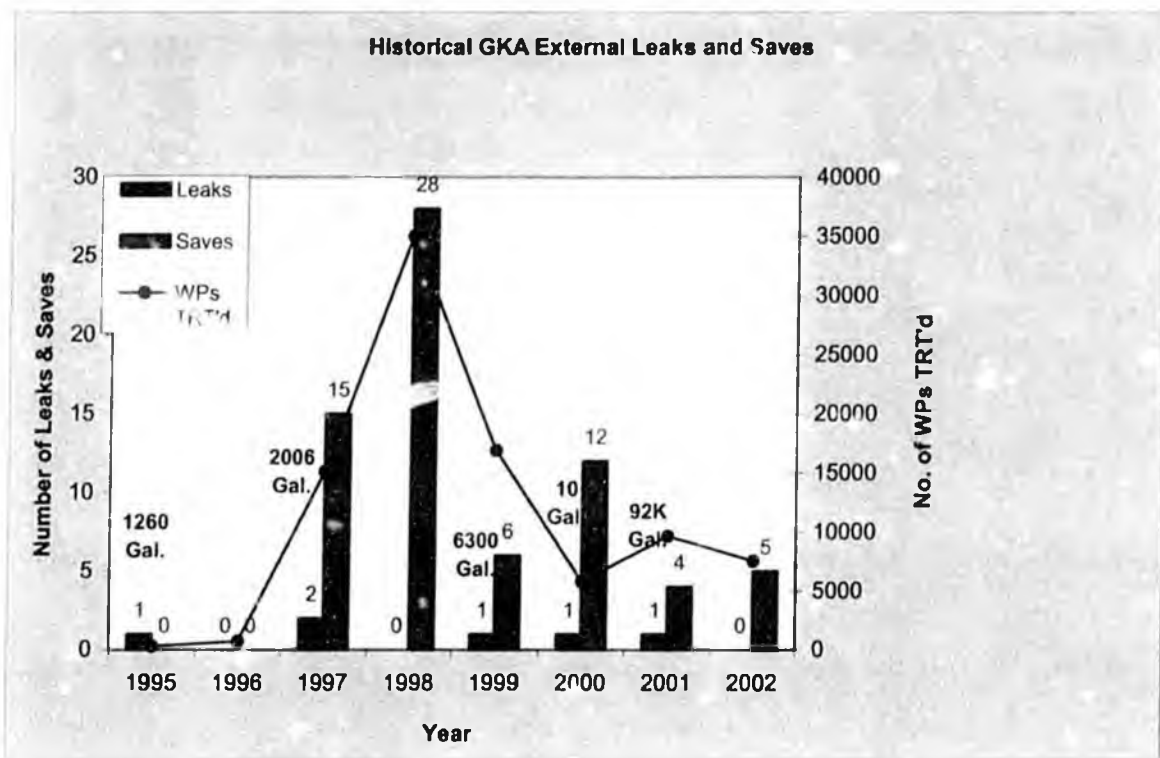
Figure A1. Leaks, saves, number of weld packs inspected with TRT, and volumes of leaks as a function of time.

Note: The leak in 2001 due to external corrosion was located in a weld pack in a below-grade piping segment, and as such, would not have been detected by the TRT inspection program. The location had not yet received PTi/TWI inspection.

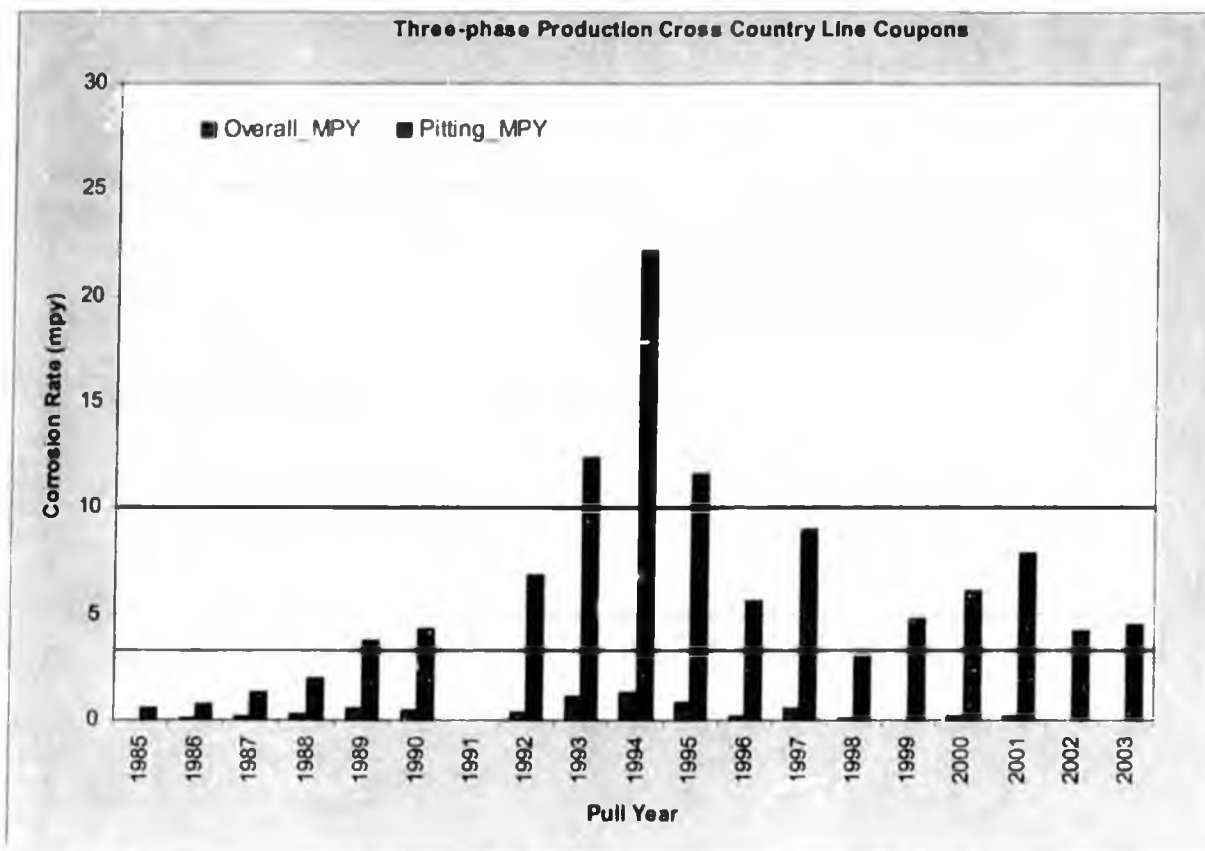
Figure 1. Three-phase Production Cross-Country Line Coupons – general and pitting corrosion rates as a function of time.

*Three-phase Production Cross-Country Lines:* The monitoring data summarized in Kugaruk Tables 1 and 2 and presented in Figure 1 suggest that general corrosion is under control. The data presented in the Tables 1 and 2 and in Figure 1 include corrosion coupon data from the wet oil lines starting at CPF3 and going to CPF1 and CPF2.

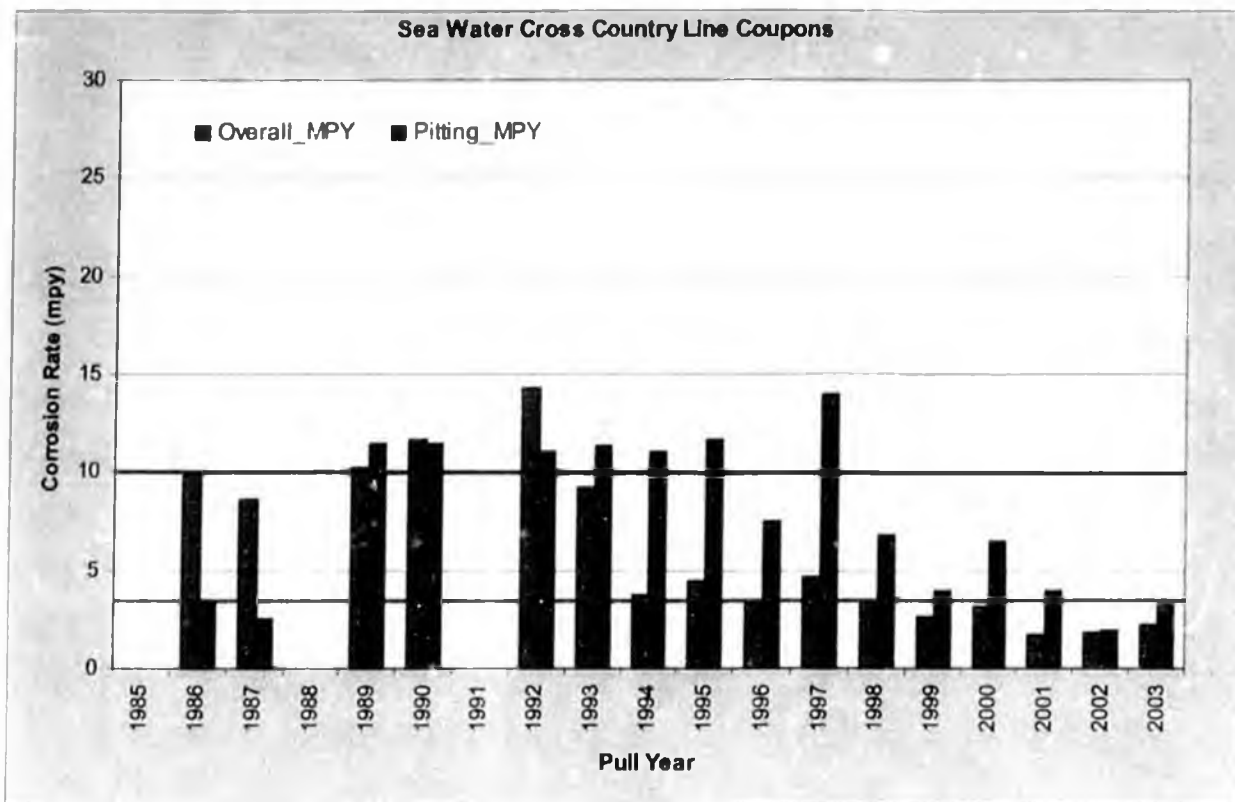
Figure 2. Seawater Cross-Country Line Coupons – general and pitting corrosion rates as a function of time.

*Sea Water Cross-Country Lines:* The monitoring data summarized in Kuparuk Tables 1 and 2 and presented in Figure 2 above, shows the average corrosion rates for the sea water cross-country line coupons remained under thresholds in 2003. The coupon location on the 30" STP discharge line showed general corrosion rates above threshold in 2003. This is likely due to short term increased dissolved oxygen levels, the origin of which is under investigation.

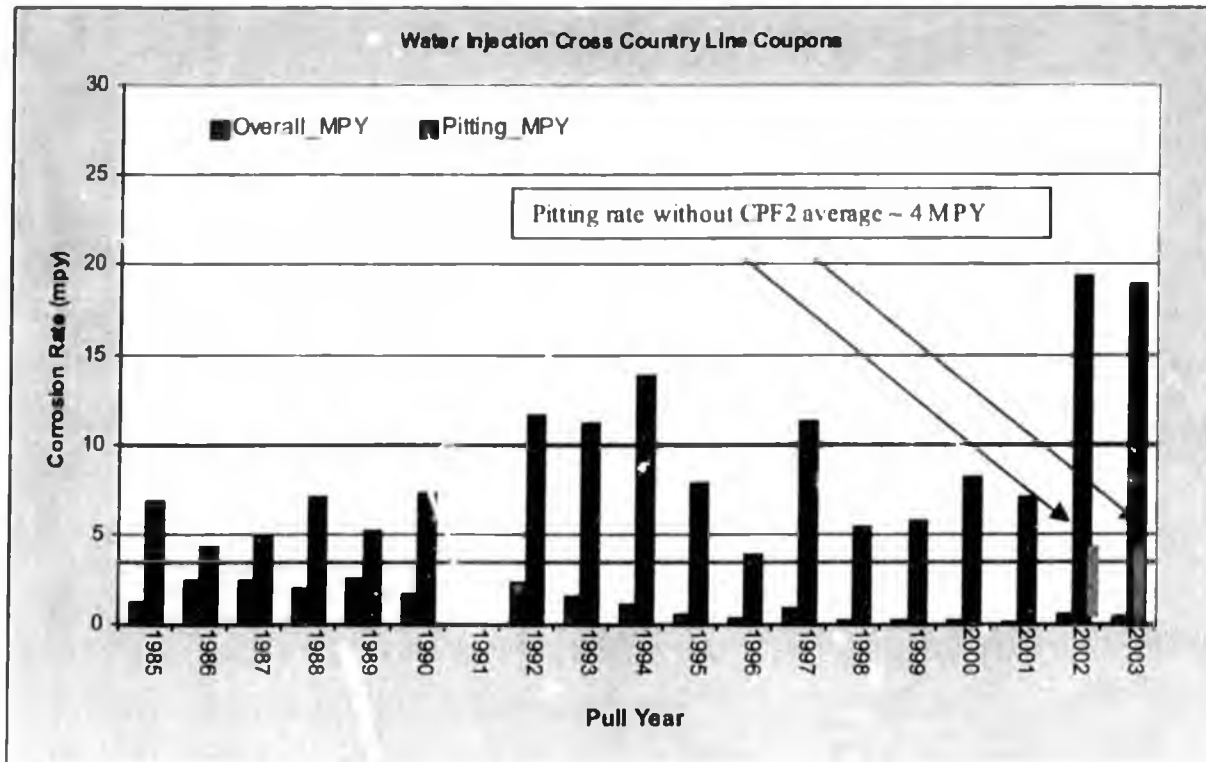
Figure 3. Water Injection Cross-Country Line Coupons – general and pitting corrosion rates as a function of time.

*Mixed Water Injection Cross-Country Lines:* The monitoring data summarized in Kuparuk Tables 1 and 2 and presented in Figure 3 show that average general corrosion rates are below the threshold, but that pitting rates for the field are above the threshold. Closer analysis of the data shows that the average pitting rate excluding CPF2 locations is well under the threshold. Recent inspection data from the CPF2 lines show some damage on three lines. This information, along with coupon results, was used to prioritize 2003 inspection efforts. RTR inspection performed in 2003 included 23,099 feet on 28 cross-country water injection lines. A review of the CPF biocide programs has been conducted and new treatment procedures are in place.

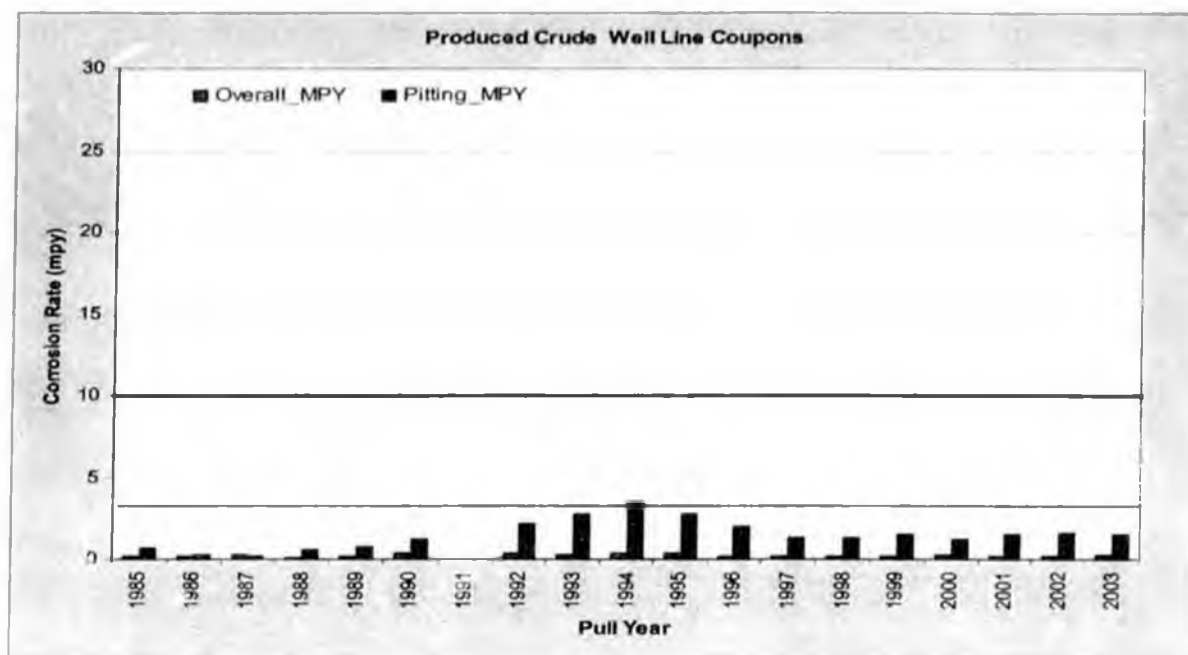
Figure 4. Three-phase Production Well Line Coupons – general and pitting corrosion rates as a function of time.

*Three-phase Production Well Flow Lines:* While the monitoring data summarized in Kuparuk Tables 1 and 2 and presented in Figures 4 and 5 suggest that corrosion rates are below targets, inspection data indicate that higher corrosion rates have been experienced historically. The well line inspection data are discussed in section 3.1.b below, and are a good example of why monitoring data alone cannot be relied upon to characterize corrosion in a given system. For three-phase production, coupons monitor free flowing fluid and have not shown the predominant, under-deposit corrosion mechanism.

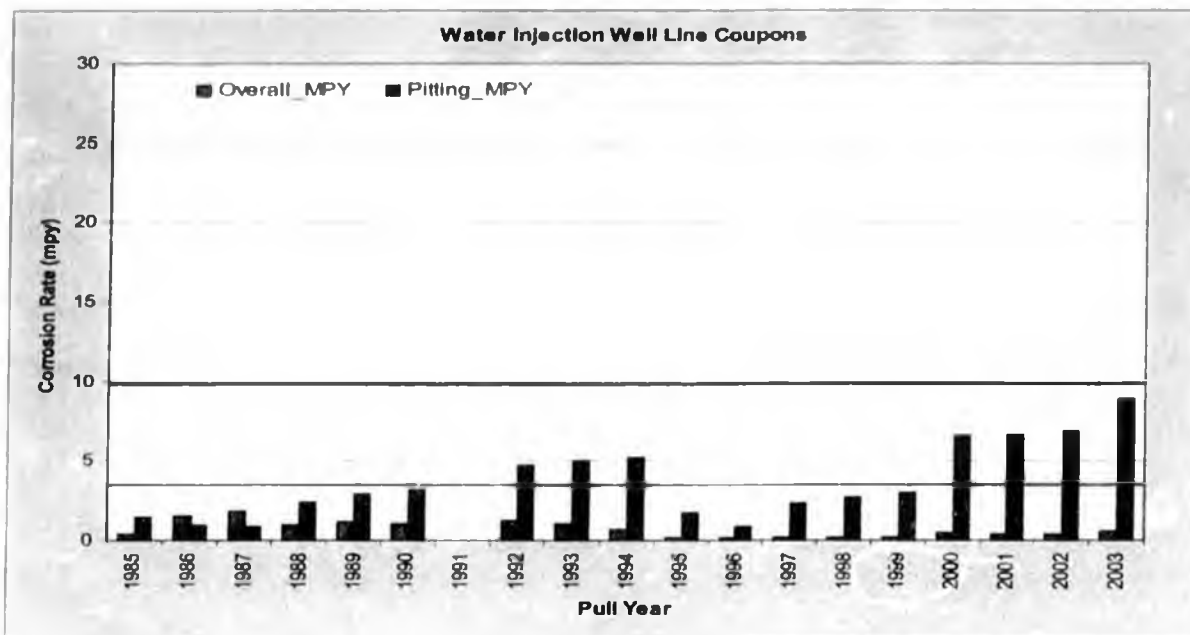
Figure 5. Water Injection Well Line Coupons – general and pitting corrosion rates as a function of time.

*Water Injection Well Flow Lines:* There is an increasing trend in the coupon pitting rates. As discussed in section 3.1.b below, the well line inspection data on water injectors show that there are a significant (22) and an increasing number of corrosion related repairs.

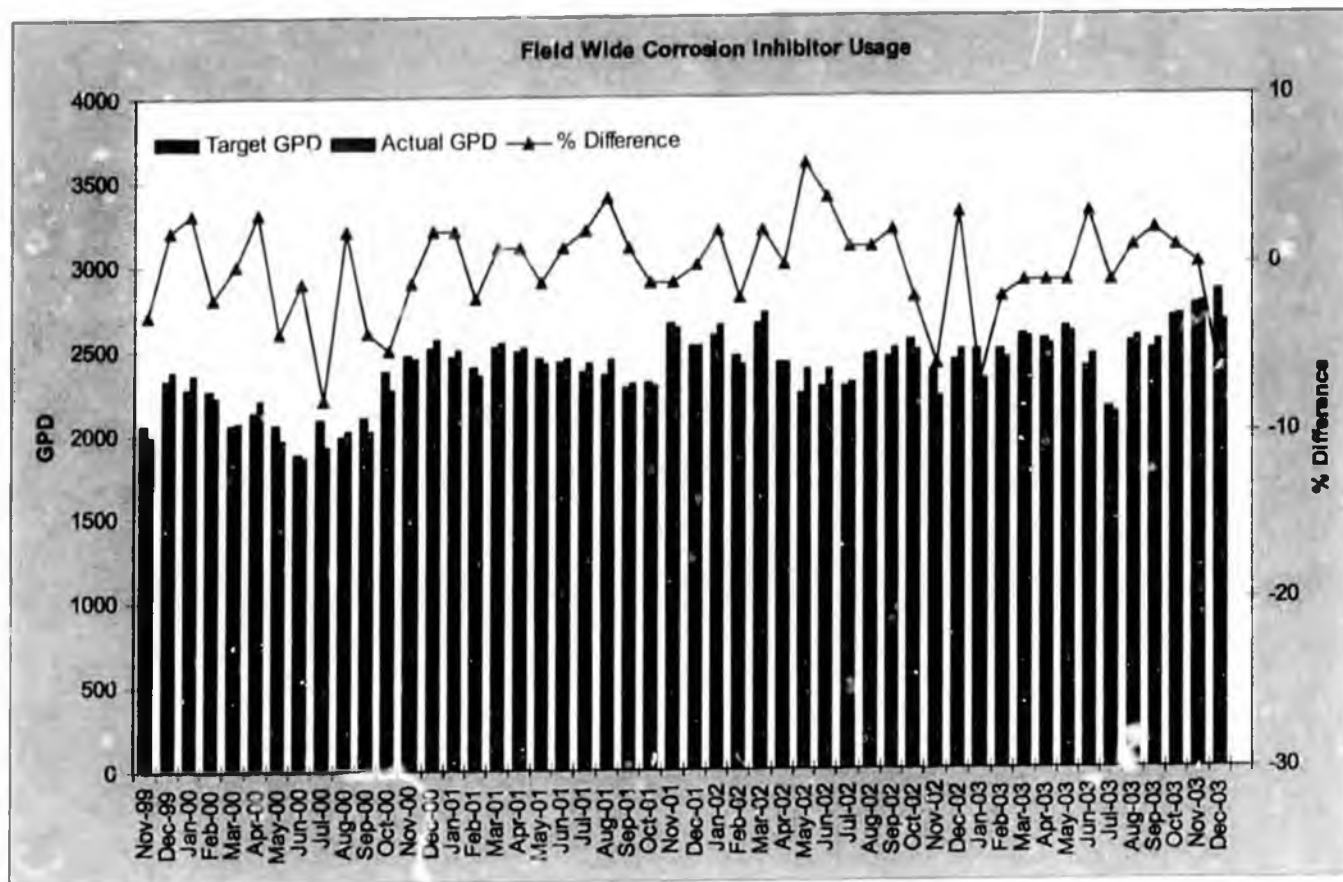
Figure 6. Field-wide Corrosion Inhibitor Use.

For the Kuparuk field, Figure 6 shows the actual number of gallons of corrosion inhibitor pumped per day, the recommended number of gallons of corrosion inhibitor per day, and the percent difference between the two. The difference fluctuated around zero percent deviation from the recommended amount of corrosion inhibitor; the average deviation for the year was -1.0%. The larger variation seen in the December 2003 data was caused by the extreme weather that caused delays in routine pump rate checks and refilling of chemical tanks.

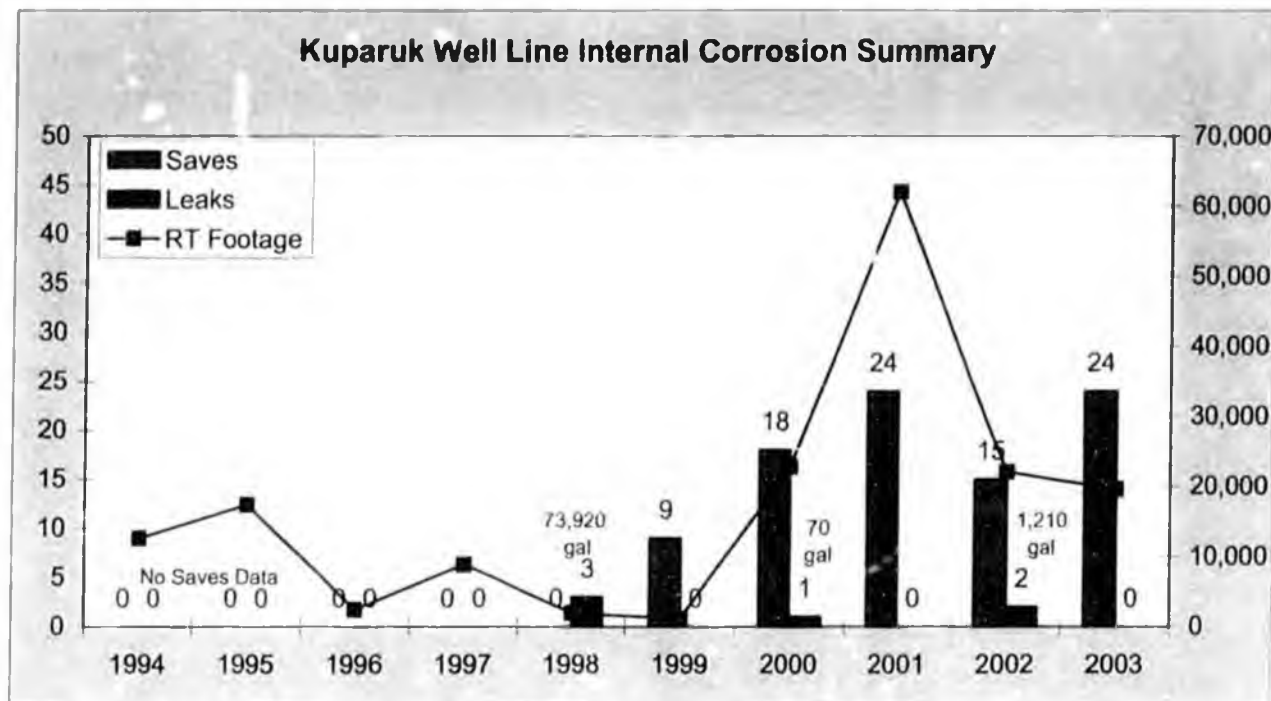
Figure 8. Summary of Well Line Internal Corrosion Inspections – RT footage, leaks, and saves as a function of time.

As indicated in Figure 8 below, repair recommendations were initiated on 24 lines (22 injection, 2 production) in 2003 because of internal corrosion damage. Repairs typically consist of either installing a sleeve or replacing the de-rated section of line. We met our primary 2003 goal of completing the inspection of all well lines requiring baseline inspection.

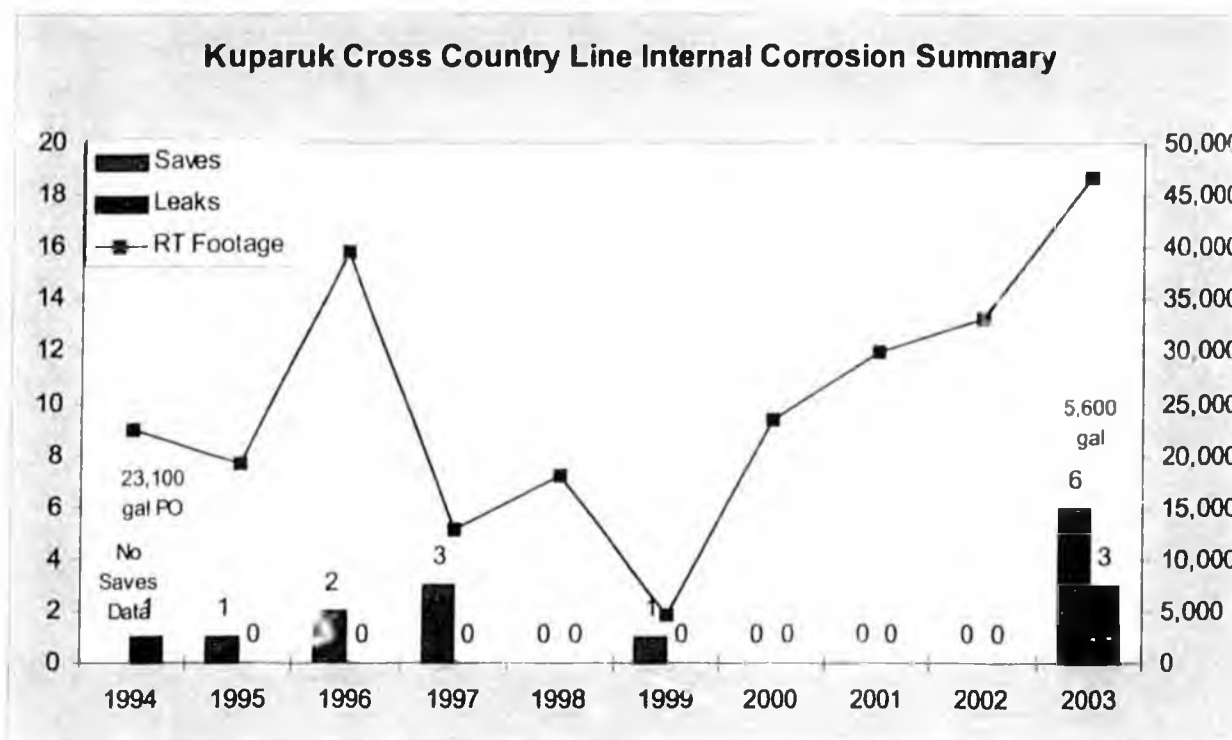
Figure 9. Summary of Cross-Country Line Internal Corrosion Inspections – RT footage, leaks, and saves as a function of time.

As indicated in Figure 9, nine repair recommendations were initiated on cross-country lines because of internal corrosion damage in 2003. The corrosion mechanisms were deadleg corrosion (five repairs), under deposit corrosion (three repairs) and weld attack on a flowing line (one repair). Because of large increase in repairs we will increase our inspection effort on deadlegs in 2004.

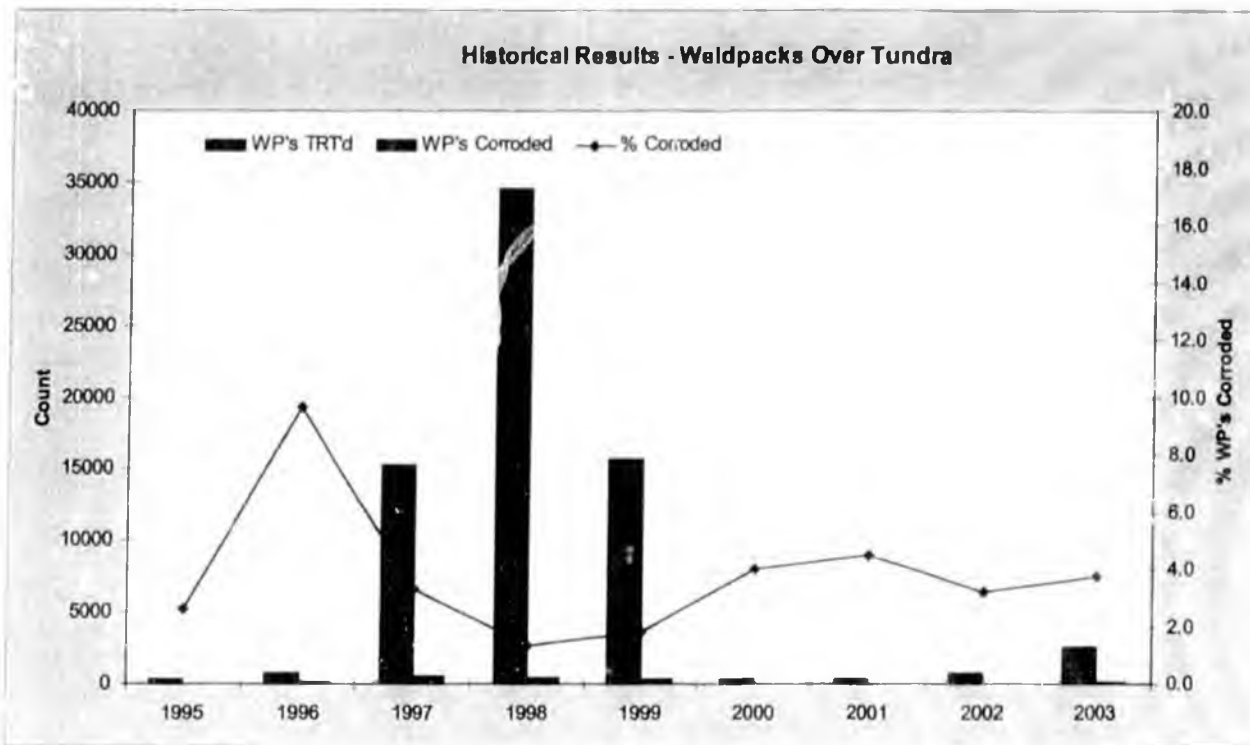
Figure 10. Summary of Weld Packs on Cross-Country Lines over Tundra (off-pad).

Figure 10 illustrates the most-complete external corrosion inspection program of the three external corrosion programs. 2002 and 2003 values include re-inspections and clean-up of locations missed or not properly documented during the original base line effort.

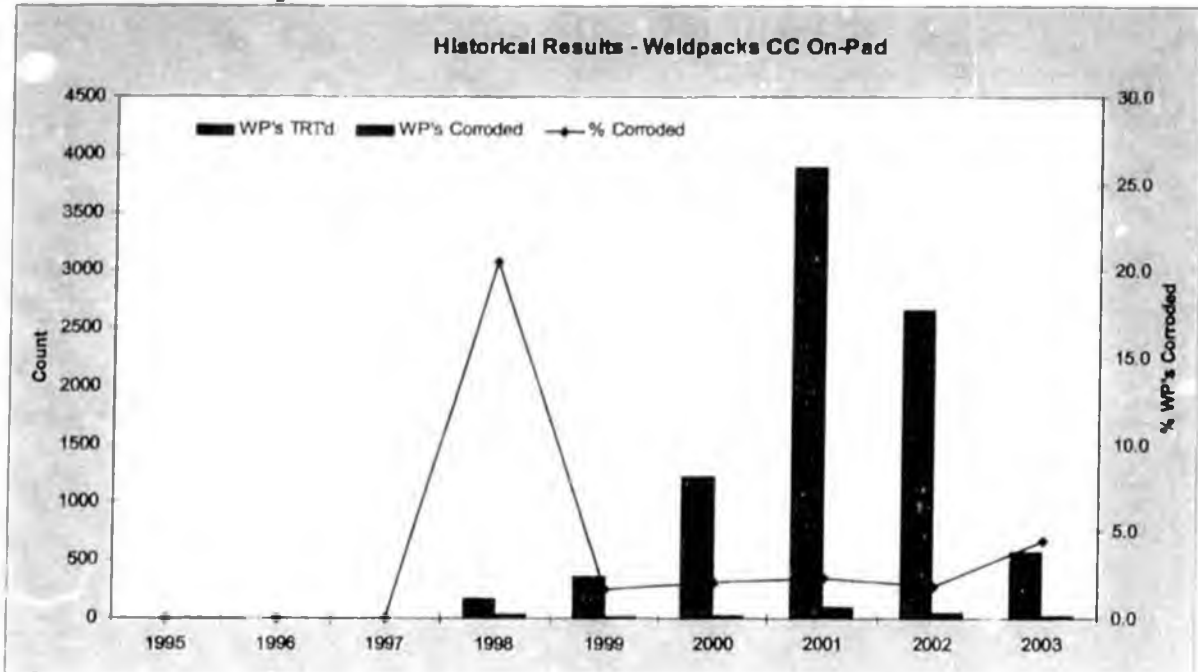
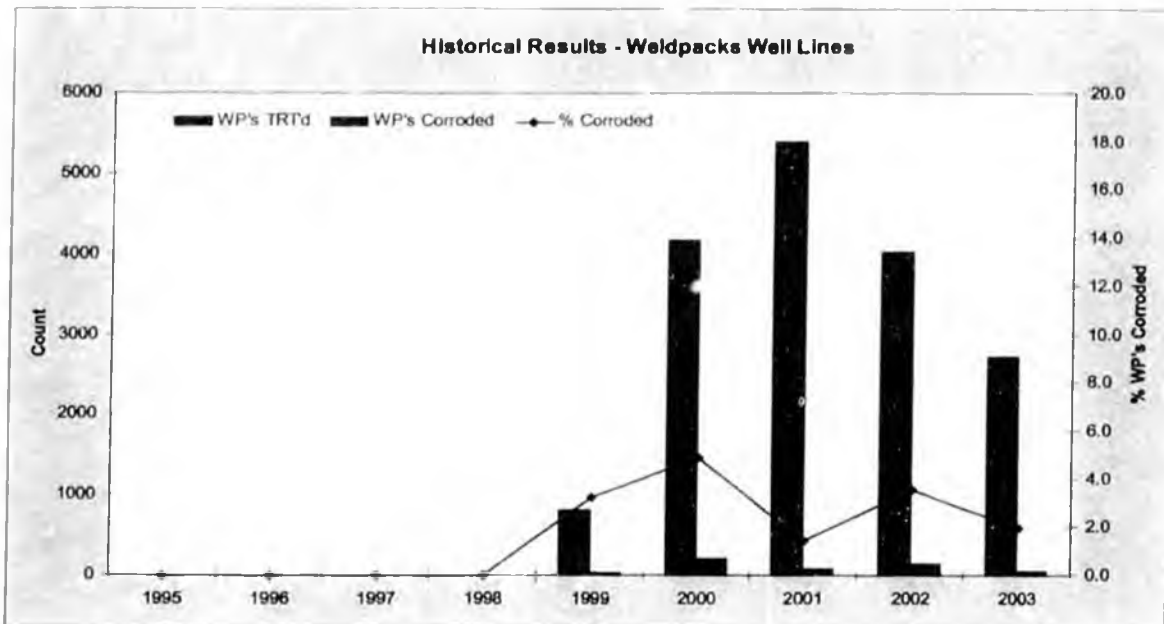
Figures 11 and 12 depict the results of the major focus of the external weld pack inspection program in 2003. The cross-country on-pad program is nearing completion and all baseline inspections should be complete by year-end 2004. The well line weld-packs were inspected using a prioritization scheme that examined the oldest, the hottest, and the thinnest-walled lines first. As of year-end 2003, 96% of the cross-country on-pad weld-packs and 91% of the well line weld-packs have received their baseline TRT inspections.
