**PRUDHOE  
BAY  
CORROSION  
CRISIS,  
8/18/06  
(FILE 9)**

**ConocoPhillips Alaska  
Commitment to Corrosion Monitoring  
Annual Reports 2000 – 2005**

# **Greater Kuparuk Area (GKA) Corrosion Programs Overview**

***Commitment to Corrosion Monitoring***  
***1<sup>st</sup> Annual Report to the Alaska Department of Environmental Conservation***

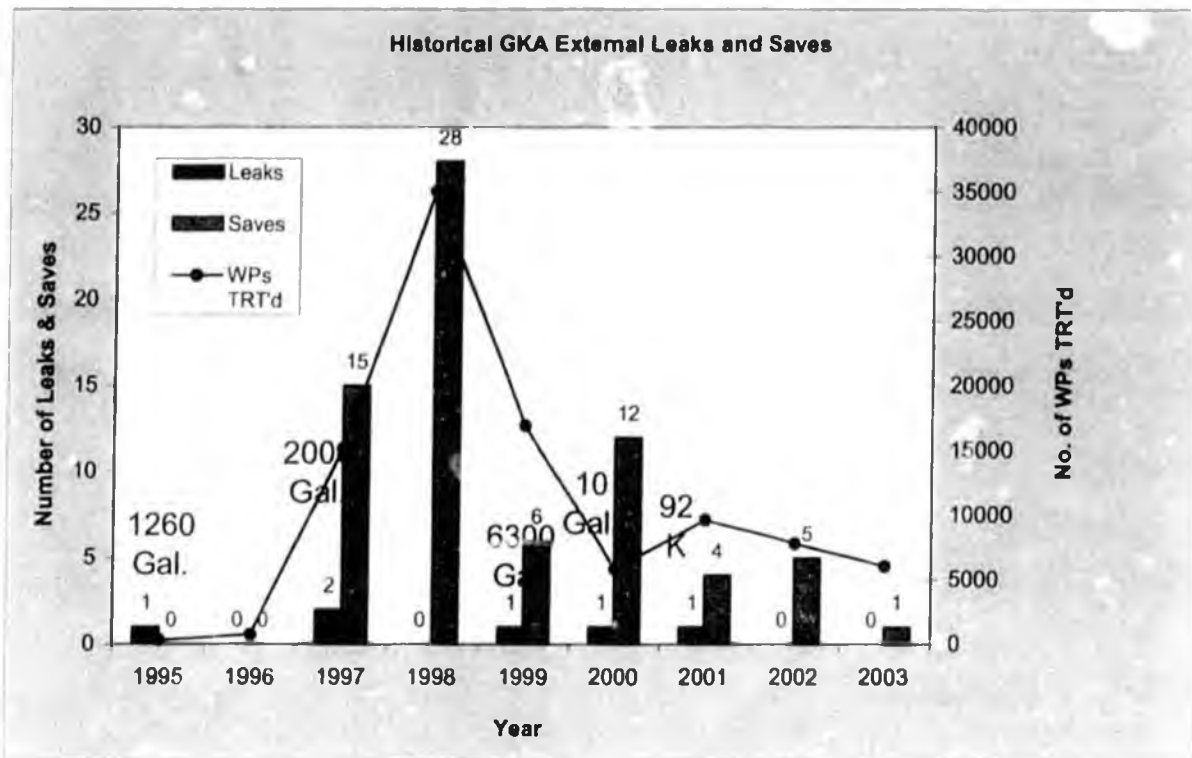
Figure A1. Leaks, saves, number of weld packs inspected with TRT, and volumes of leaks as a function of time.

Note: The leak in 2001 due to external corrosion was located in a weld pack in a below-grade piping segment, and as such, would not have been detected by the TRT inspection program. The location had not yet received PTI/TWI inspection.

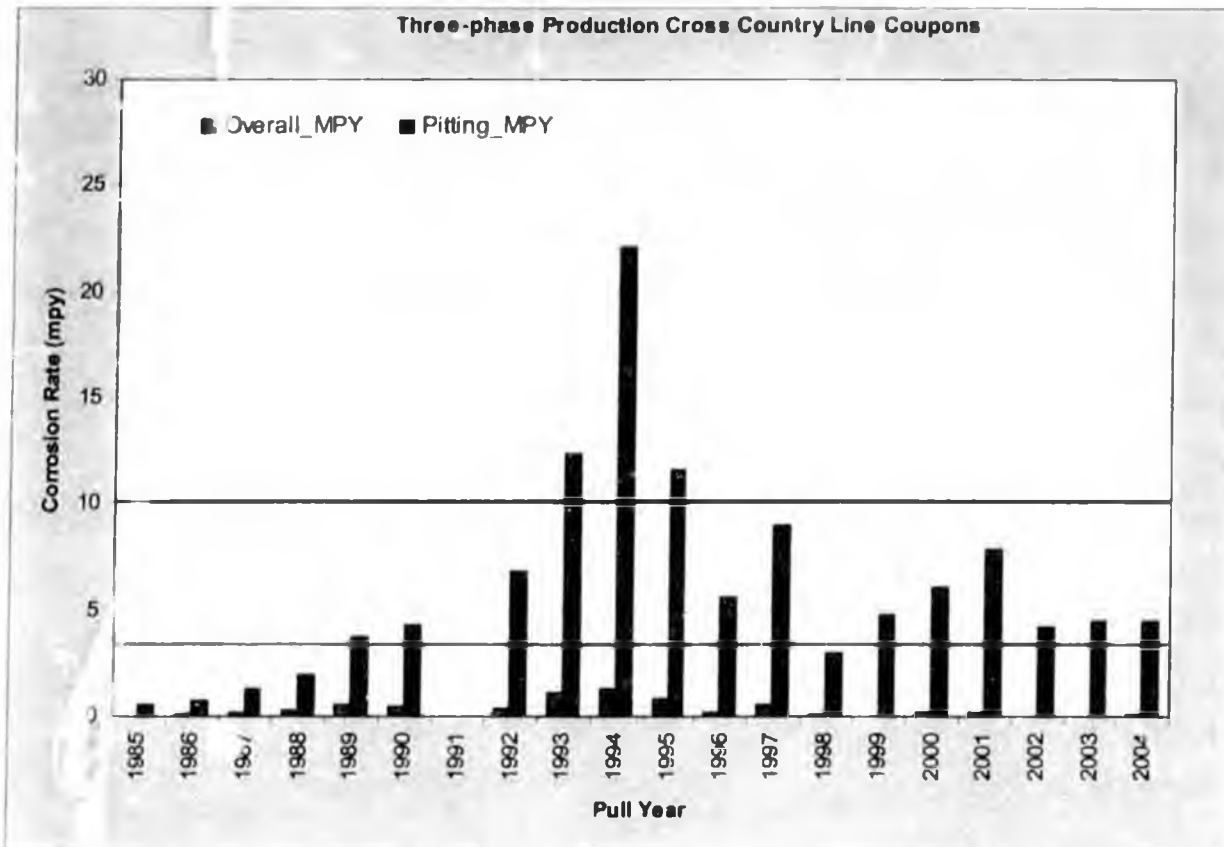
Figure 1. Three-phase Production Cross-Country Line Coupons – general and pitting corrosion rates as a function of time.

*Three-phase Production Cross-Country Lines:* The monitoring data summarized in Kuparuk Tables 1 and 2 and presented in Figure 1 suggest that general corrosion is under control. The data presented in the Tables 1 and 2 and in Figure 1 include corrosion coupon data from the wet oil lines starting at CPF3 and going to CPF1 and CPF2.

Recurring CRM inspections also support the conclusion that corrosion is under control in the three-phase production cross-country lines. In 2004, 587 corrosion-rate monitoring (CRM) inspections were conducted, with two minor increases found. Other internal inspection data also support the CRM data conclusions and are discussed in section 3.1.c, below.

Where corrosion rates exceeded targets, corrosion inhibitor concentrations were increased and/or the amount of inspection was increased excluding: one corrosion inhibitor test location (2WUVPO); and one location that had increased inspection damage over a 12-month period and that had its corrosion inhibitor concentration increased at the end of 2003 (1L10PO). In 2004, coupon or probe corrosion rates exceeded targets on fifteen lines and action was taken on all fifteen of these lines. In 2004, inspection results indicated minor corrosion had occurred on six lines; corrosion inhibitor concentrations were increased in four of these lines. A complete listing of the lines with coupon/probe corrosion rates that exceeded targets and/or where inspection indicated increased damage is given in Table 3.

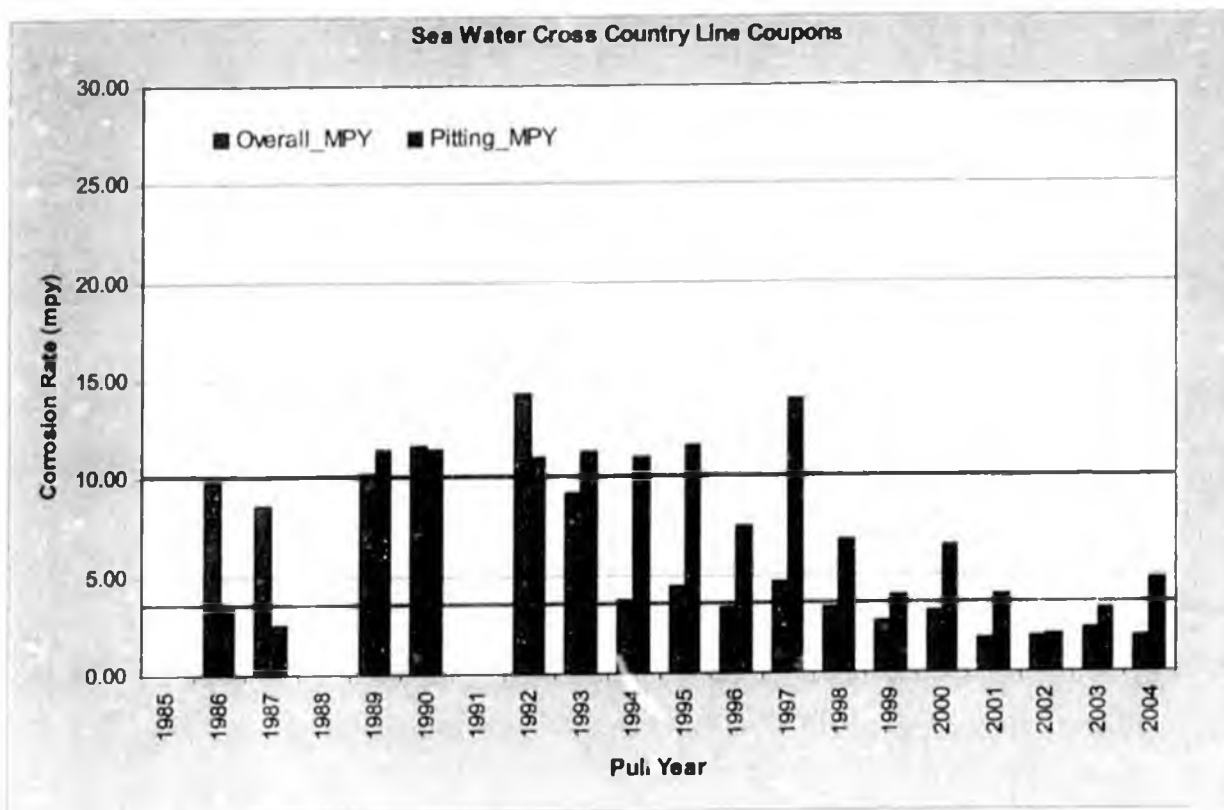
Figure 2. Seawater Cross-Country Line Coupons – general and pitting corrosion rates as a function of time.

*Sea Water Cross-Country Lines:* The monitoring data summarized in Kuparuk Tables 1 and 2 and presented in Figure 2 above, shows the average corrosion rates for the sea water cross-country line coupons remained under thresholds in 2004.

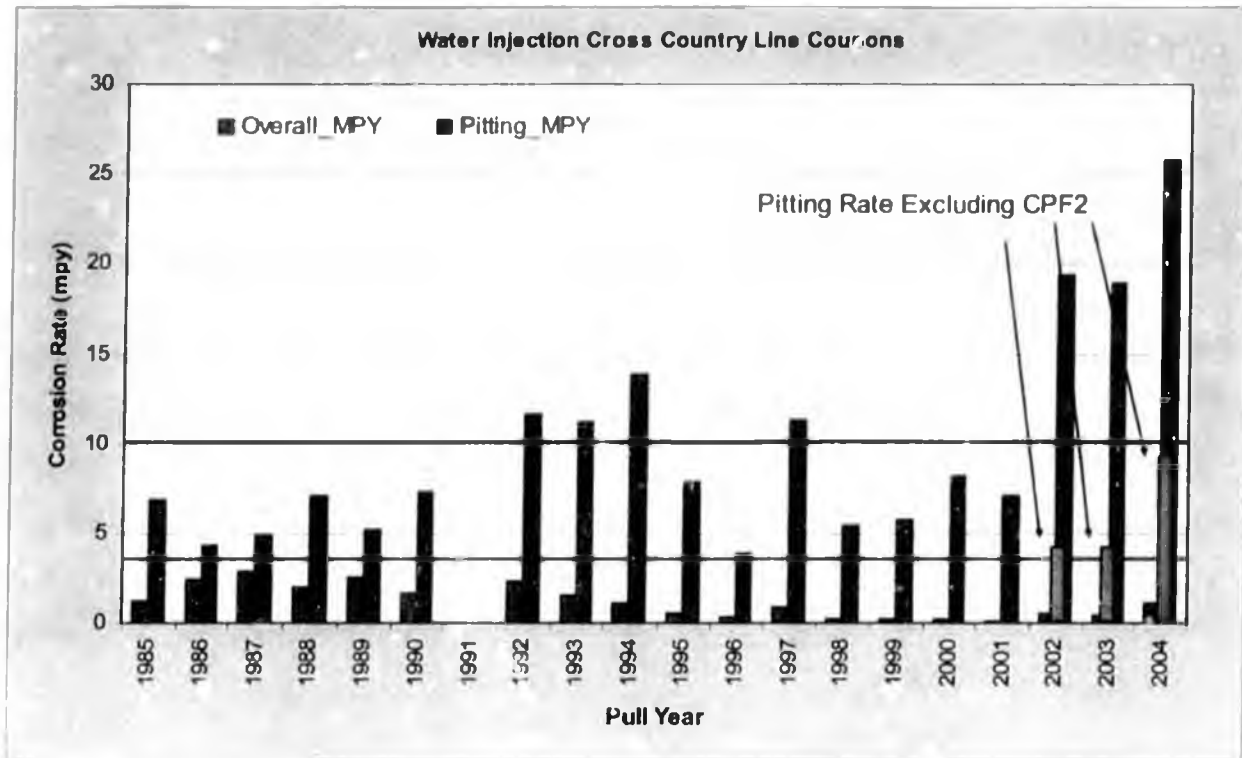
**Figure 3. Water Injection Cross-Country Line Coupons – general and pitting corrosion rates as a function of time.**

*Mixed Water Injection Cross-Country Lines:* The monitoring data summarized in Kugaruk Tables 1 and 2 and presented in Figure 3 show that average general corrosion rates are below the threshold, but that pitting rates for the field are above the threshold. Closer analysis of the data shows that the average pitting rate excluding CPF2 locations is under the threshold. Coupon results are used to prioritize inspection efforts. During the second half of 2004, equipment was installed and procedures were implemented to provide enhanced biocide treatments at CPF2. The first quarter 2005 coupon pulls from CPF2 show that pitting rates are lower than the 2004 average, but are still above threshold. In addition to the biocide treatment enhancements, an additional 80K BWPD of SW has been added to CPF2. This will increase line velocities and is anticipated to help reduce the under-deposit corrosion seen on many of these coupons.

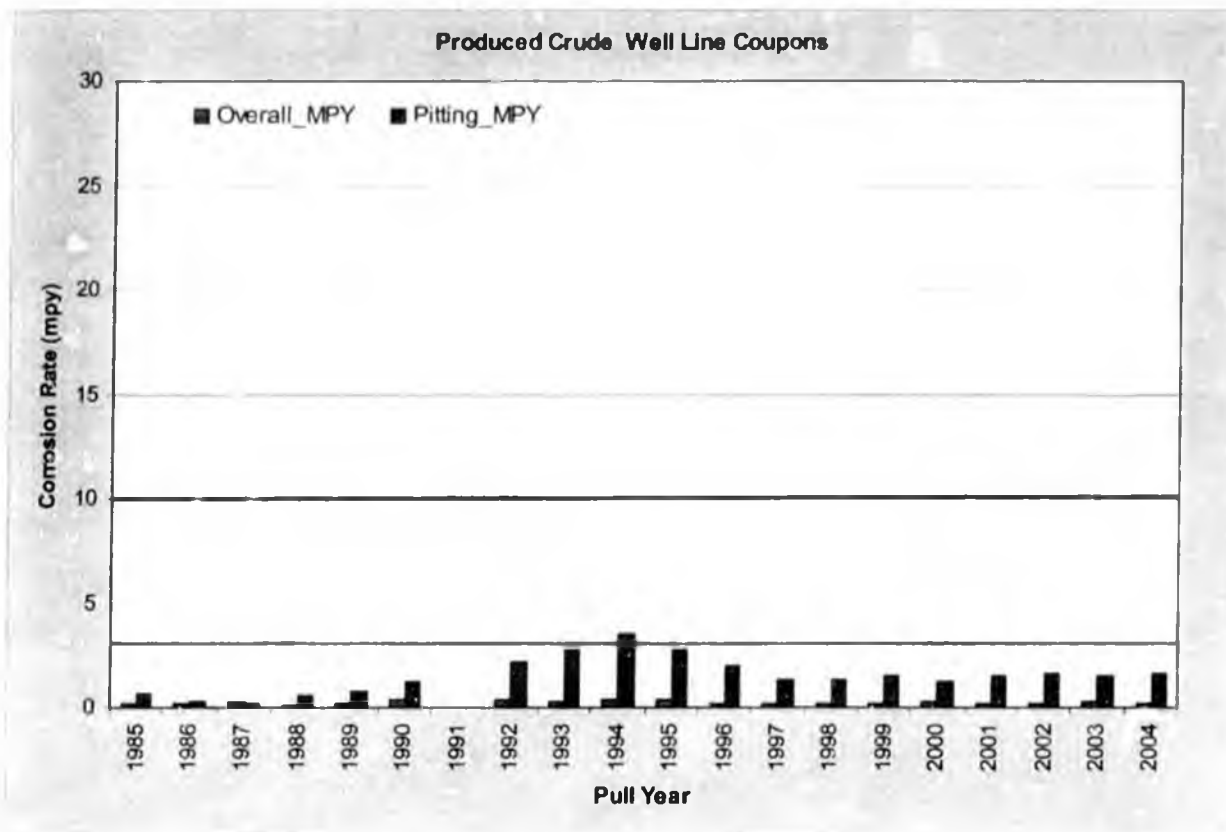
Figure 4. Three-phase Production Well Line Coupons – general and pitting corrosion rates as a function of time.

*Three-phase Production Well Flow Lines:* While the monitoring data summarized in Kupařk Tables 1 and 2 and presented in Figures 4 and 5 suggest that corrosion rates are below targets, inspection data indicate that higher corrosion rates have been experienced historically. The well line inspection data are discussed in section 3.1.b below, and are a good example of why monitoring data alone cannot be relied upon to characterize corrosion in a given system. For three-phase production, coupons monitor free flowing fluid and have not shown the predominant, under-deposit corrosion mechanism.

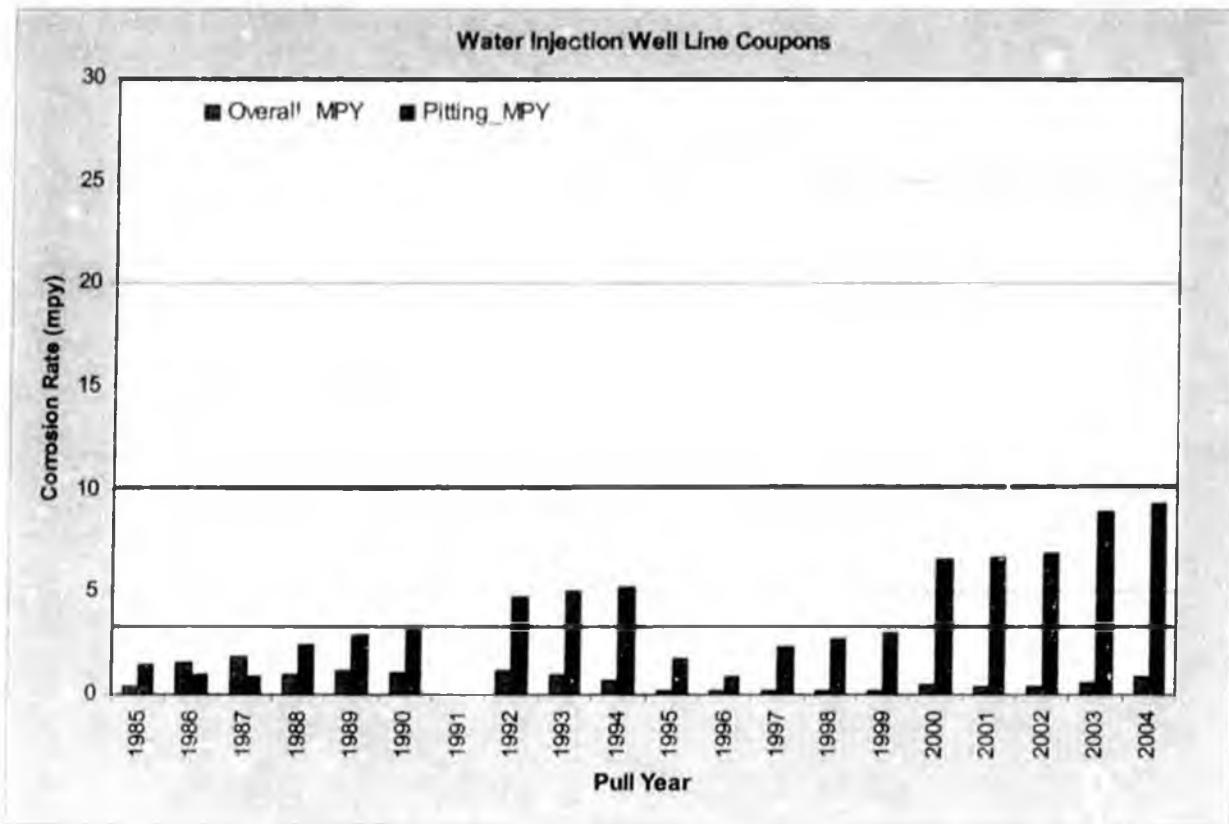
Figure 5. Water Injection Well Line Coupons - general and pitting corrosion rates as a function of time.

*Water Injection Well Flow Lines:* As discussed in section 3.1.b below, the well line inspection data on water injectors show that there are a significant number of corrosion related repairs. The water feeding this system is treated at the facilities with biocide and is discussed under Figure 3 - Water Injection Cross-Country Line Coupons

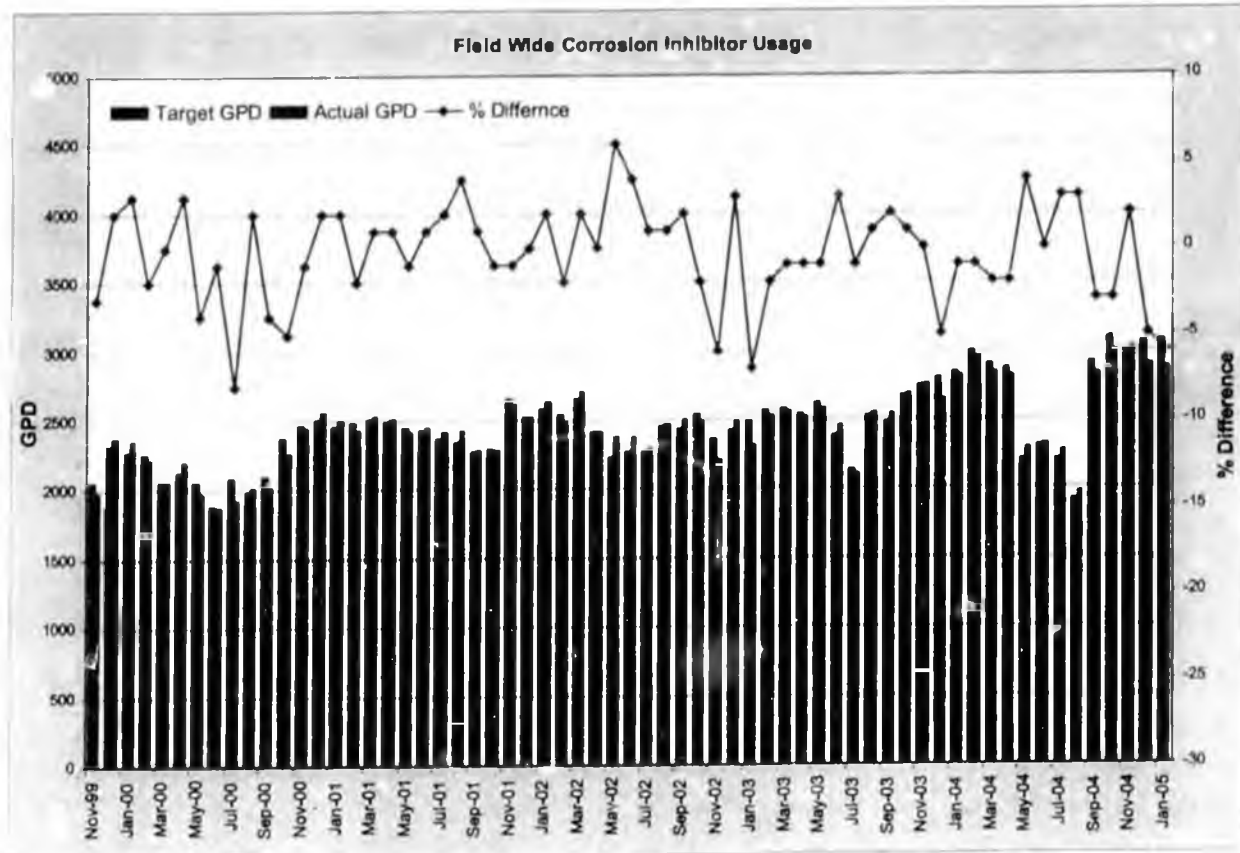
Figure 6. Field-wide Corrosion Inhibitor Use.

For the Kuparuk field, Figure 6 shows the actual number of gallons of corrosion inhibitor pumped per day, the recommended number of gallons of corrosion inhibitor per day, and the percent difference between the two. The average deviation for the year was  $-0.85\%$ . The larger variation seen in the November and December 2004 data was caused by the extreme weather. The lower usage seen in May through August was due to pumping a more concentrated blend of the same field-wide corrosion inhibitor (the concentration of active components in both blends is the same).

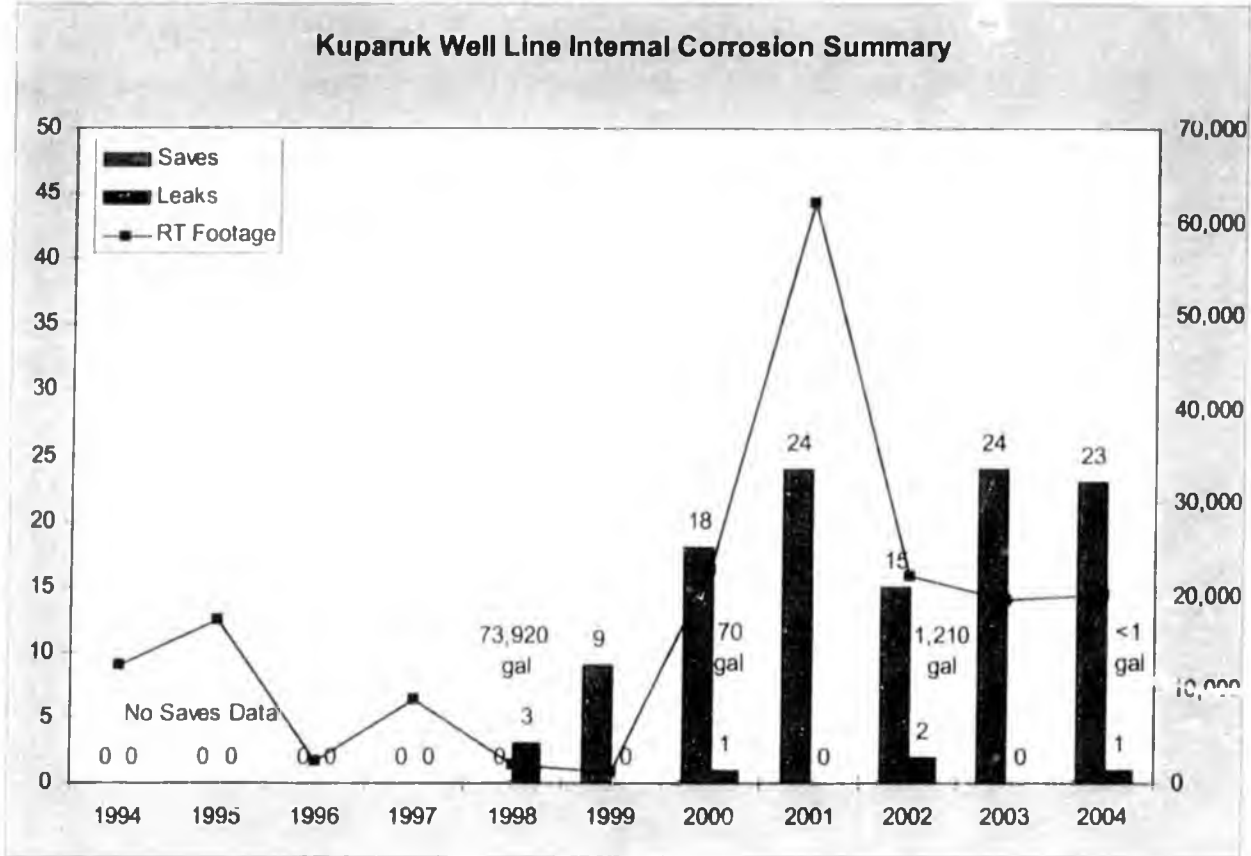
Figure 8. Summary of Well Line Internal Corrosion Inspections – RT footage, leaks, and saves as a function of time.

As indicated in Figure 8 below, repair recommendations were initiated on 24 lines (16 water injection, 8 production) in 2004 because of internal corrosion damage. Except for the leak, the corrosion mechanisms were all underdeposit corrosion. The leak, determined not to be an ADEC-reportable spill, was in a water injection line and was caused by erosion associated with a straightening vane pack. More information on the leak can be found in section 3.1.g.

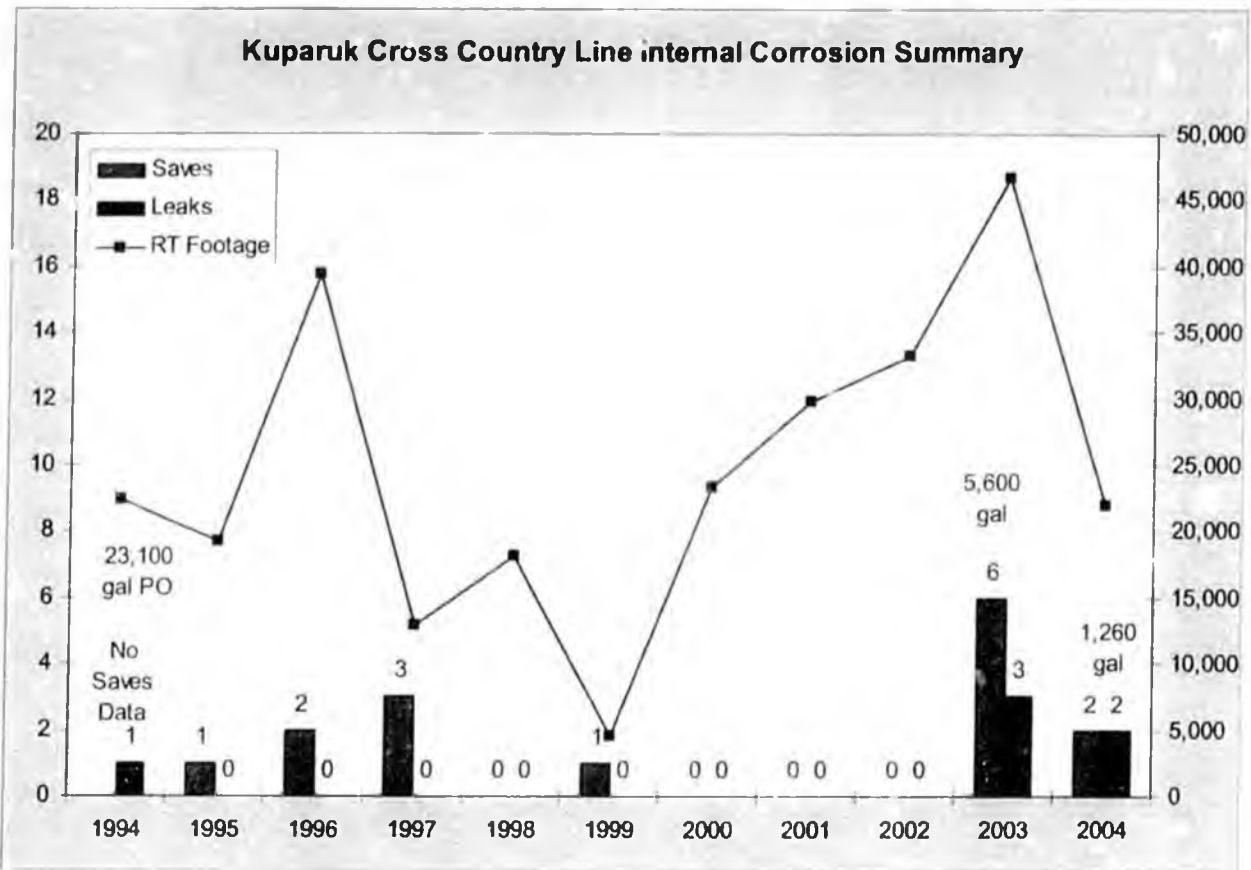
Figure 9. Summary of Cross-Country Line Internal Corrosion Inspections – RT footage, leaks, and saves as a function of time.

As indicated in Figure 9, four repair recommendations were initiated on cross-country lines (1 seawater injection, 3 production) because of internal corrosion damage in 2004. The corrosion mechanism for the three production lines was deadleg corrosion. The corrosion mechanism for the seawater injection line leak, determined not to be an ADEC-reportable spill, was microbiologically induced corrosion. More information on the leak can be found in section 3.1.g.

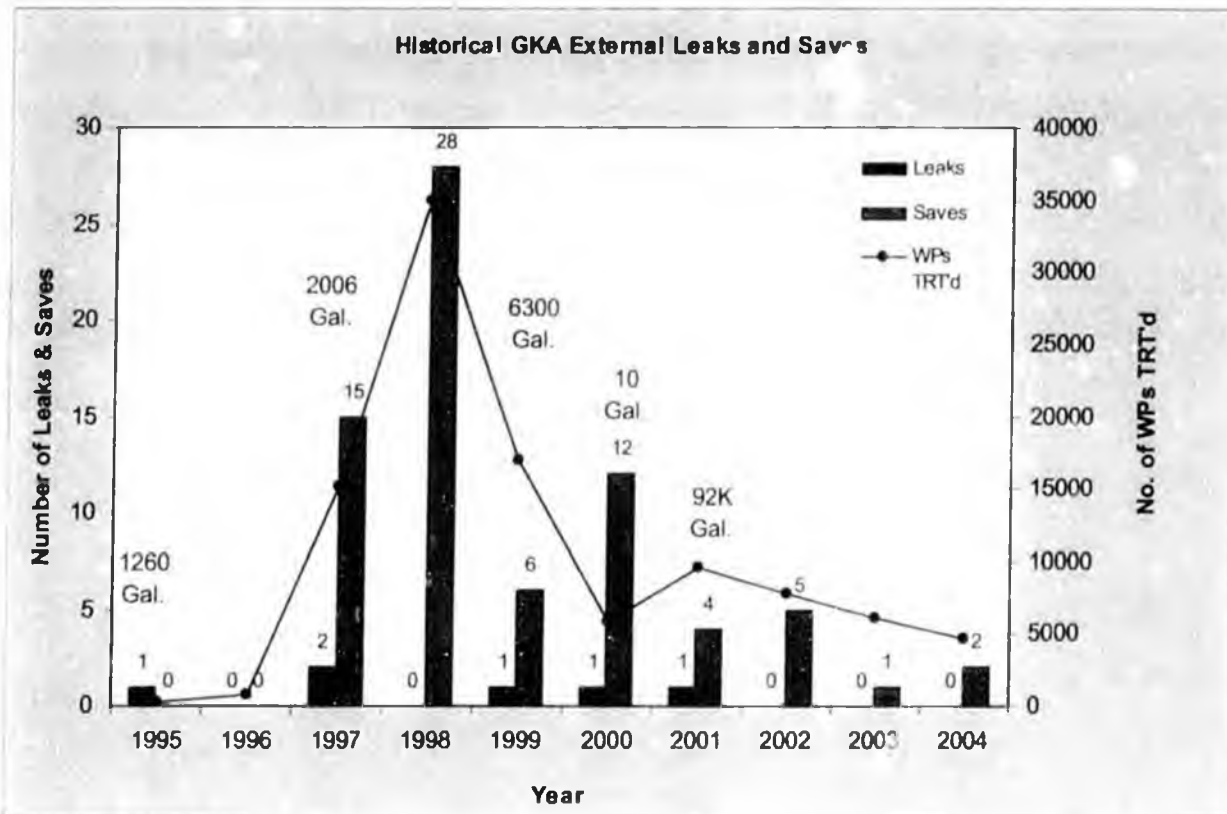
Figure 10. Leaks, saves, number of weld packs inspected with TRT, and volumes of leaks as a function of time.

A total of 672 locations were inspected using tangential radiography (TRT), significantly exceeding the goal of 406 for 2004. Of the 672 locations, none needed repair while 96 locations were refurbished. The baseline inspections on all weld packs due for inspection is now considered complete.

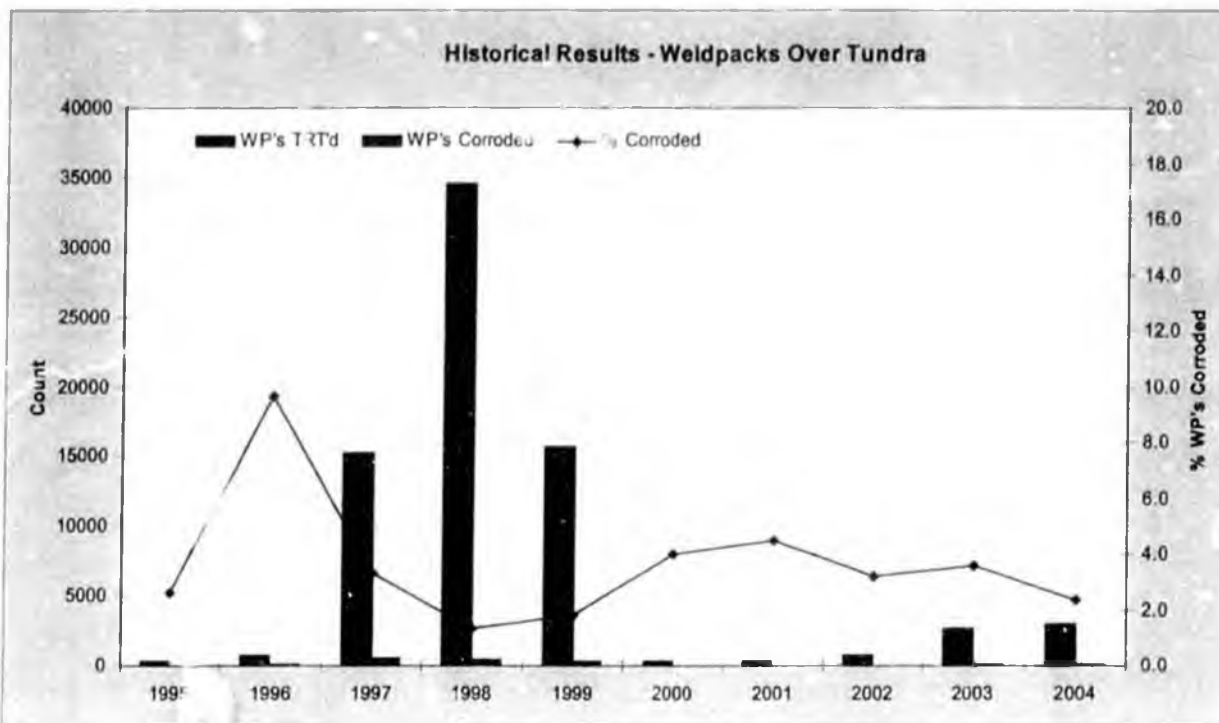
Figure 11. Summary of Weld Packs on Cross-Country Lines over Tundra (off-pad).

Figure 11 illustrates the most-complete external corrosion inspection program of the three external corrosion programs. 2002, 2003, and 2004 values include re-inspections and clean-up of locations missed or not properly documented during the original base line effort.

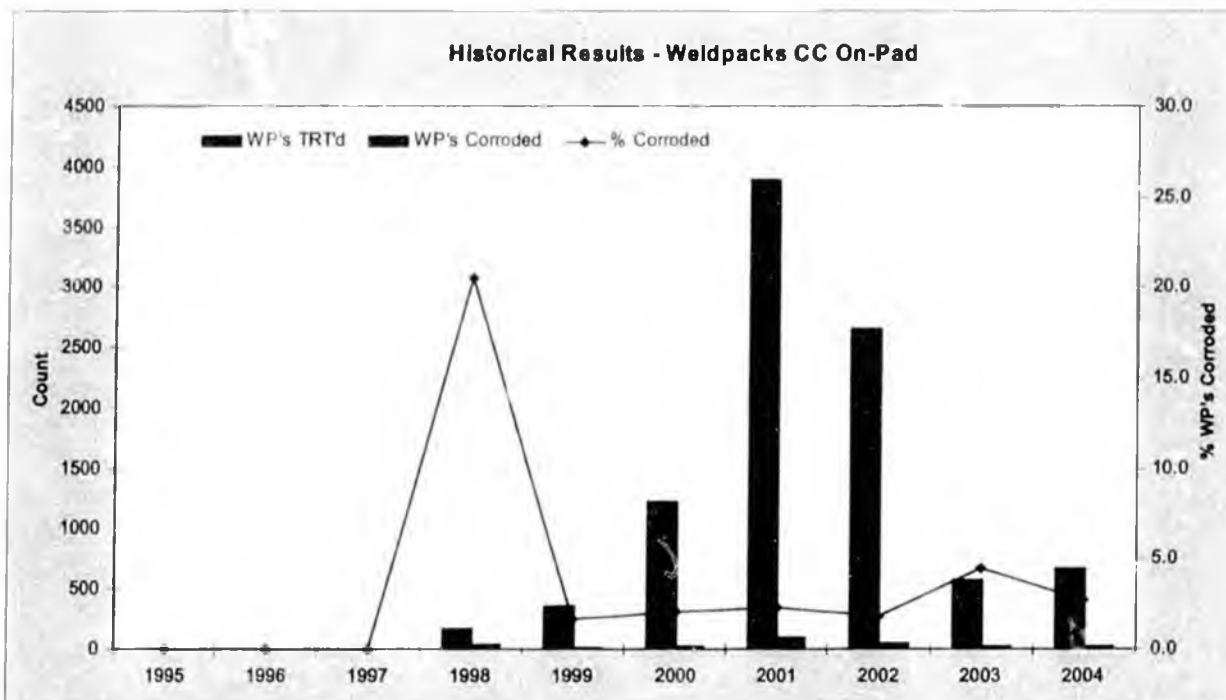
Figure 12. Summary of Weld Packs on Cross-Country Lines on Pads.

Figures 12 and 13 depict the results of the major focus of the external weld pack inspection program in 2004. The cross-country program and the well line weld pack program met milestones in 2004 by completing all of the baseline TRT inspections of all weld packs in their respective areas.

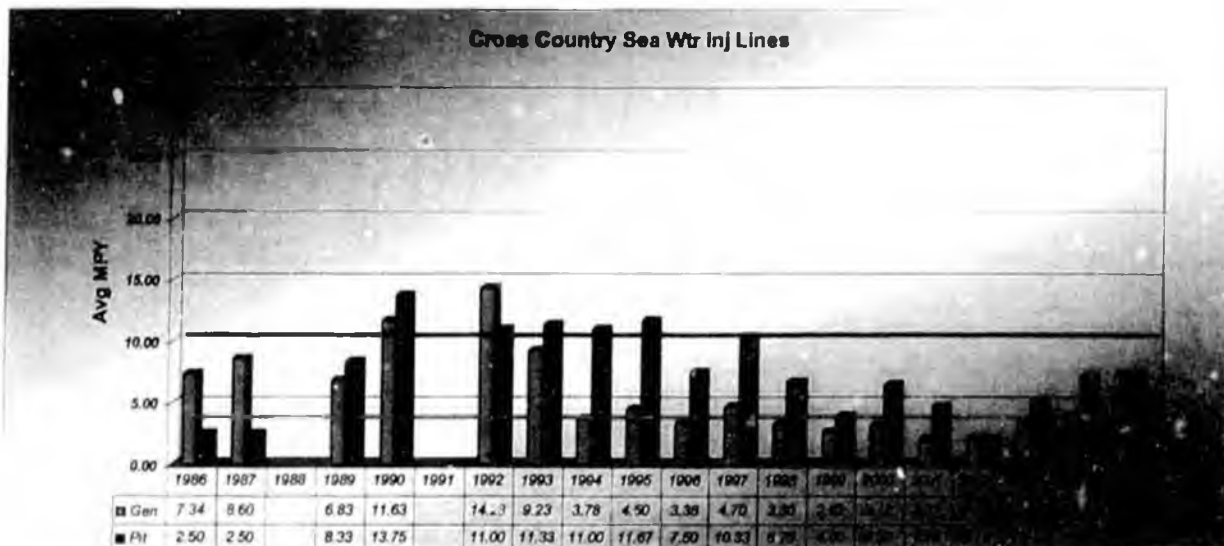
**Figure 2. Seawater Cross-Country Line Coupons – general and pitting corrosion rates as a function of time.**

*Sea Water Cross-Country Lines:* The monitoring data summarized in Kuparuk Tables 1 and 2 and presented in Figure 2 above, show the average corrosion rates for the sea water cross-country line coupons. Higher coupon corrosion rates were caused by higher dissolved oxygen concentrations seen during 2005 break-up and oxygen scavenger was added to decrease the dissolved oxygen concentration; these coupons are located near the exit of the sea water treatment plant (STP) and are not believed to be indicative of corrosion in the sea water injection system. Increased coupon corrosion rates detected are currently under review, with biocide concentration and pigging frequency increased in early 2006. Smart pigging of the 30-inch sea water line from the STP to the CW Skid is planned for 2006.

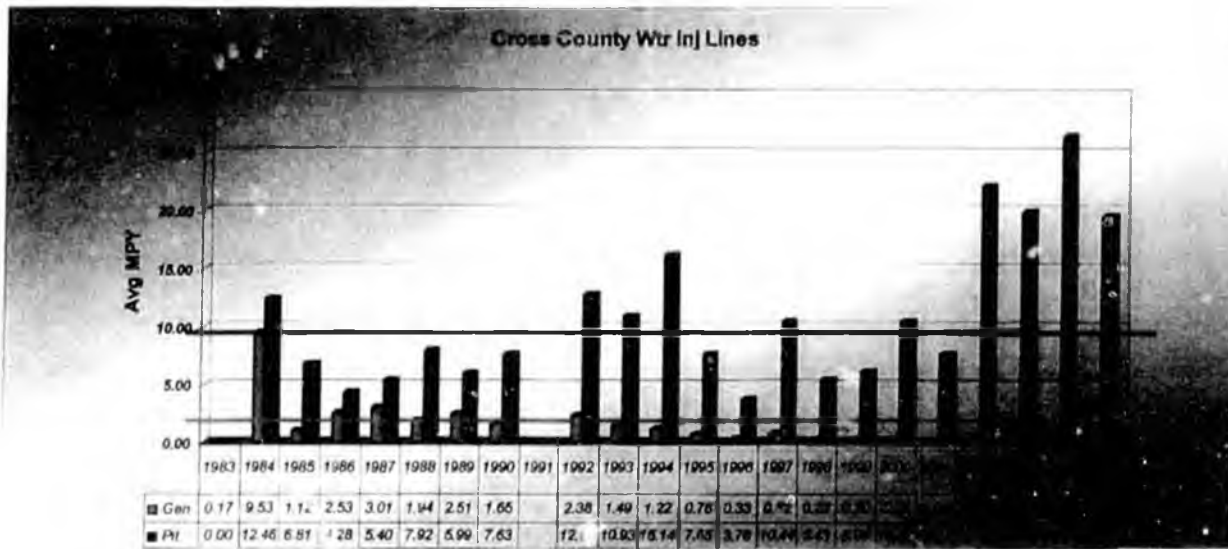
Figure 3. Water Injection Cross-Country Line Coupons – general and pitting corrosion rates as a function of time.

*Water Injection Cross-Country Lines:* The monitoring data summarized in Kuparuk Tables 1 and 2 and presented in Figure 3 show that average general corrosion rates are below the threshold, but that pitting rates for the field are above the threshold. Seawater and produced water commingling was suspended at CPF2 in August 2005 and coupons replaced then; coupons were retrieved from CPF2 in late November with pitting rates reduced markedly from previous pulls. Coupon results are used to prioritize inspection efforts. During 2005 additional equipment was installed and procedures were implemented to provide enhanced biocide treatments at CPF2. Cleaning pigs were upgraded to include brushes in addition to the disks and the pigging procedures changed to include multiple (three) pig runs per monthly cleaning cycle.

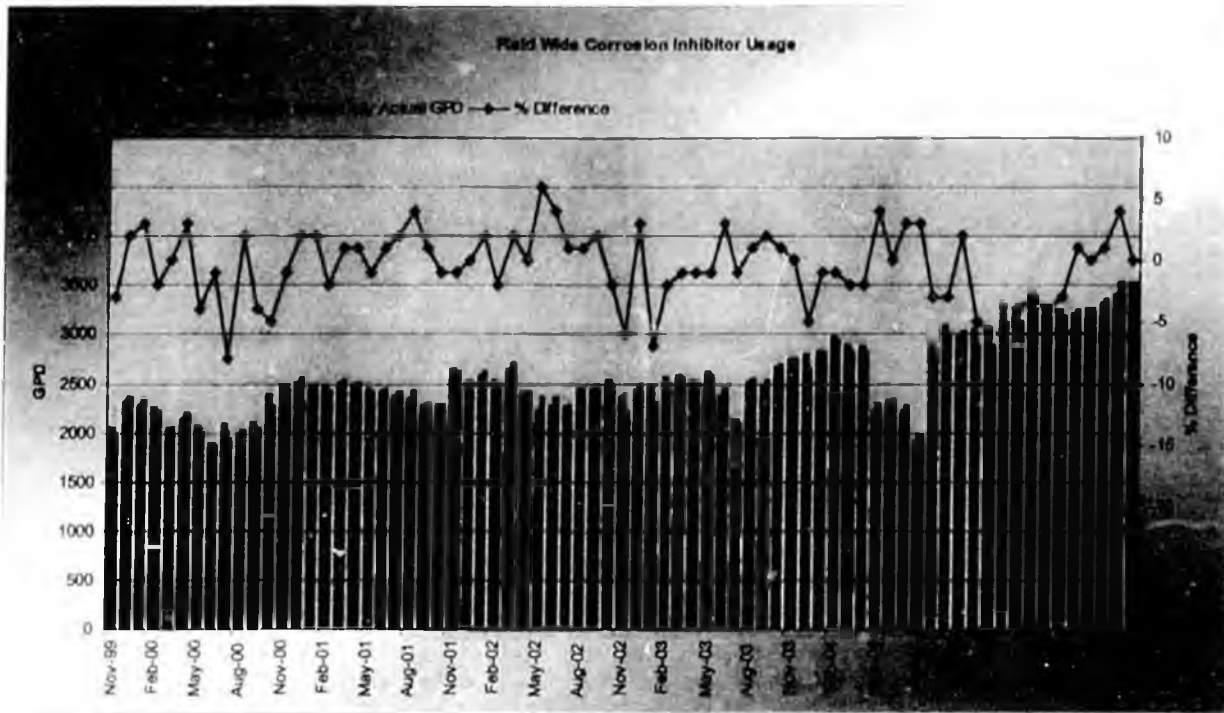
Figure 6. Field-wide Corrosion Inhibitor Use.

For the Kuparuk field, Figure 6 shows the actual number of gallons of corrosion inhibitor pumped per day, the recommended (target) number of gallons of corrosion inhibitor per day, and the percent difference between the two. The average deviation for the year was -1.85%. The large variation seen in the early parts of the year are usually caused by the extreme weather. Several pump upgrades were accomplished in 2005 to accommodate increased volumes.

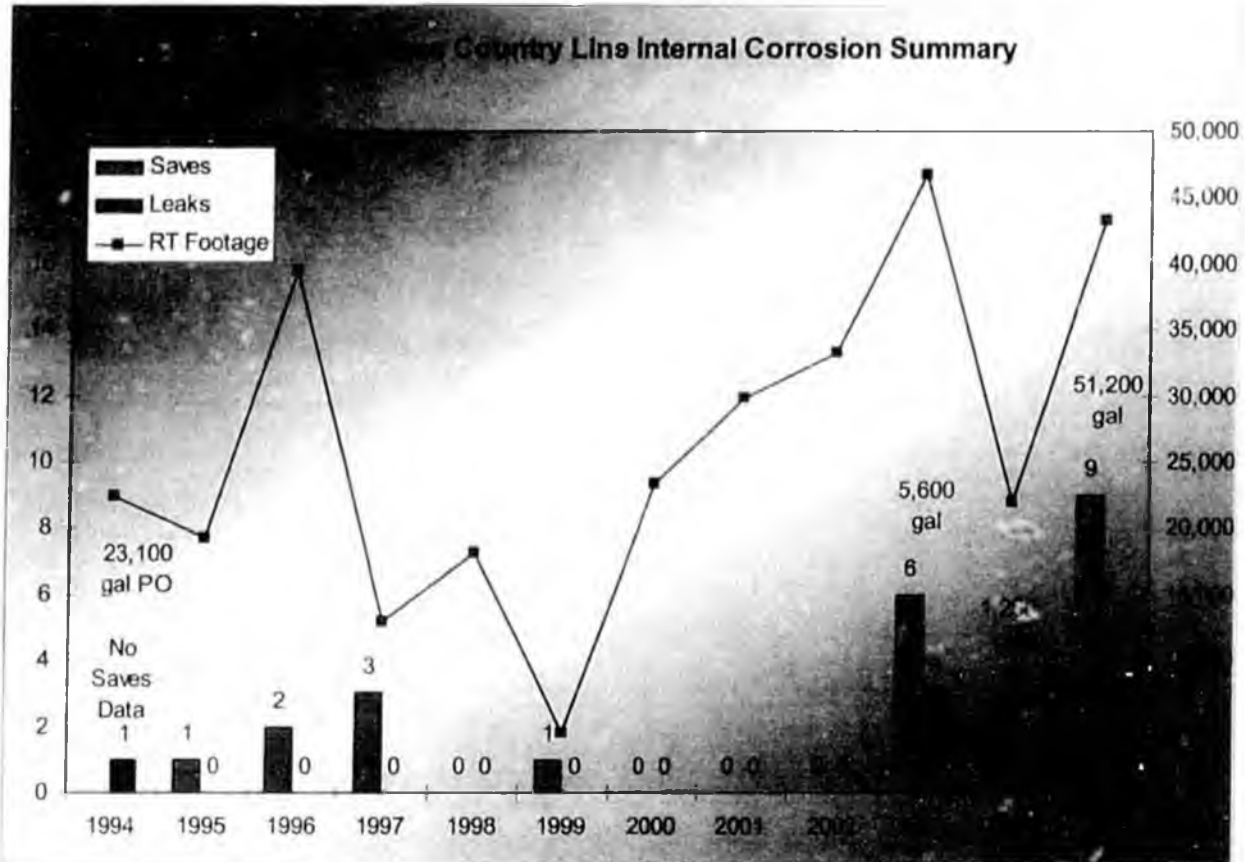
Figure 9. Summary of Cross-Country Line Internal Corrosion Inspections – RT footage, leaks, and saves as a function of time.

As indicated in Figure 9, 12 repair recommendations were initiated on cross-country lines (8 water injection, 4 production) because of internal corrosion damage in 2005. The corrosion mechanism for all repair recommendations was deadleg/underdeposit corrosion. All three leaks were in the water injection system. More information on the leaks can be found in section 3.1.g.

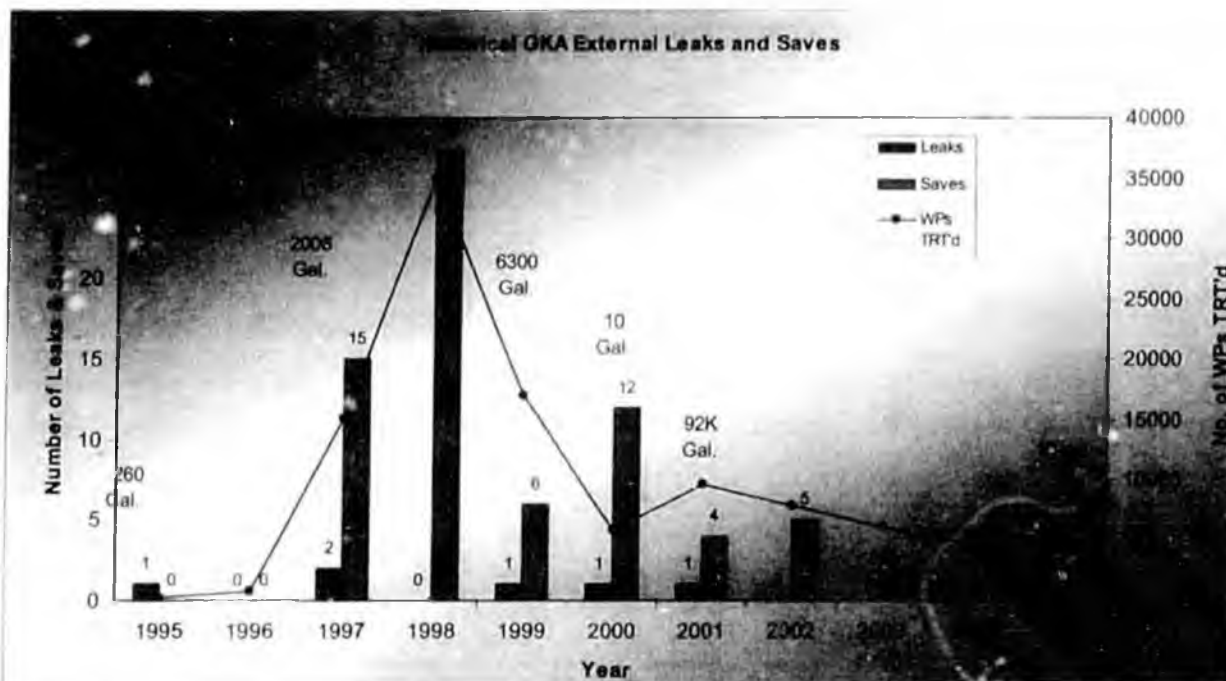
Figure 10. Leaks, saves, number of weld packs inspected with TRT, and volumes of leaks as a function of time.

- Completed 4,646 TRT surveys of cross country line and well line weld packs due for recur inspection.
- Completed our goal of inspecting 100 additional Tarn-style weld packs (~257 to date) to ensure this new design is working properly. The weld pack design appears to be performing as planned. No corrosion has been detected.
- Inspection of 100 refurbished weld packs to verify the soundness of the Denso Tape refurbishments. The refurbishment technique appears to be performing as planned.

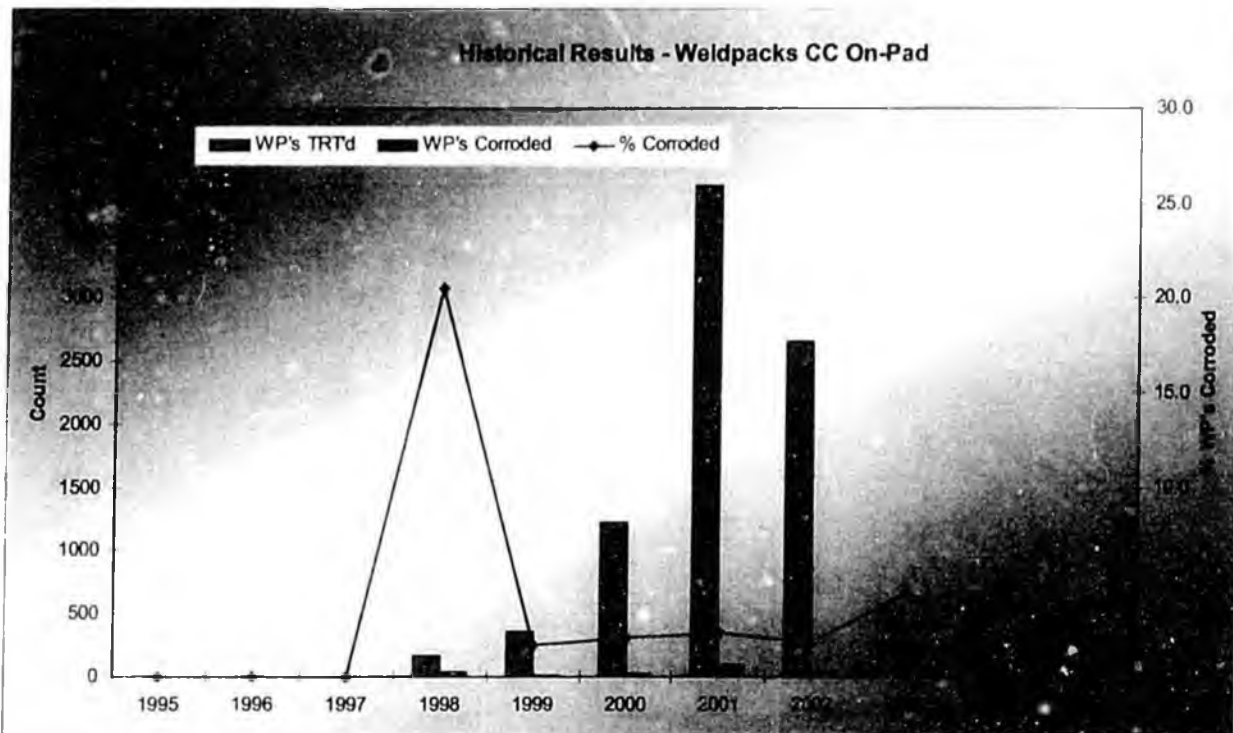
Figure 12. Summary of Weld Packs on Cross-Country Lines on Pads.

The number of CUI locations inspected with TRT, the number of CUI locations found corroded, and the percentage of CUI locations corroded for the cross-country lines over tundra, cross-country lines on-pad, and well lines are given in Figures 11, 12, and 13 beginning on the next page.
