Northwest Arctic Borough  
School District

*Current Capital  
Improvement Project Needs*

**BUCKLAND**

## ENGINEER'S CERTIFICATE OF INSPECTION

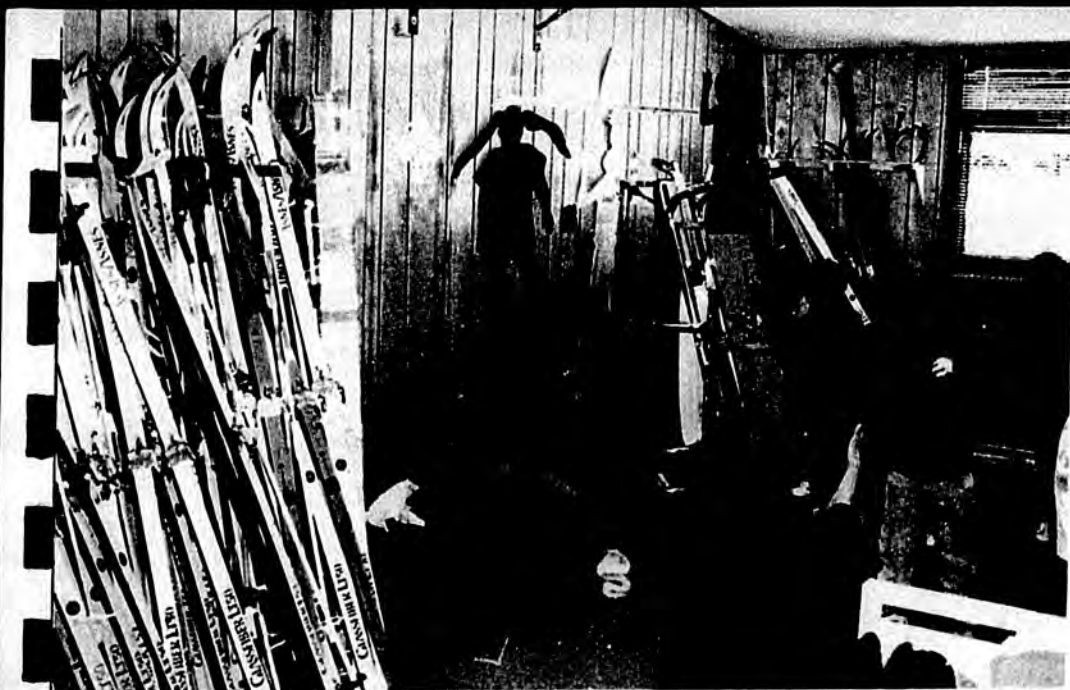
**PHOTO 1**

Bilingual classroom at the rear of the preschool building: This room is used to store cross-country ski equipment. Note: coats, hats, and gloves are stored on the floor.

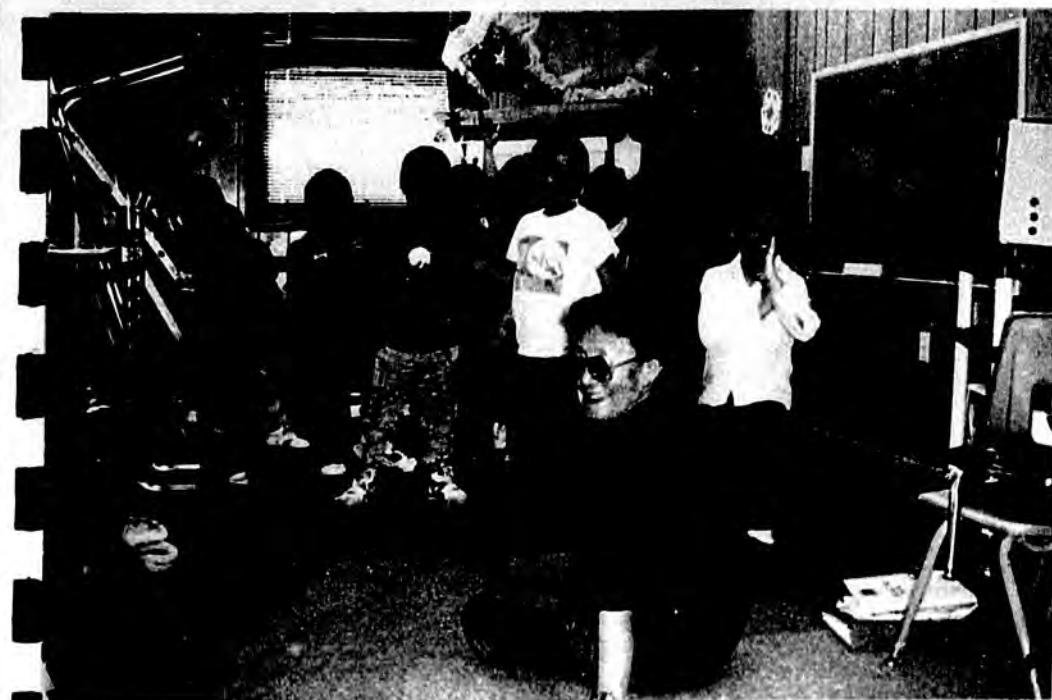
**PHOTO 2**

Another view of the same area as in photo 1. Students cannot use seating because the room is too small.

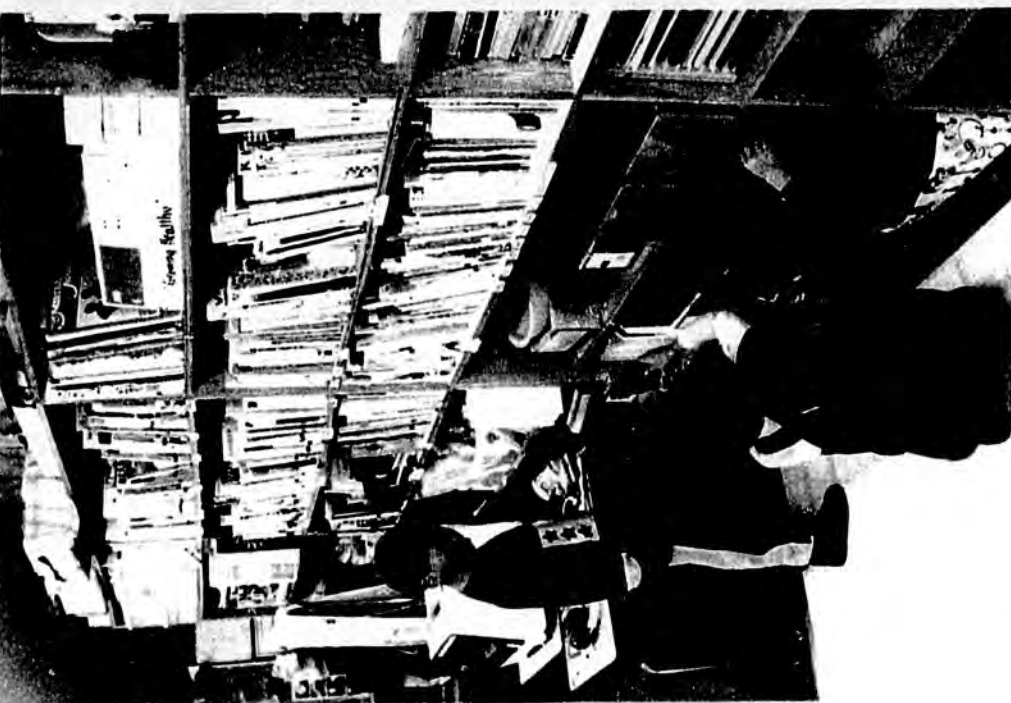
**PHOTO 17**

Preschool book storage: This area should actually be incorporated into a media center. This would provide more space for preschool activity in the preschool room and would also provide instructional opportunities for preschoolers in the media center.

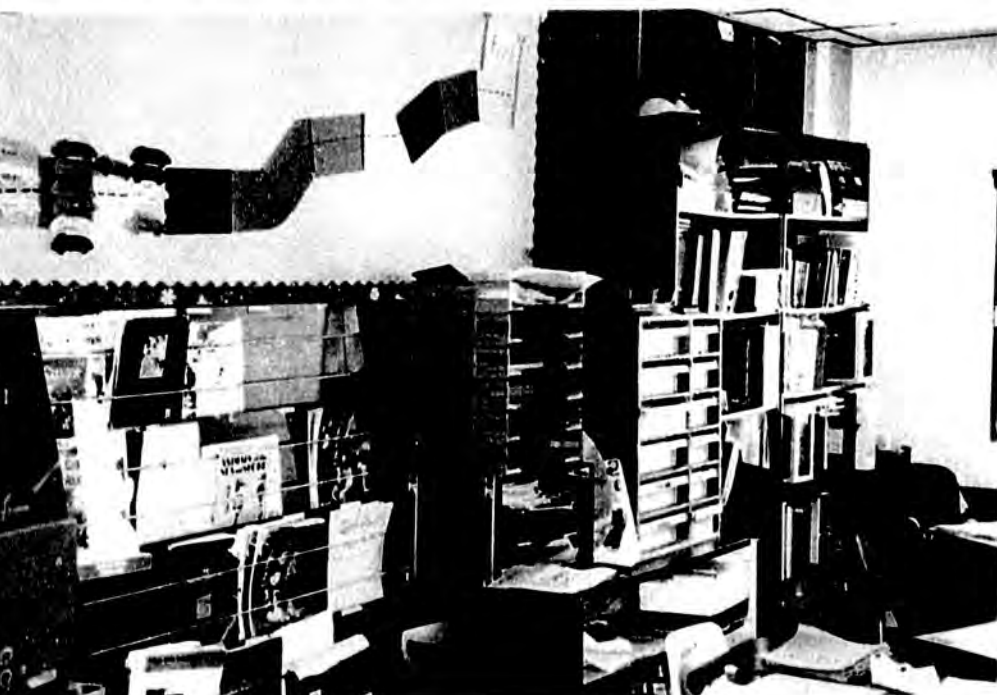
**PHOTO 18**

Storage area in a classroom adjacent to a removable classroom partition. The original design concept was to allow flexibility by removing wall when extra space was needed. Because these storage shelves and racks must be placed against this wall, the wall can no longer be moved.

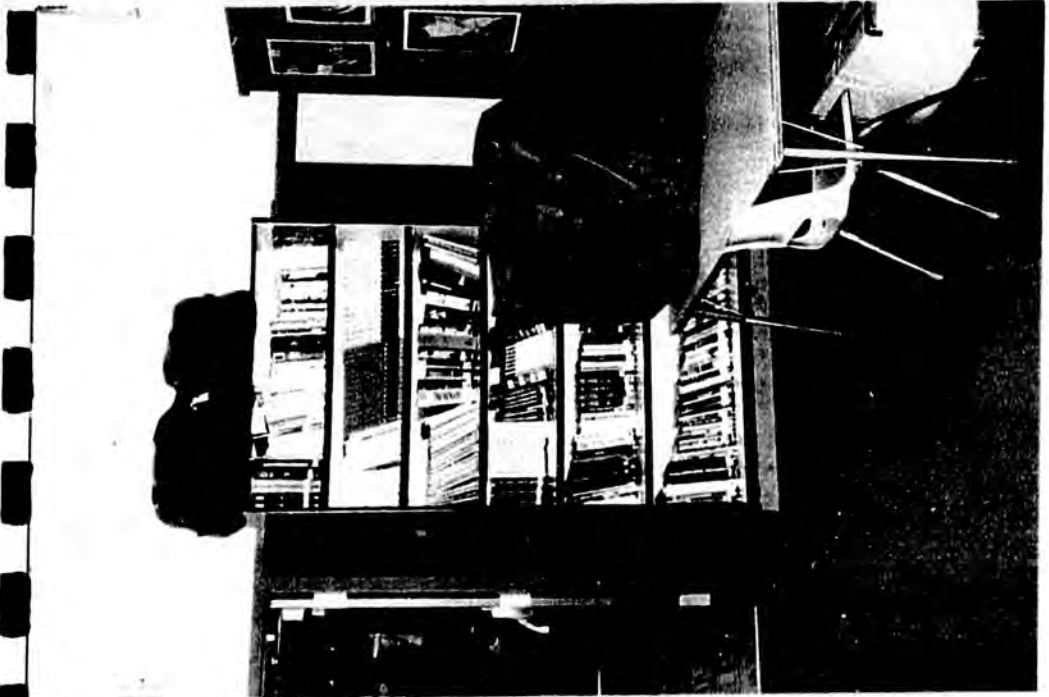
**PHOTO 20**

Media storage consuming space that should be used for student-accessible media materials, not equipment storage.

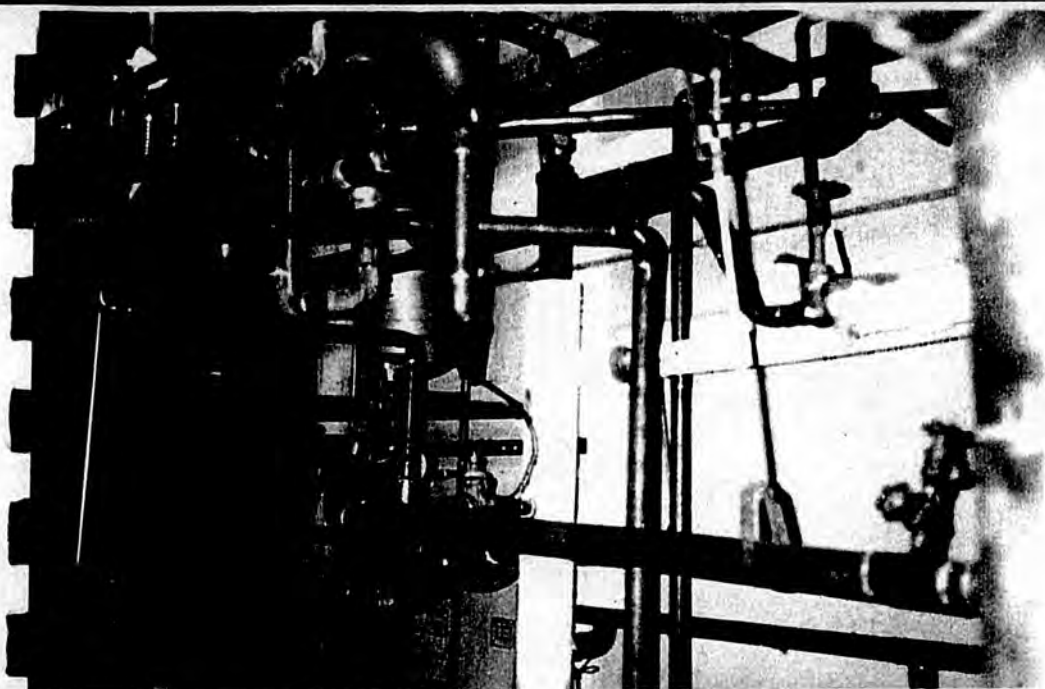
**PHOTO 4**

This photo illustrates the complexity of the mechanical systems installation at Buckland. Mechanical systems have experienced numerous renovations. These renovations have created situations similar to this throughout the facility.

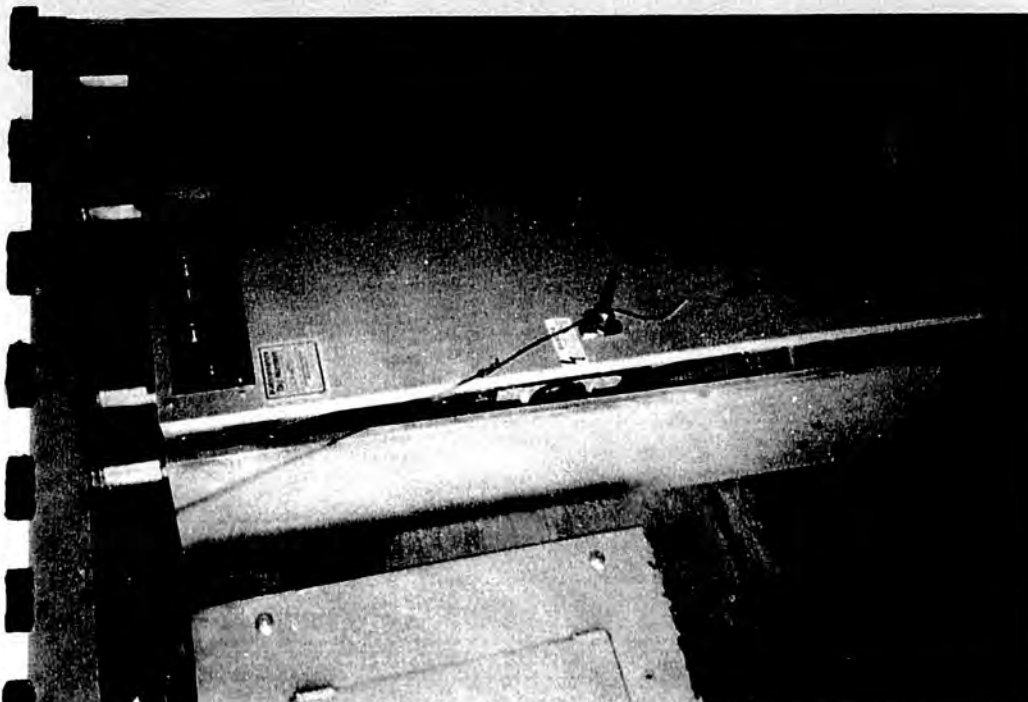
**PHOTO 8**

Electrical box with cable running into it from below, causing the door to be left open and expose live parts.

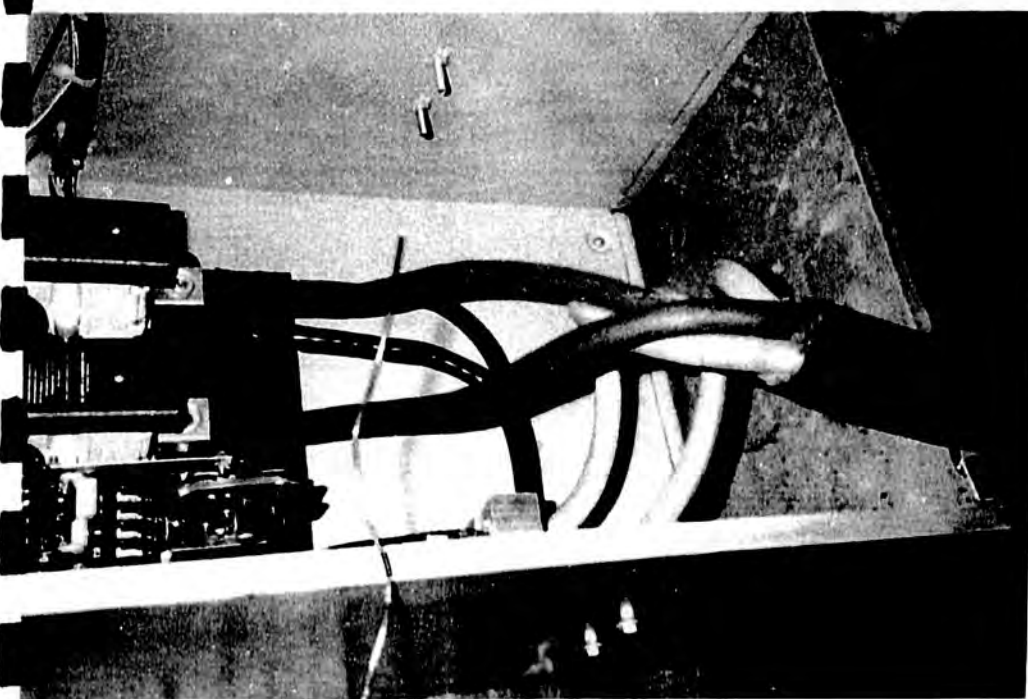
**PHOTO 9**

Electrical leads exposed due to problem in previous photo.

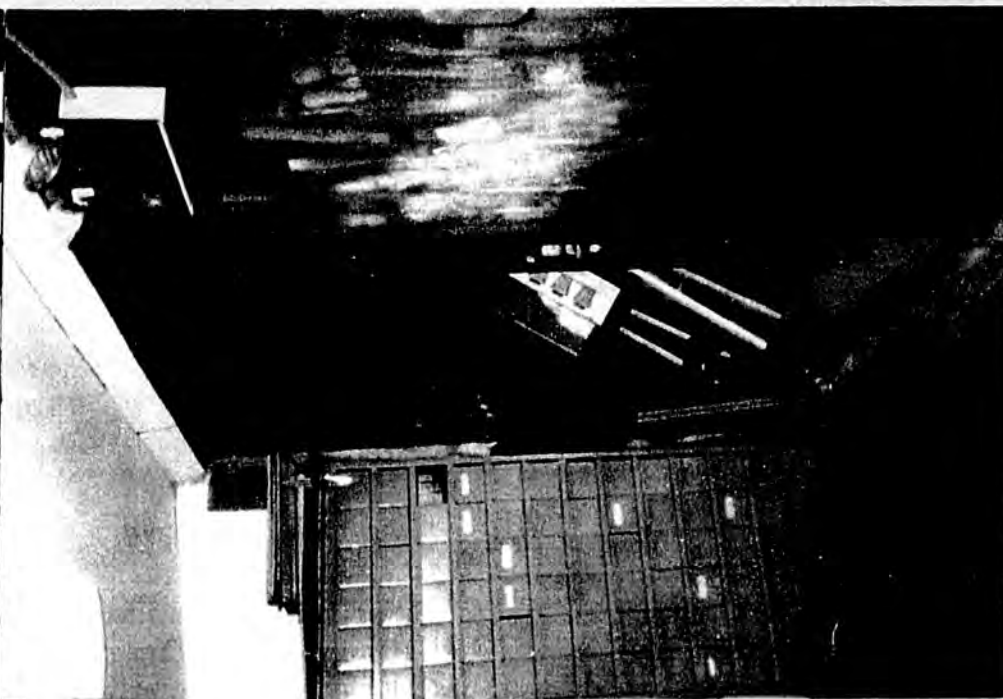
**PHOTO 23**

This is the exit passageway out of the shop building. There is approximately a 4-inch change in elevation in the exit passageway. This passageway does not meet code requirements.

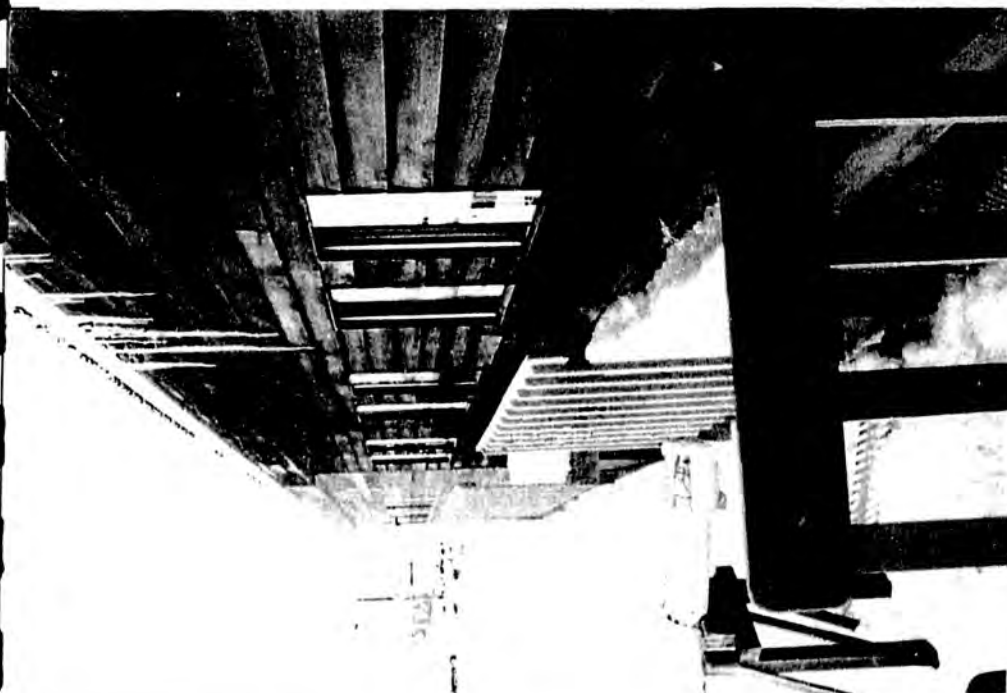
**PHOTO 24**

Egress is blocked by snow and rain runoff under the eave. There is no safe access to ground level from this platform; there are no handrails.

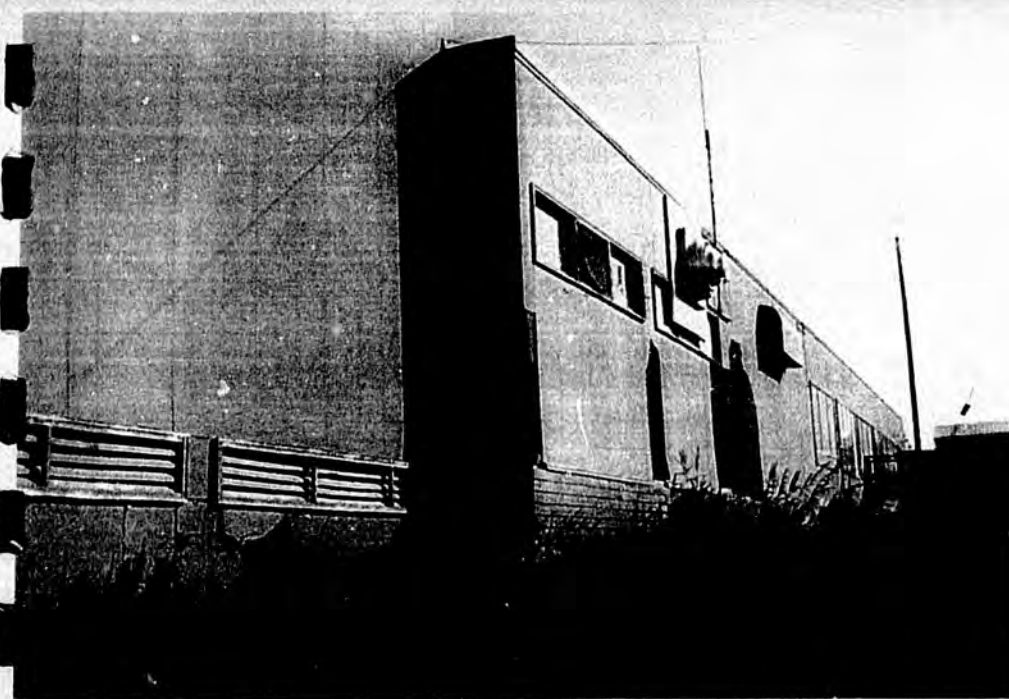
**PHOTO 1**

Holes were found in the elementary building's siding or siding has been removed. This could allow decay to occur.

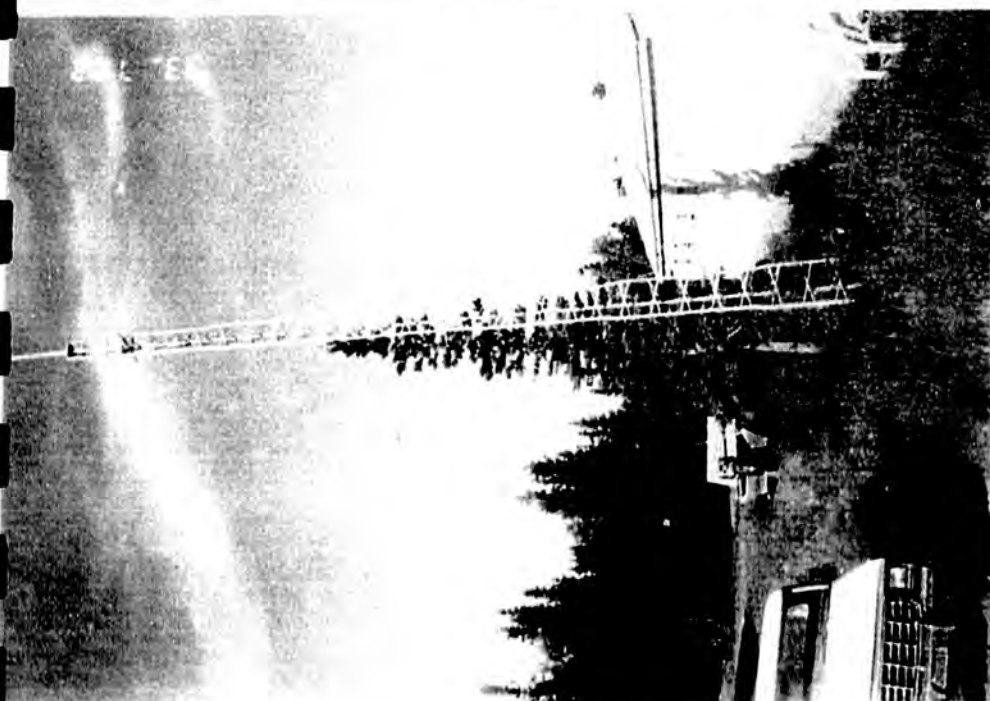
**PHOTO 12**

Antenna tower appears to be jacking and leaning. May become unstable and topple.
