ALASKA LEGISLATURE

COMMITTEE FILES

HB 167 (file 1)

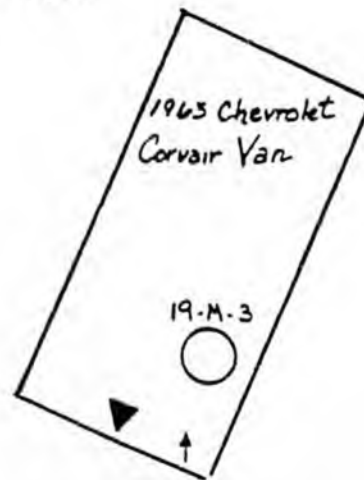
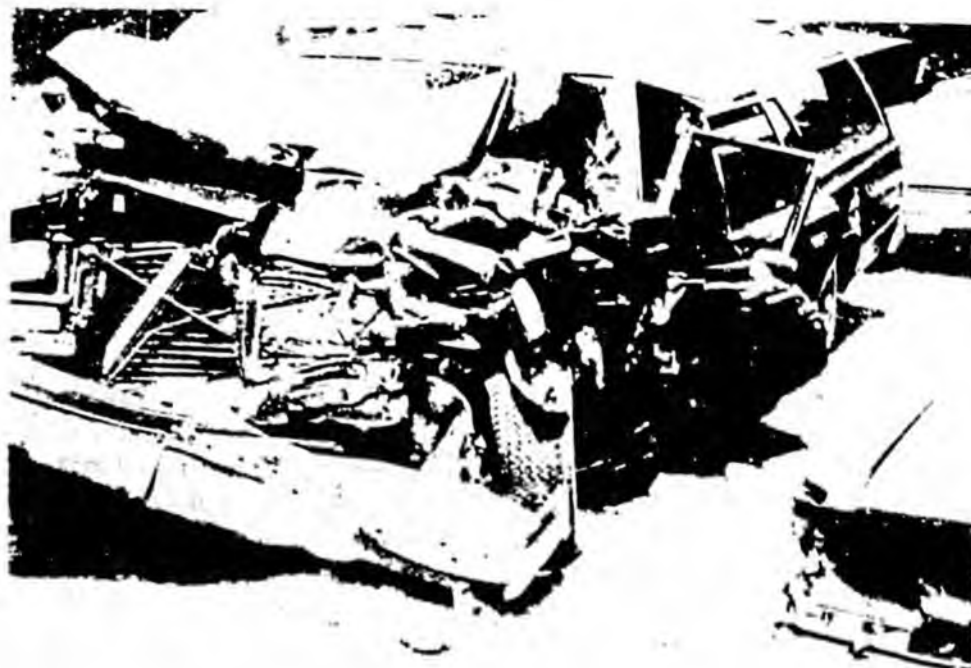
CASE 13 (SEA-85-H-OR20)

Case vehicle: 1978 Buick Estate station wagon
Case vehicle weight: 4,570 pounds
Case vehicle Delta V: 28.9 mph

A 1978 Buick Estate station wagon was struck in the front, slightly left of center, by the left front corner of a 1963 Chevrolet van. The Buick was occupied by a lap/shoulder belted 36-year-old female driver, a lap belted 5-year-old boy at center front, a 6-year-old boy wearing a lap/shoulder belt at right front, and two 4-year-old girls seated in the left and right rear seats, restrained by lap belts. The force of this head-on collision destroyed the front structures of both vehicles.

The Safety Board investigation did not note loading marks on the system webbing at this position. The A pillar, instrument panel, and steering assembly were displaced several inches rearward. The steering column was broken, and the hub and wheel were displaced several inches outboard. The A pillar, deformed rearward approximately 6 inches at its base, had hair embedded around a trim mounting screw located on its interior side. The driver's portion of the split bench seat was found at its extreme forward adjustment on a 7-inch track.

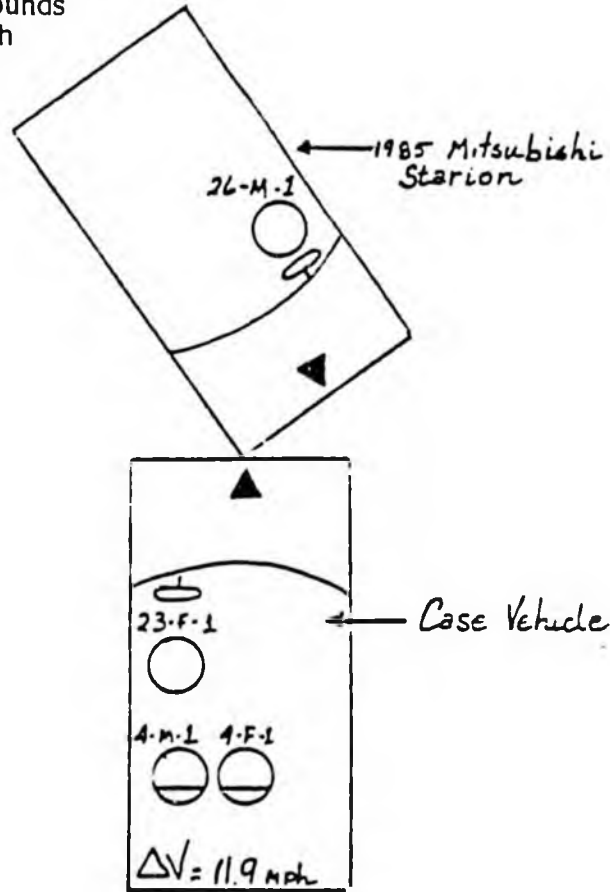
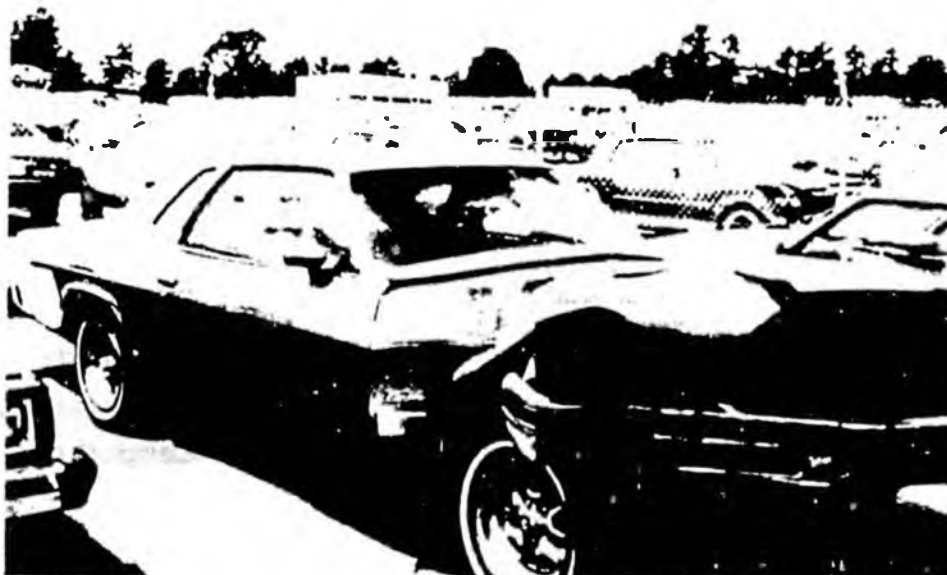
CASE 14 (ATL-85-H-OR19)

Case vehicle: 1975 Oldsmobile Cutlass
Case vehicle weight: 3,964 pounds
Case vehicle Delta V: 11.9 mph

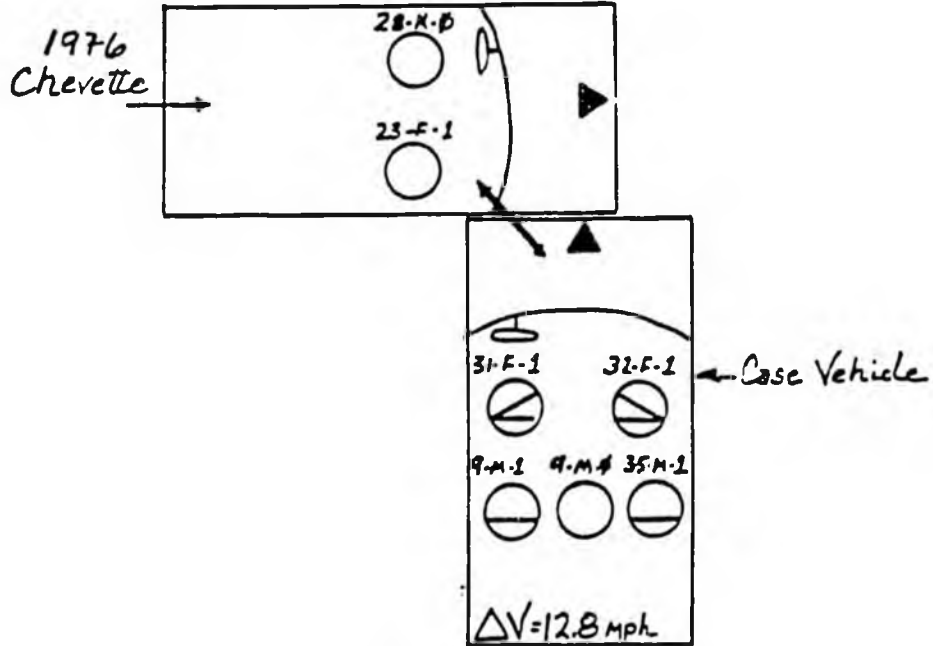
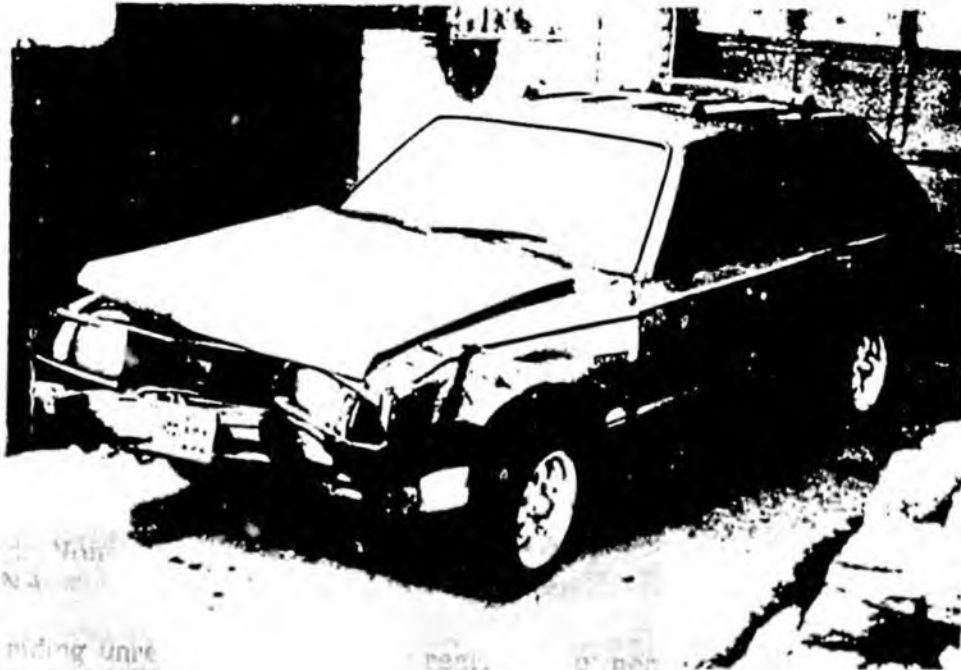
CASE 16 (MKC-85-H-OR26)

Case vehicle: 1980 Ford Subaru GL station wagon
Case vehicle weight: 3,111 pounds
Case vehicle Delta V: 12.8 mph

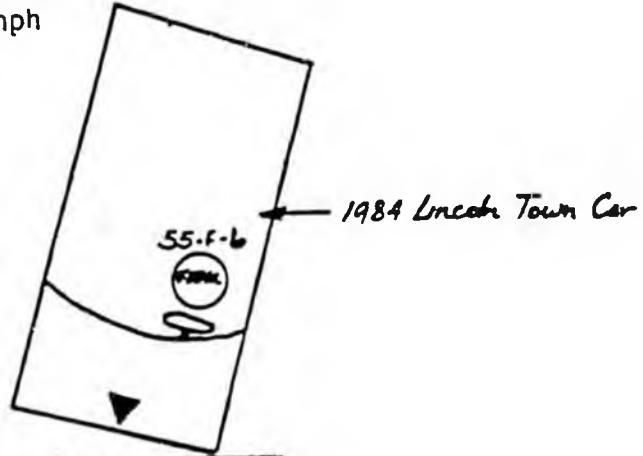
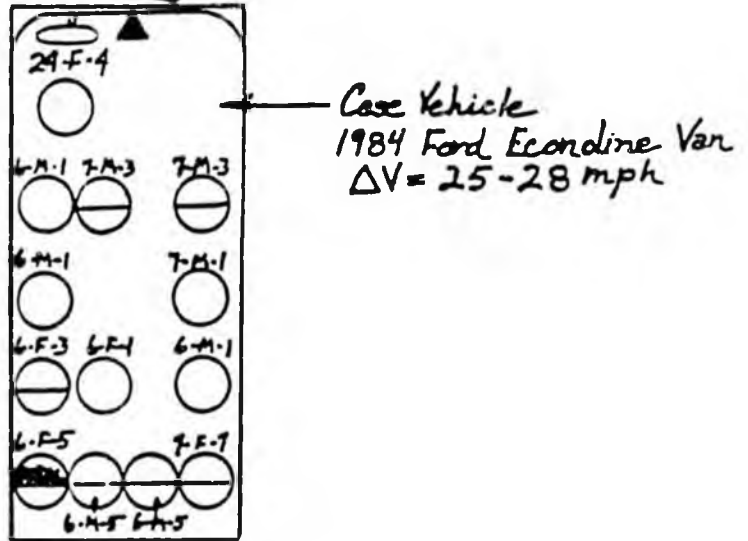
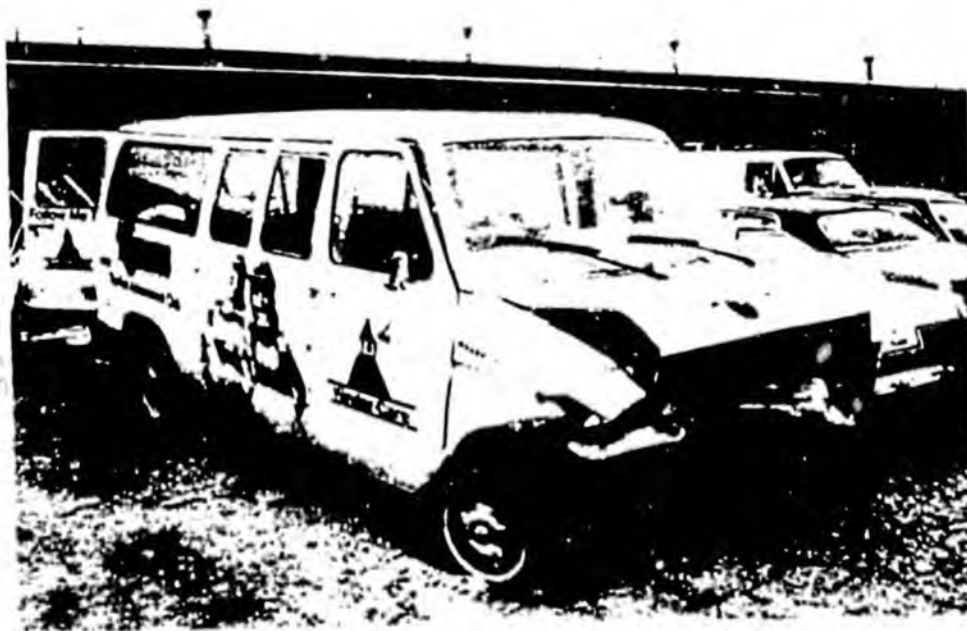
CASE 23 (CHI-85-H-OR18)

Case vehicle: 1984 Ford Econoline Van
Case vehicle weight: 4,935 pounds
Case vehicle Delta V: 25-28 mph
