ALASKA LEGISLATURE COMMITTEES, 2003-2007

11957 SENATE RESOURCES

## Corrosion - 2002 Meet and Confer IV

**BP and State of Alaska Charter Agreement**  
**Corrosion Monitoring Review 2002**  
**Meet and Confer V**

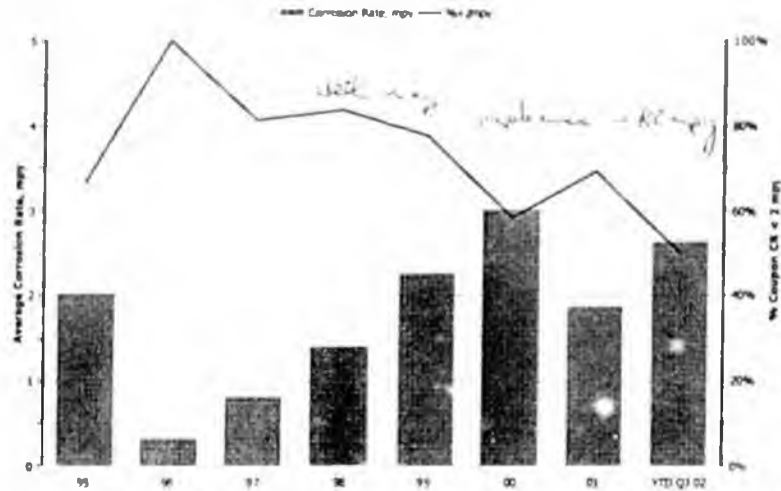
SW System WLC Corrosion Rates

*with a log*  
*impurities - 80 mpy*

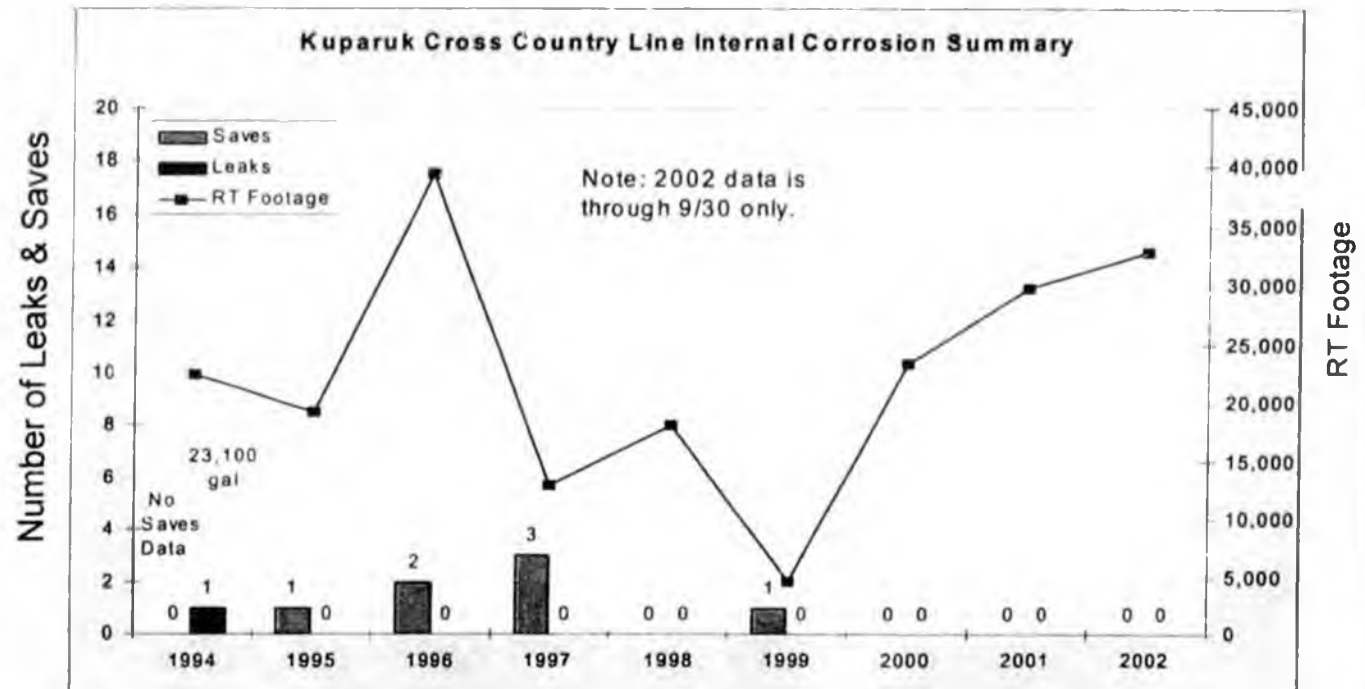
### Internal Corrosion Spills - Cross Country Lines

1994 Spill 24" 1Y/R Crude CC Line

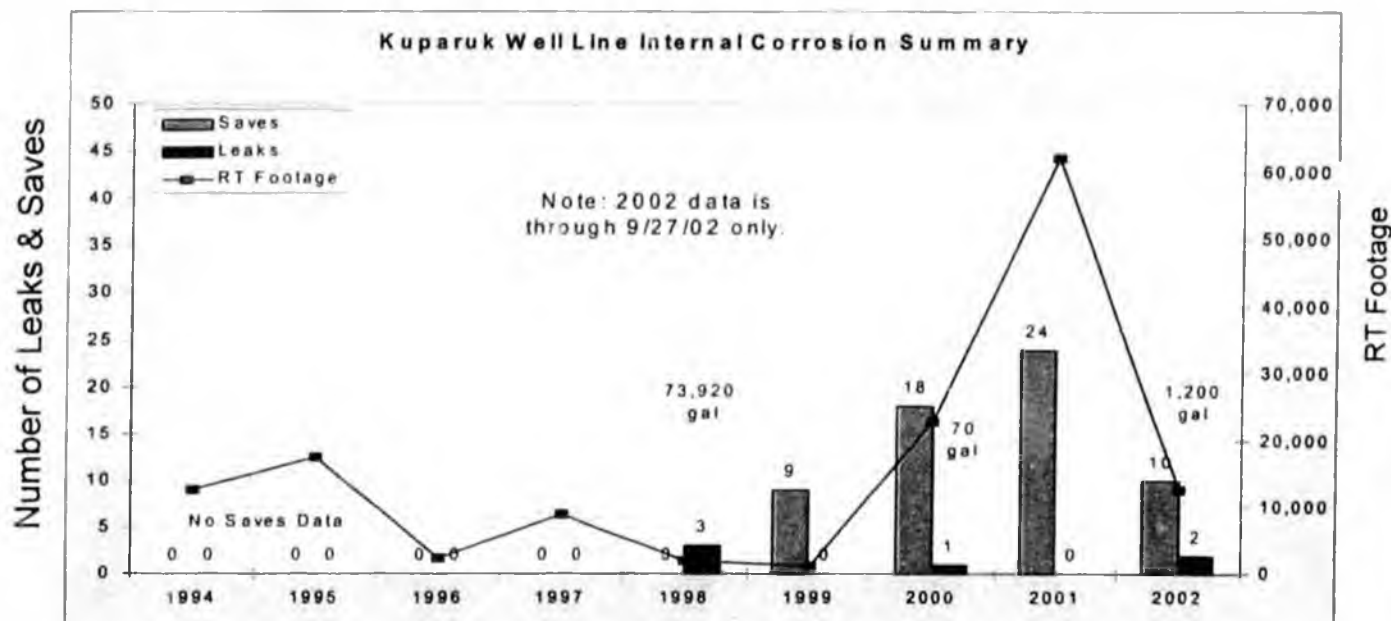
#### Internal Corrosion Spills – Well Lines

38 Spills	1L-1 6" WI
	1L-3 6" WI
	1A-9 6" WI
2000 Spill	1G-8 6" PC
2002 Spills	2A-18 6" PC
	2T-13 6" PC

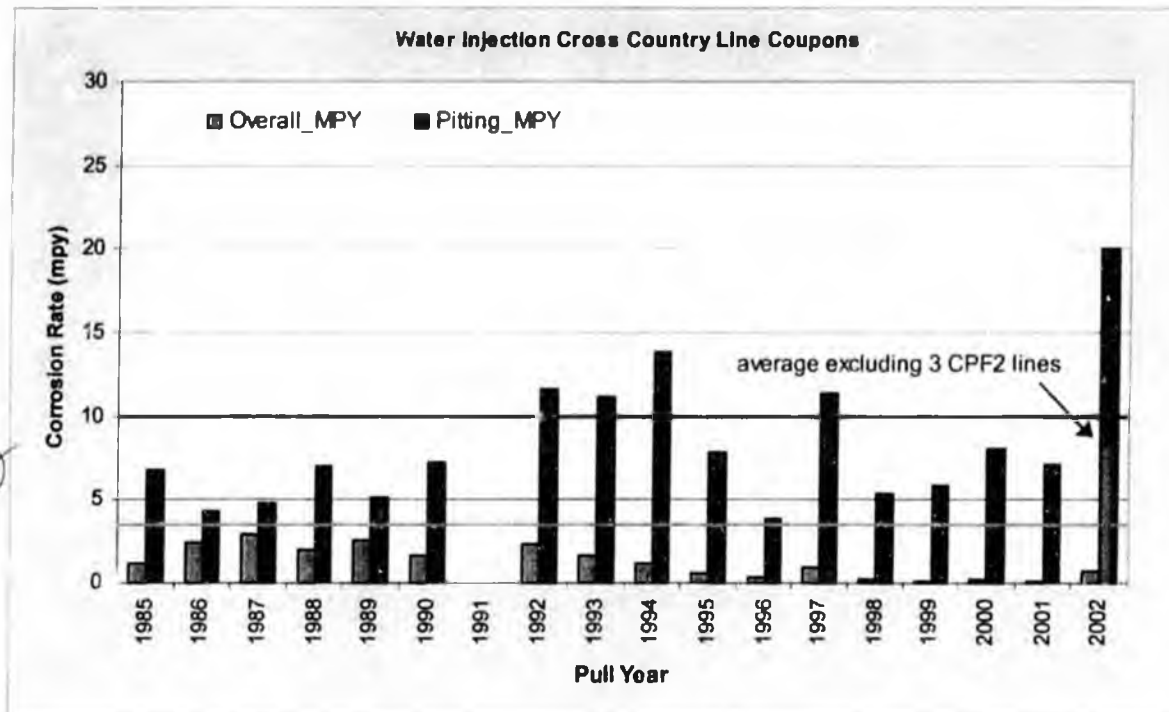
*CPF2 lines  
all @  
facility  
unpassable  
6-10-02  
100-100  
-103*

### Area of Concern

- ✓ Coupon average corrosion rates in the water injection cc lines have increased
- ✓ Average affected mainly by a 3 lines at CPF2. Field average pitting rate excluding "bad actors" falls below threshold.
- ✓ Recent inspection data from the 3 CPF2 lines shows only minor damage (worst case B grade)
- ✓ Nevertheless, work is underway to find the cause

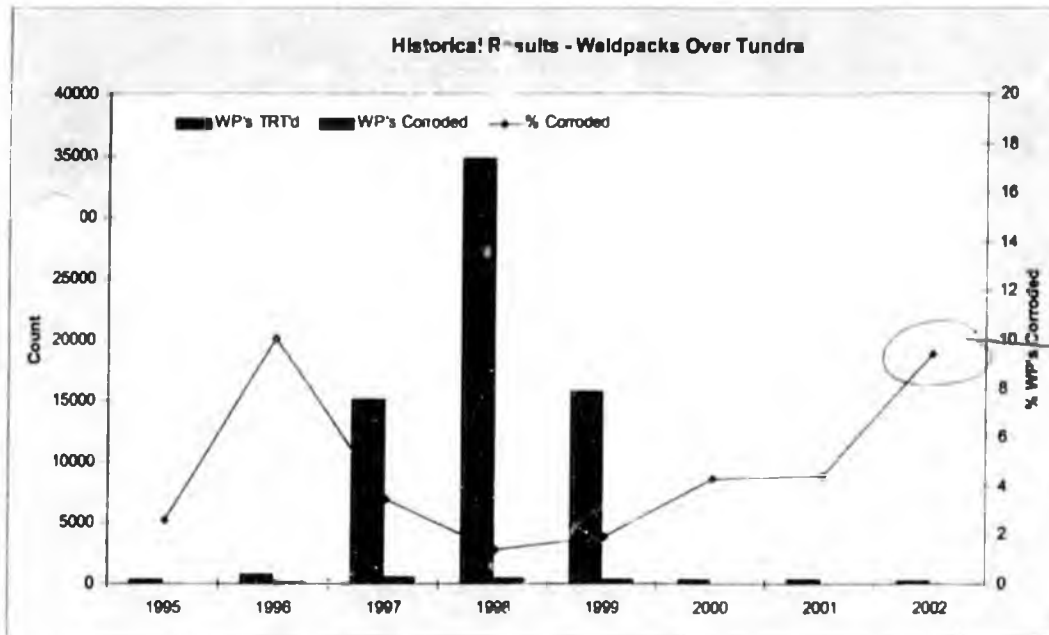
- ✓ Initial TRT inspection of over-tundra CC weld packs and refurbishment of heavy wet and corroded weld packs was completed by YE 2001. Final walk down verifications are underway.

Began initial recur effort in 2002, targeted medium-wet weld packs in saddles from initial survey

- ✓ Increase in %-Corroded was expected due to target population

*near cycle 2003 - should move to a more even cycle ~ 5000/yr*

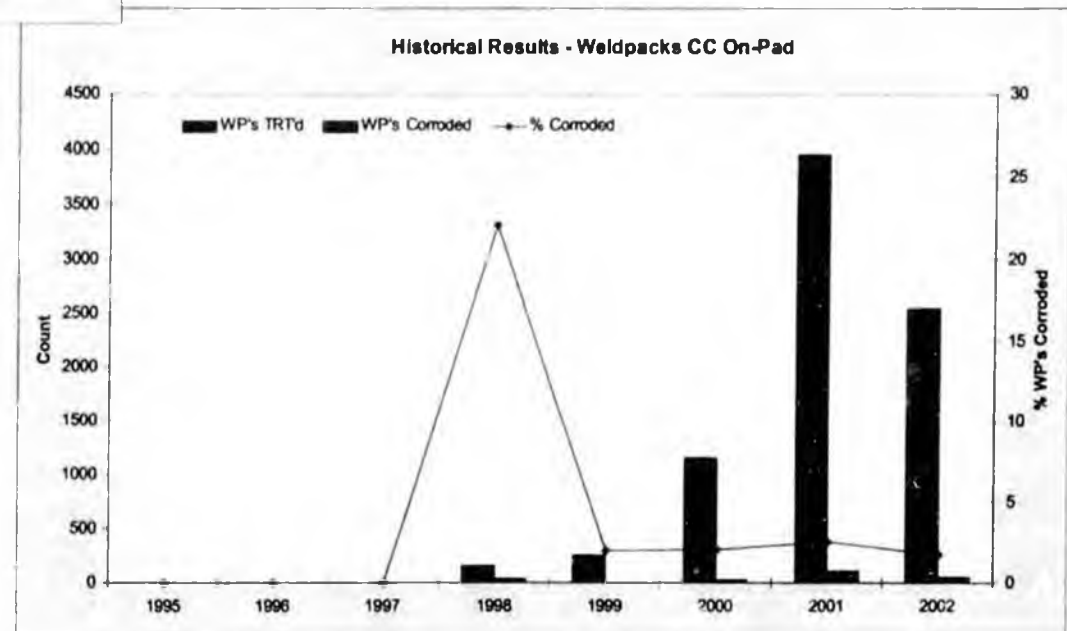
## CC Lines On Pad: ⇒⇒

- ✓ TRT'd 2542 on-pad cross country weld packs YTD, exceeding 2002 FY goal of 1780
- ✓ 91% of on pad cross-country line weld packs have been TRT'd to-date
- ✓ The % corroded weld packs found has dropped slightly, ~ 1.8%

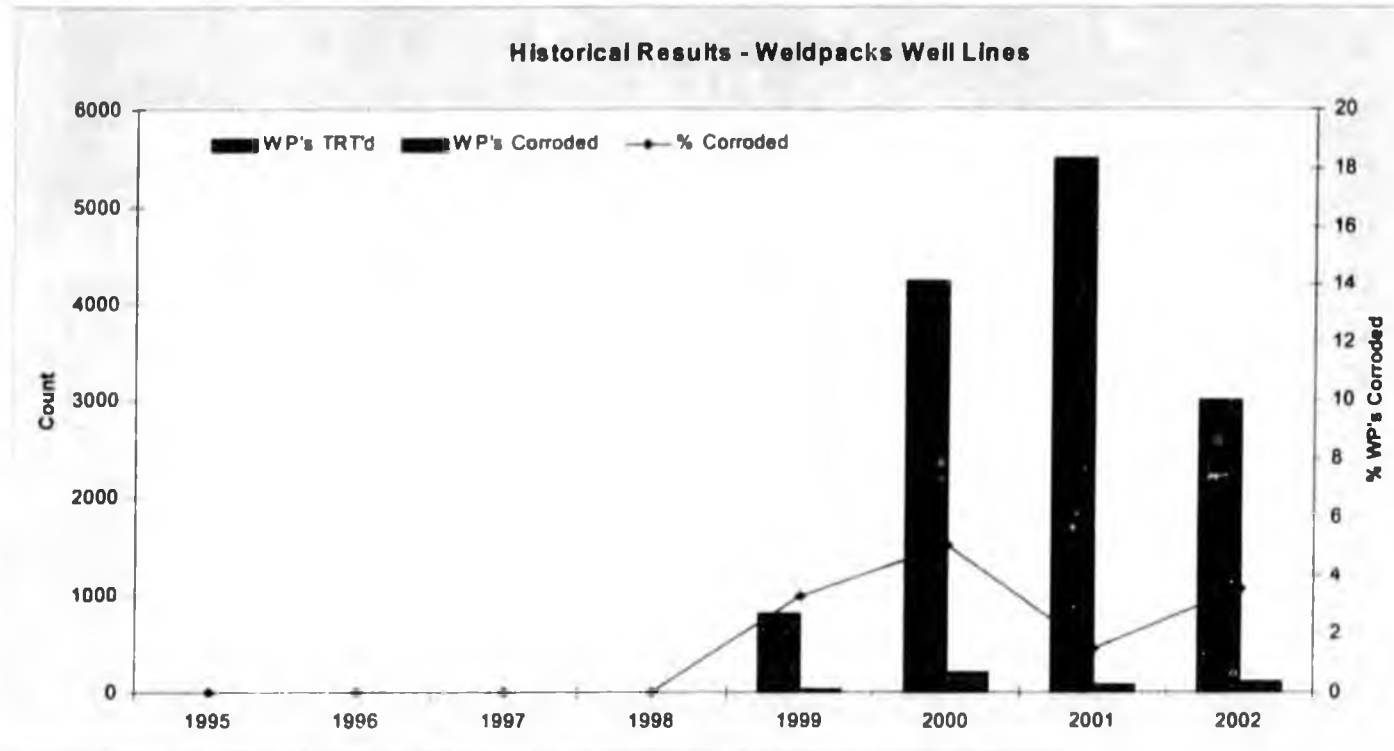
## Well Lines External Corrosion

- ✓ TRT'd 3007 well line weld packs YTD
- ✓ On-track to reach 2002 goal of 4000 weld packs TRT'd *now met*
- ✓ 55% of the well line weld packs have been TRT'd YTD
- ✓ Goal is to complete well line weld pack TRT baseline inspections by YE 2005
- ✓ Continue to monitor %-corroded and respond to trends
