**Greater Kuparuk Area (GKA)  
Western North Slope (WNS)  
Corrosion Programs Overview**

*Commitment to Corrosion Monitoring  
6<sup>th</sup> Annual Report to the Alaska Department of Environmental Conservation*

Prepared by  
**ConocoPhillips Corrosion Team**

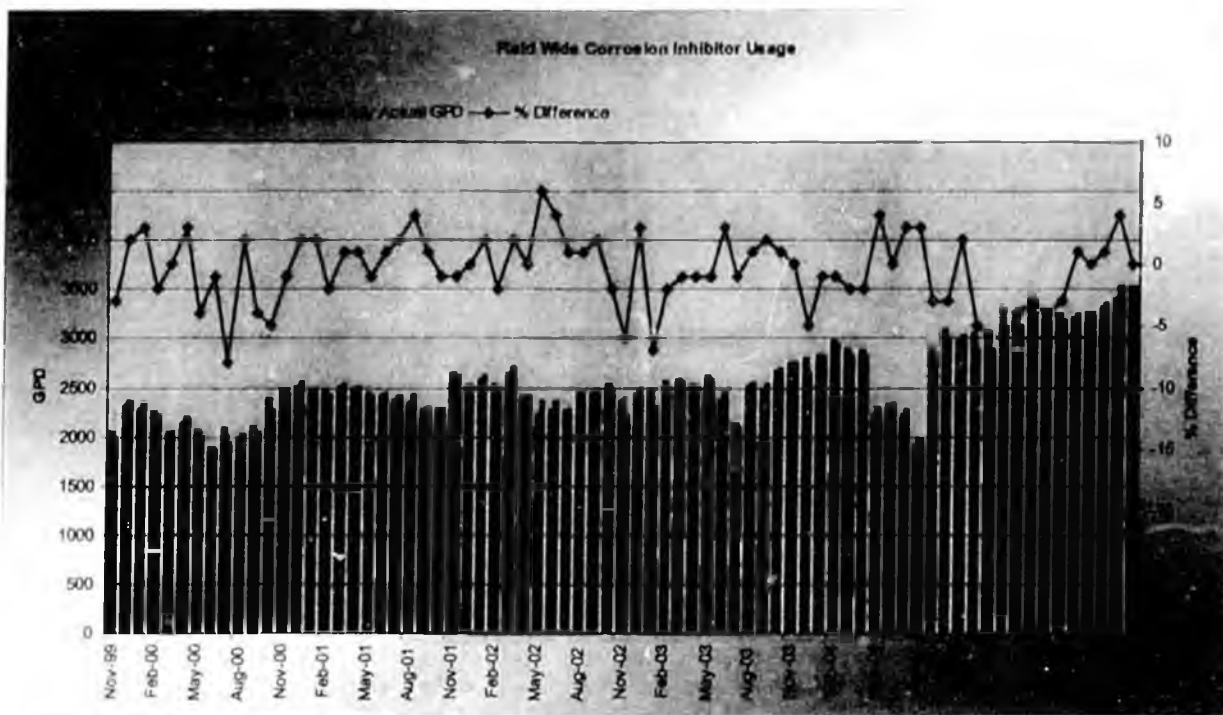
Figure 6. Field-wide Corrosion Inhibitor Use.

For the Kuparuk field, Figure 6 shows the actual number of gallons of corrosion inhibitor pumped per day, the recommended (target) number of gallons of corrosion inhibitor per day, and the percent difference between the two. The average deviation for the year was -1.85%. The large variation seen in the early parts of the year are usually caused by the extreme weather. Several pump upgrades were accomplished in 2005 to accommodate increased volumes.

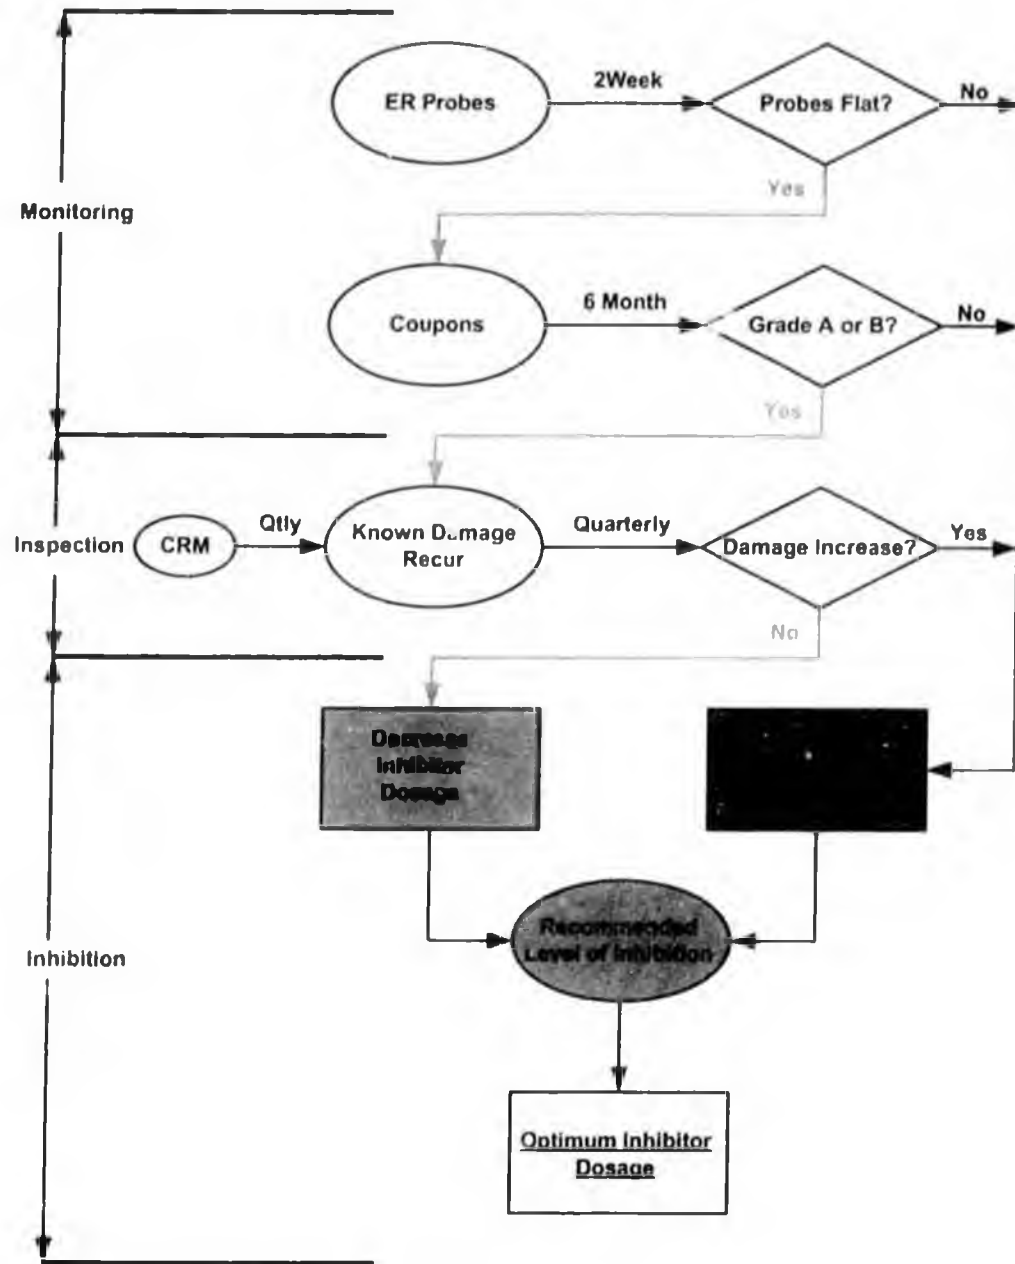
Figure 7. Corrosion Inhibitor Feedback System.

The mitigation program is described in the inhibitor feedback flow chart, Figure 7 below. Reasons for changes to target inhibitor concentrations are given in Table 3 below.
