## Department of Transportation and Public Facilities

February 28, 2017

Thank you for the opportunity to present information relative to Senate Bill 50 during the February 23, 2017, meeting of the Senate Transportation Committee. In response to questions posed by committee members, the following information is provided:

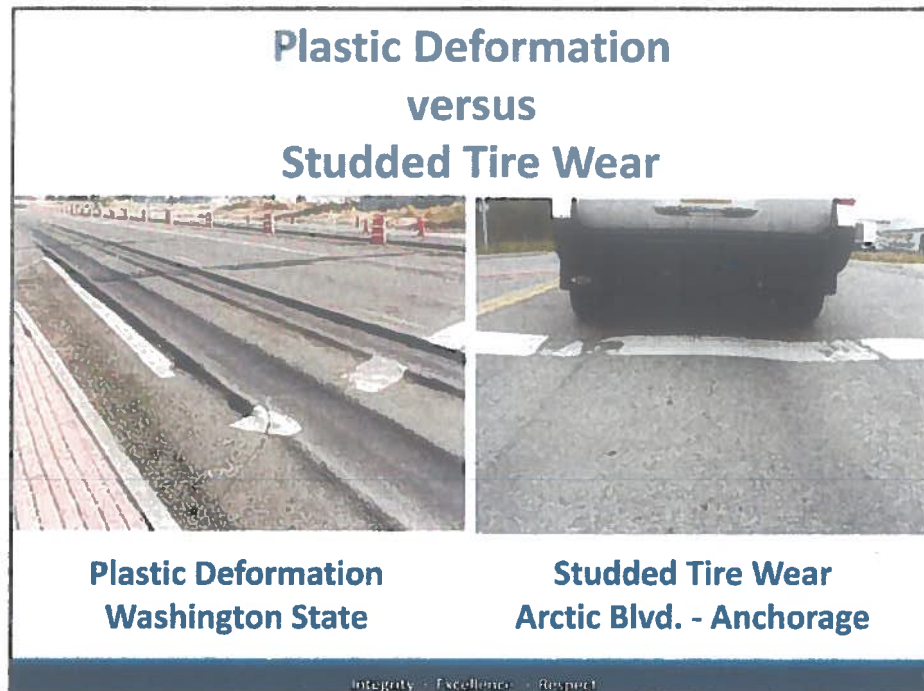
In the WA rutting photo, notice the ridges or bulges at the edges of the wheel paths. The asphalt mix is being consolidated and displaced laterally. This type of rutting is called plastic flow or deformation, due to heavy trucks (notice the dual-tire imprint in each wheel path), typically occurring during hot summer months when the mix is soft.

The Anchorage photo shows rutting as depression in the wheel path without any ridges or bulges at the edges of wheel path ruts. That is indicative of abrasive rutting, i.e. removal/dislodging of material from the wheel path.

The majority of the rutting seen on southcentral and southeastern Alaska highways is due to studded tire abrasive wear. Some plastic deformation is seen at intersections where trucks stop and/or turn (e.g. Old Seward and O'Malley intersection, where trucks from the adjacent industrial areas take the intersection to reach the Seward Hwy).

- During hot summer months, traffic loading may cause wheel path depression in the form of plastic deformation in the asphalt surface layer, causing consolidation and lateral movement of the asphalt material, in addition to uplifting (shearing) along the sides of the rut. The main feature of this type of rutting is the continuous longitudinal bulge or ridge that forms at the edges of the rut.
- Material removal from the pavement surface through studded tires' abrasive wear is seen as depression or indentation in the wheel path, accompanied by discoloration of the wheel path relative to its surrounding pavement (due to aggregate abrasion and polishing), and the absence of a bulge or ridge at the edges of the rut. (The enclosed slide is a comparison between the two types of surface rutting; refer to the notes under the slide).
