POSITION PAPER

TITLE: Handicapped Access on Ferries

An elevator type and its installation site are to be determined for the LeCONTE. The elevator is to provide access for handicapped passengers between the main and passenger decks. It is generally accepted that there is no optimum site for the elevator and this installation will disrupt the vessel's current arrangement and/or loading/unloading operations. The goal then is to identify the viable options with their associated disruptions, and select a site, after formulating a plan to adapt operations to the re-configured vessel. This report section discusses the two general types of elevators, open and enclosed hoistway elevators; discusses elevator machinery; and ranks four sites for the recommended closed hoistway type elevator. The four sites are then further developed into conceptual plans, specifications, and cost estimates, and a recommendation is presented. Appendix A contains Alaska Marine Highway System's (AMHS) preliminary engineering work on open hoistway type installation sites and equipment, with a short commentary.

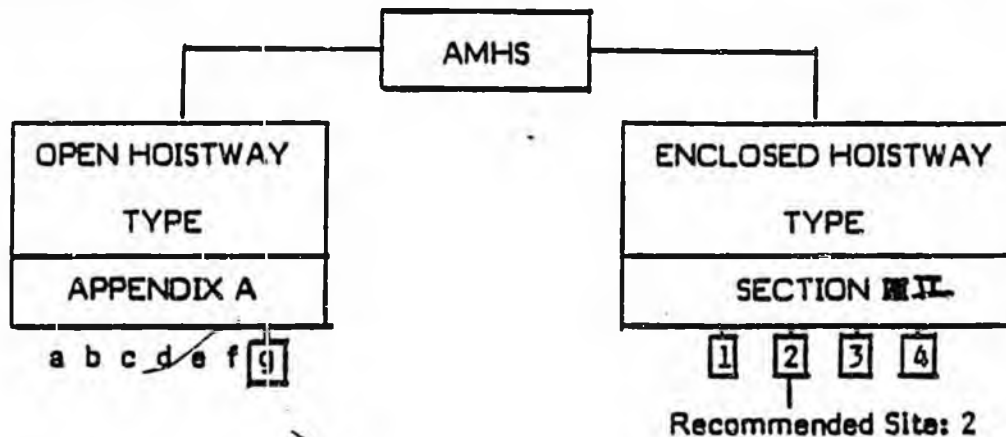
AMHS should make two decisions at this time. First the type of elevator is to be chosen: open or enclosed hoistway. Secondly the site is to be selected. The sites are dependent on the elevator type. Certain sites are appropriate to one type and not necessary applicable to the other, hence the type needs to be selected first. This decision process is illustrated below:

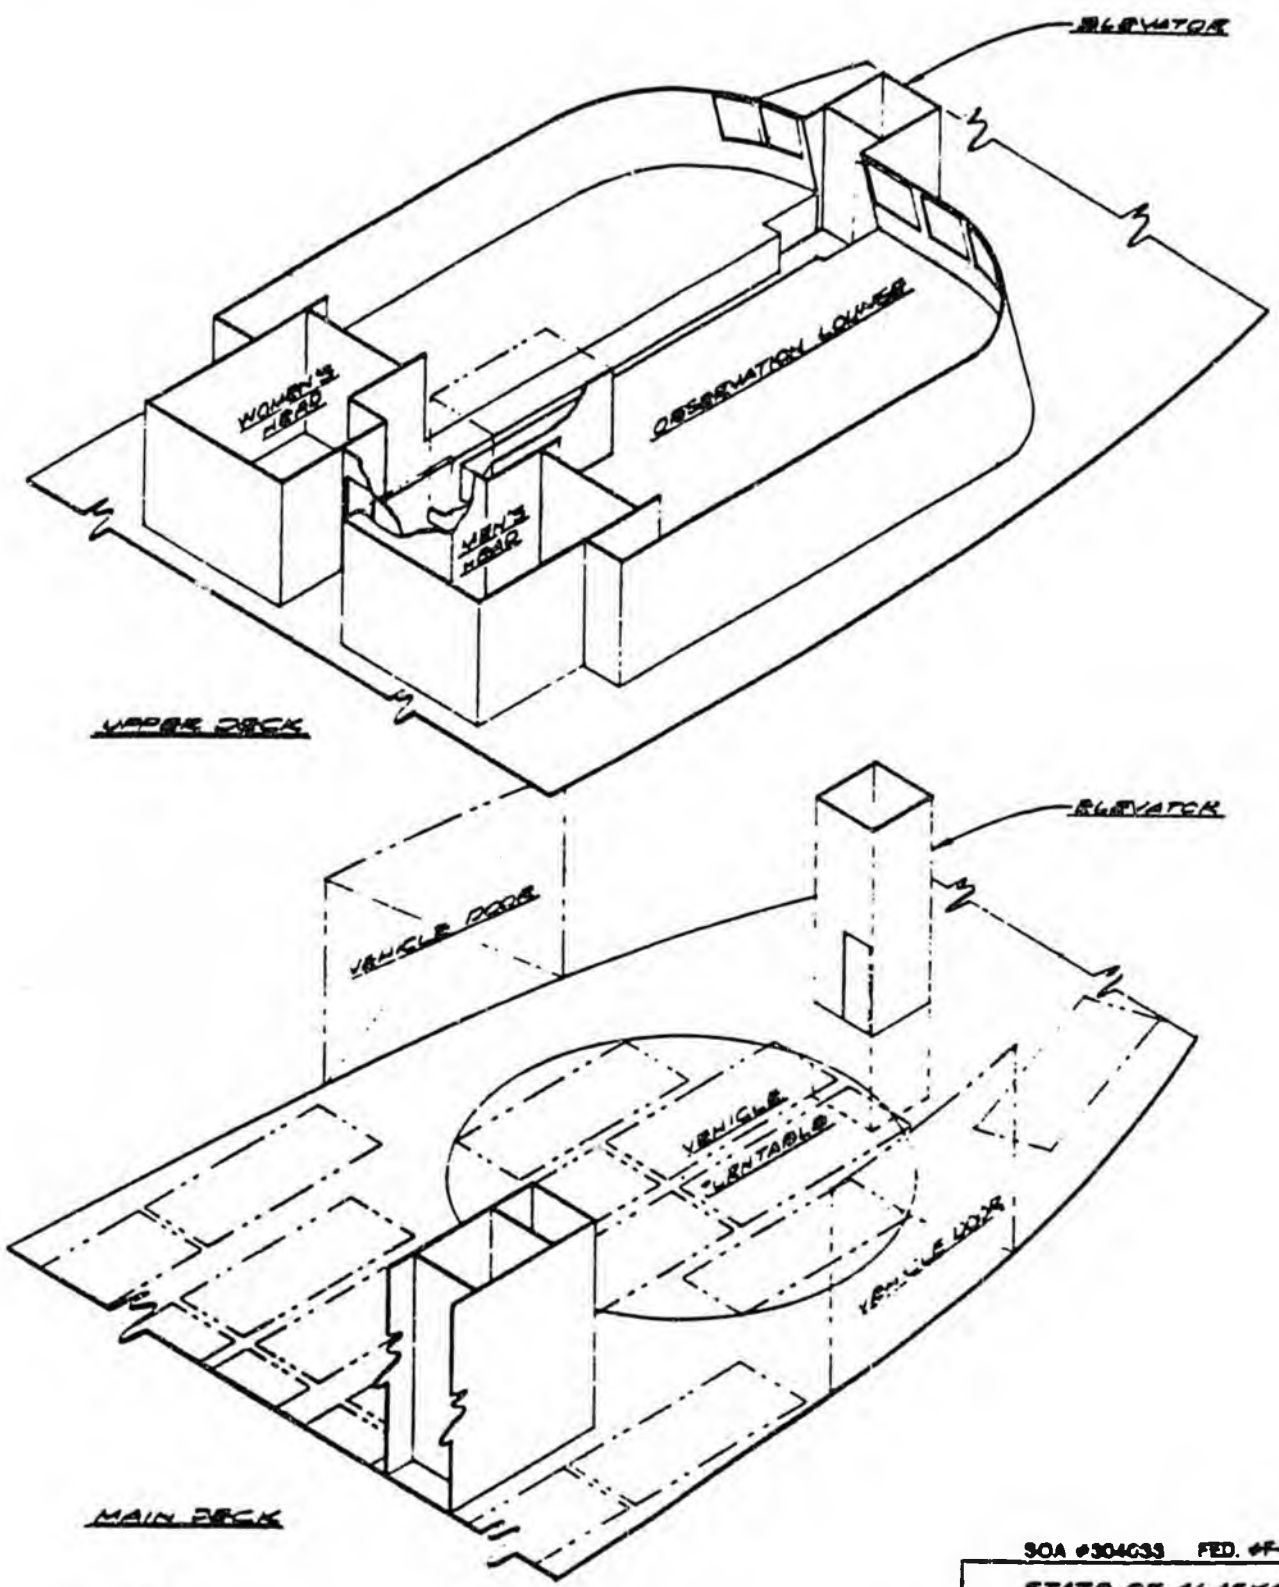
SITE #1

ITEM	SYSTEM	DESCRIPTION	QUANTITY	UNIT WEIGHT	UNIT LABOR	UNIT MAT'L.	TOTAL WEIGHT	TOTAL LABOR	TOTAL MATERIAL	REMARKS
		ELEVATOR INSTALLATION								
		OPTION 3								
		REMOVE INTERFERENCES	104 HR		\$ 35/HR			\$ 3640	\$ 200	
		EXCESS UPPER DECK FOR WALKWAY	518 HR		\$ 35/HR			18130	5500	
		FABRICATE & INSTALL ELEVATOR TRUNK	850 HR		\$ 35/HR			29750	6000	
		INSTALL ELEVATOR HOOR-UP & TEST	720 HR		\$ 35/HR			25200	1000	
		FABRICATE & INSTALL FAIRING-UPPER DEK	120 HR		\$ 35/HR			4200	800	
		PREPARE & PAINT SURFACES	112 HR		\$ 35/HR			3920	2000	
		REINSTALL INTERFERENCES	76 HR		\$ 35/HR			2660	-	
		SUB-TOTALS	2500 HR					\$ 87500	\$ 15500	
		ELEVATOR & ACCESSORIES							90000	
		10% CONTINGENCY						8750	10550	
		TOTAL						96250	116050	= \$ 212,300

4. Elevator Site 1: Forward End of Observation Lounge

- o Main deck structure will need modification as important longitudinal beams will be interrupted.

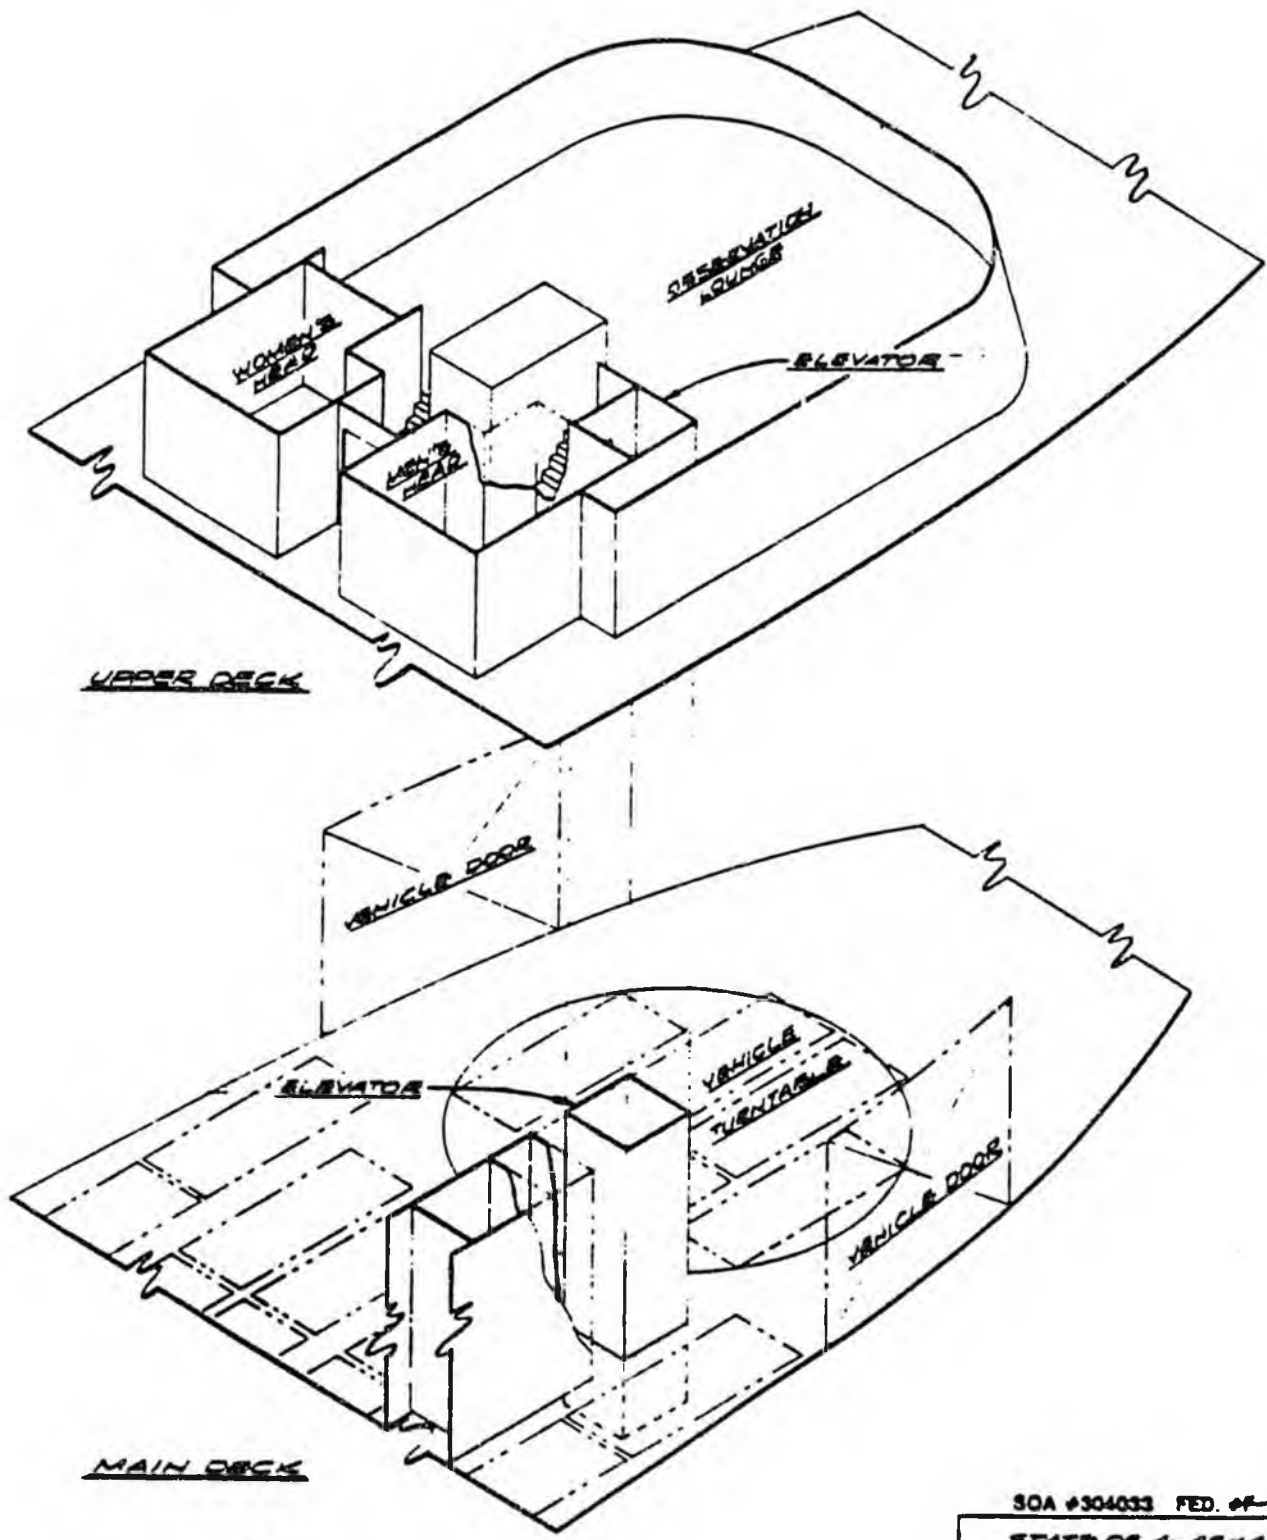
SITE #2

ITEM	SYSTEM	DESCRIPTION	QUANTITY	UNIT WEIGHT	UNIT LABOR	UNIT NAT'L.	TOTAL WEIGHT	TOTAL LABOR	TOTAL MATERIAL	REMARKS
		ELEVATOR INSTALLATION								
		OPTION 2								
		REMOVE INTERFERENCES	96 HR		\$ 35/HR			\$ 3360		
		LOWER UPPER DECK TO FOYER LEVEL	154 HR		\$ 35/HR			\$ 5390	\$ 800	
		FABRICATE & INSTALL ELEVATOR TRUNK	770 HR		\$ 35/HR			\$ 26950	\$ 5400	
		INSTALL ELEVATOR, HOOK UP & TEST	720 HR		\$ 35/HR			\$ 25200	\$ 1000	
		PREPARE & PAINT SURFACES	64 HR		\$ 35/HR			\$ 2240	\$ 1000	
		REINSTALL INTERFERENCES	32 HR		\$ 35/HR			\$ 1120	\$ 200	
		SUB-TOTALS	1836 HR					\$ 64260	\$ 8400	
		ELEVATOR & ACCESSORIES							\$ 90,000	
		10% CONTINGENCY						\$ 6426	\$ 9840	
		TOTAL						\$ 70,686	\$ 108,240	= \$ 178,926

AMHS personnel agreed and accepted the Glostén Associates recommended "enclosed hoistway" concept and elevator installation site #2 (approximate frames 33 to 36, starboard side forward of the machinery casing) as the optimum design.

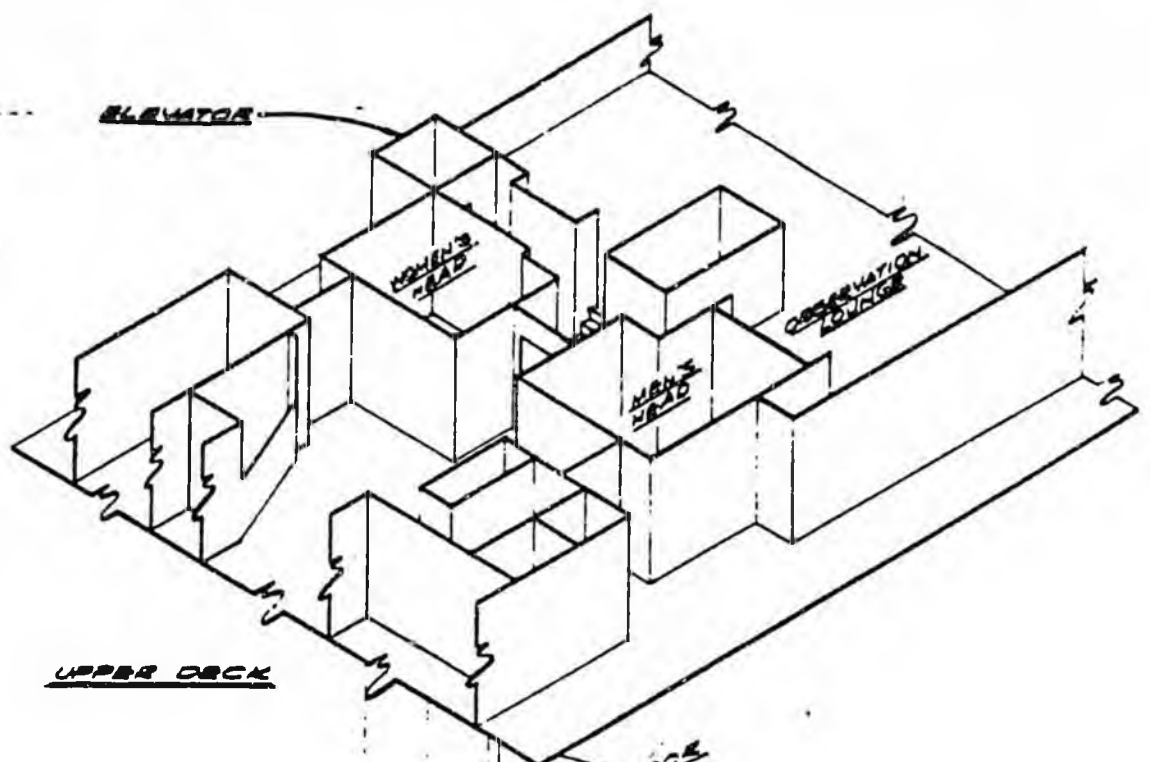
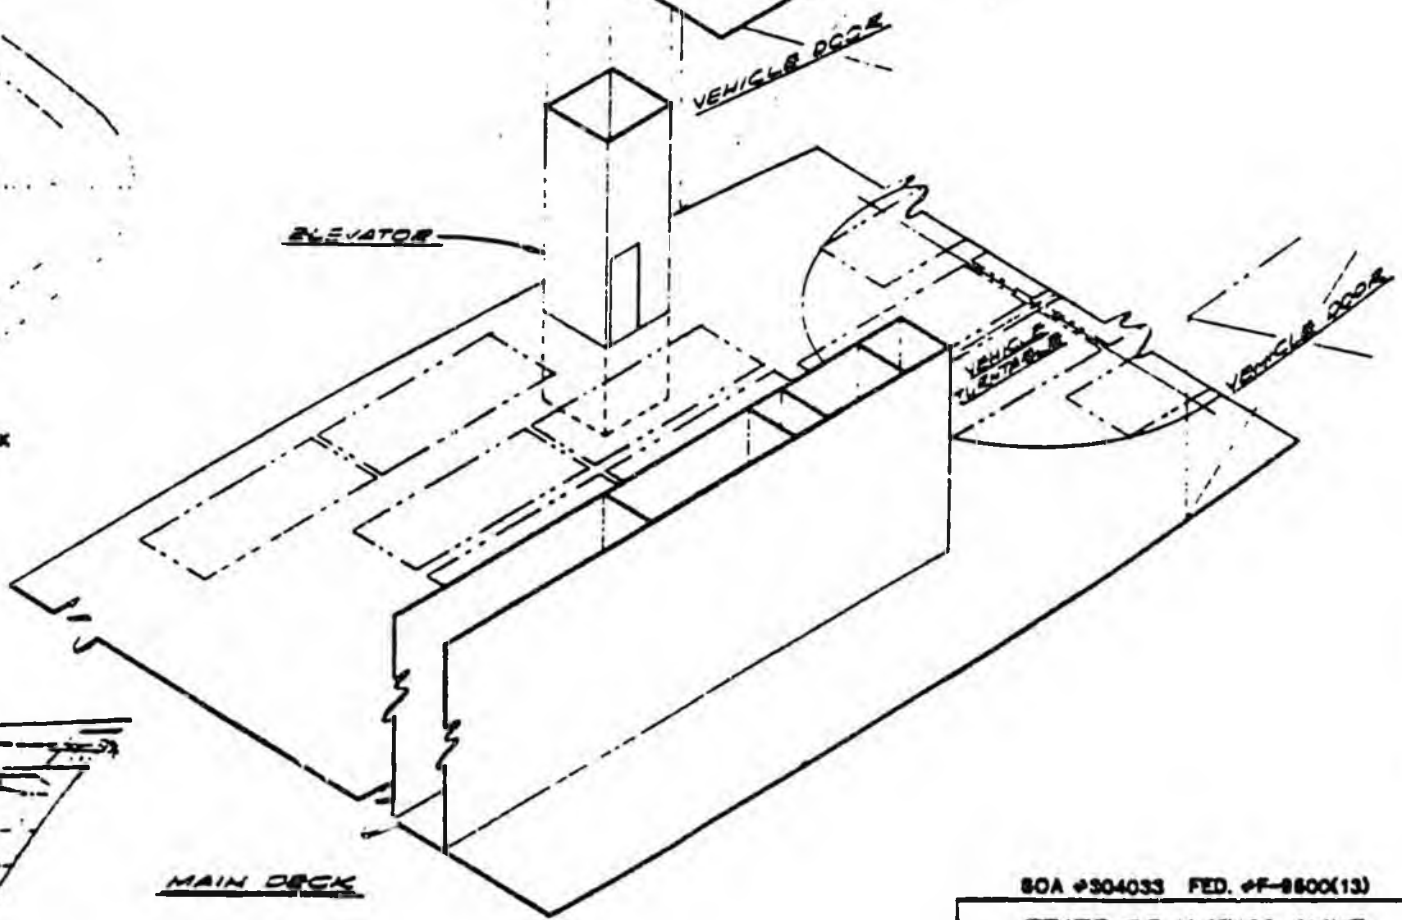
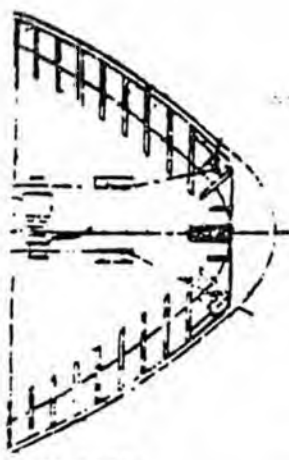
SITE #3

ITEM	SYSTEM	DESCRIPTION	QUANTITY	UNIT WEIGHT	UNIT LABOR	UNIT MAT'L.	TOTAL WEIGHT	TOTAL LABOR	TOTAL MATERIAL	REMARKS
		ELEVATOR INSTALLATION								
		OPTION 3								
		REMOVE INTERFERENCES	48 HR		\$ 35/HR			\$ 1680		
		RELOCATE FIRST AID ROOM	302 HR					10590	\$ 2000	
		FABRICATE & INSTALL ELEVATOR TRUNK	510 HR					20350	5700	
		INSTALL ELEVATOR, WOOK UP & TEST	720 HR					25200	1000	
		PREPARE & PAINT	17 HR					2240	1000	
		MODIFY ELEVATOR ENTRANCE - UPPER DEK	90 HR					3150	500	
		REINSTALL INTERFERENCES	16 HR					560		
		SUB-TOTALS	2050					71,750	10,500	
		ELEVATOR & ACCESSORIES							90,000	
		10% CONTINGENCY						7175	10,000	
		TOTAL						78,925	110,500	= \$ 189,425

UPPER DECK

MAIN DECK

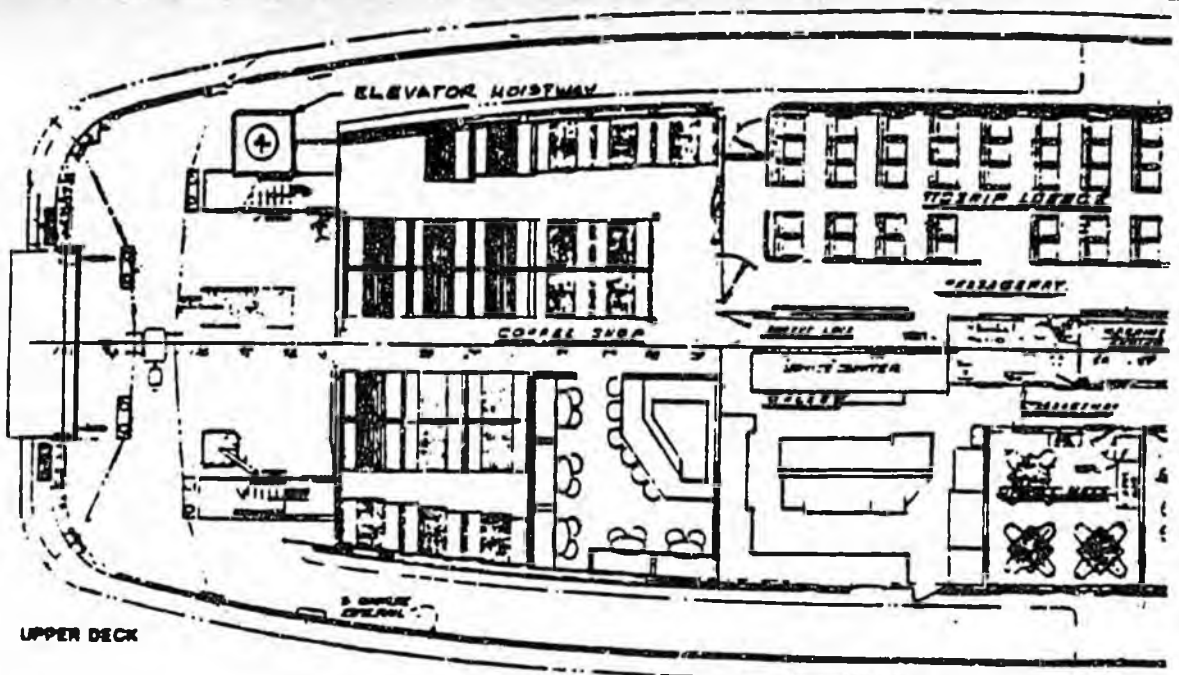
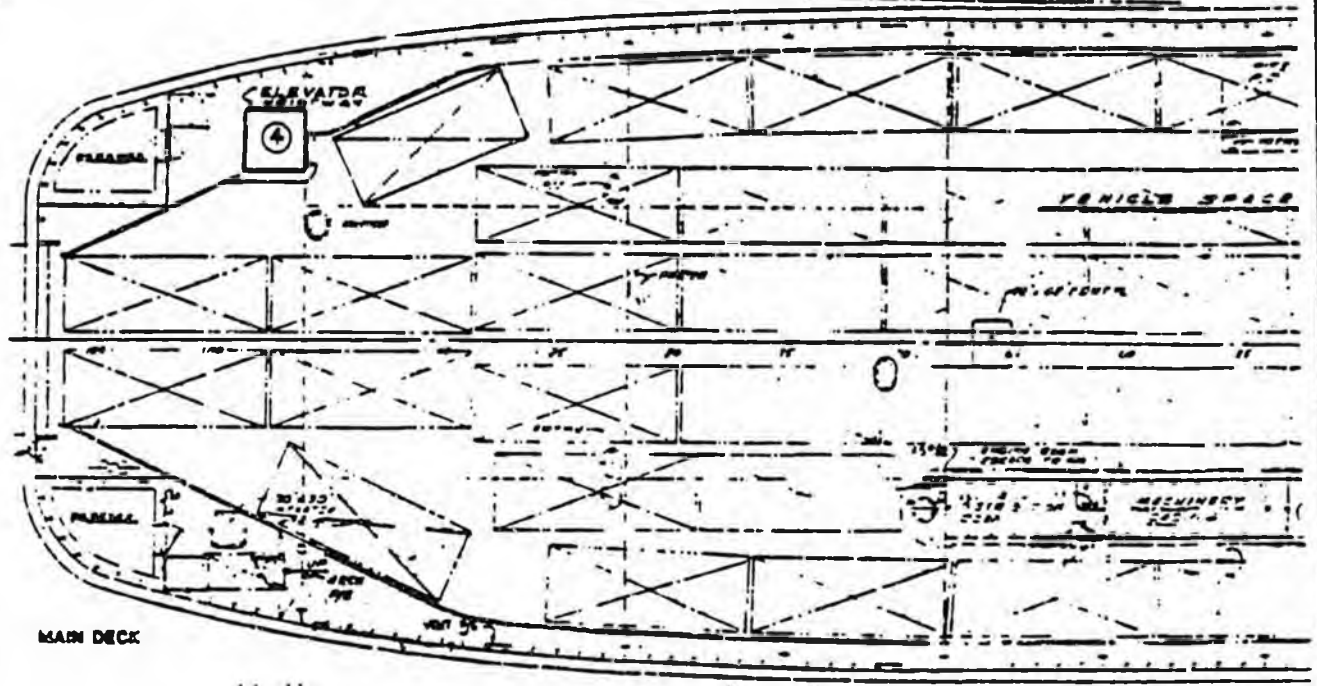
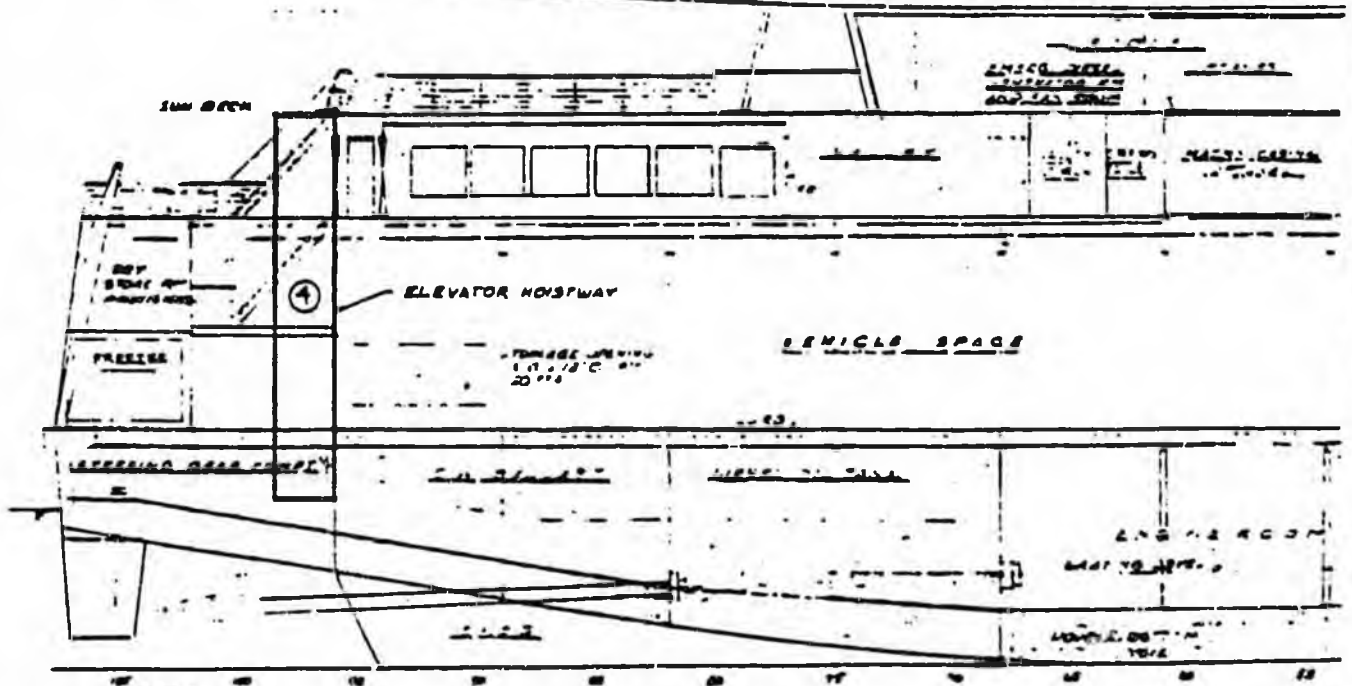
ITEM	SYSTEM	DESCRIPTION	QUANTITY	UNIT WEIGHT	UNIT LABOR	UNIT MAT'L.	TOTAL WEIGHT	TOTAL LABOR	TOTAL MATERIAL	REMARKS
		ELEVATOR INSTALLATION								
		OPTION #4								
		REMOVE INTERFERENCES	106 HR		\$35/HR			3710		
		REDO BAR/CREEPER SHOP ASBGT	652 HR					22810	5100	
		FADEKATE & INSTALL ELEVATOR TRUNK	850 HR					29750	5400	
		INSTALL ELEVATOR, HOOK UP & TEST	792 HR					27710	1100	
		PREPARE & PAINT	64 HR					2240	1000	
		REINSTALL INTERFERENCES	16 HR					560		
		END-TOTALS	2480					86800	12600	
		ELEVATOR & ACCESSORIES							90000	
		10% CONTINGENCY						8680	10260	
		TOTAL						95480	112860	= 208,340

UPPER DECK

MAIN DECK

INBOARD PROFILE

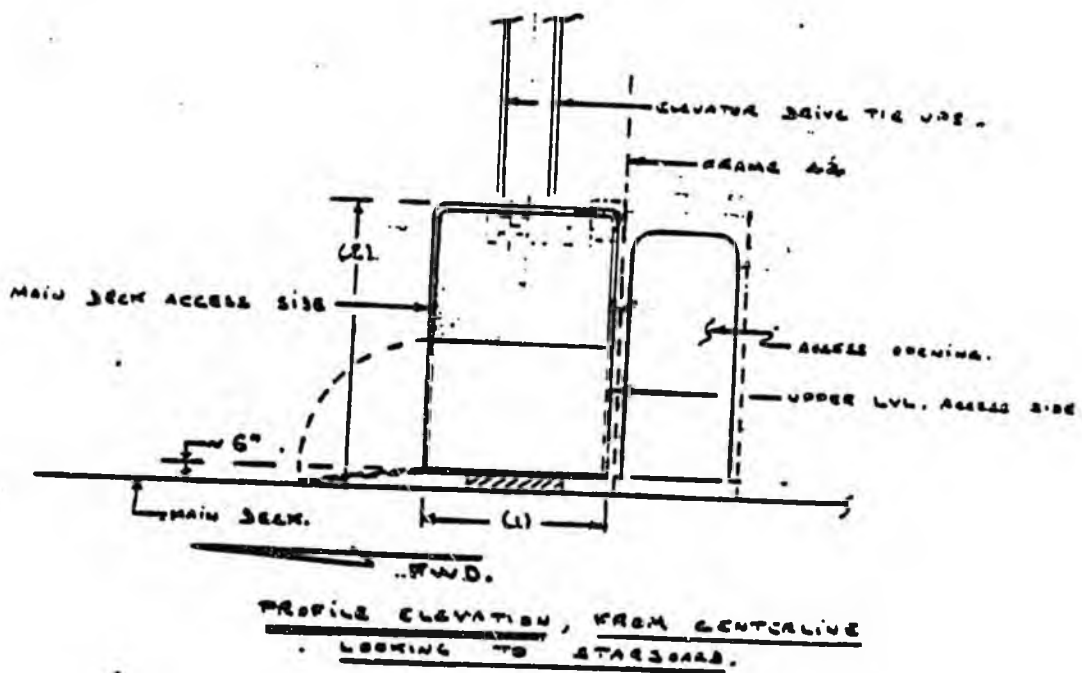
ENCLOSURE 1
 TO GLOSTON
 LETTER TO MSC,
 15 NOV 86

LA CENTE / AURORA - PROPOSED ELEVATOR,
MAIN DECK LVL. ILLUSTRATIONS.

- (1). APPROXIMATELY 5'-4" MAX. OUTSIDE DIM.
- (2). APPROXIMATELY 7'-8" MAX. AVAILABLE TO CLEAR OVERHEAD BEAMS IN THE UPPER POSITION.

1. LECONTE Proposed Elevator, Main Deck Illustrations, 1 sheet.
2. LECONTE Proposed Elevator, Elevation and Upper Deck Plan View, 1 sheet.
3. LECONTE Elevation, 1 sheet.
4. LECONTE Main Deck Arrangement, 1 sheet.
5. LECONTE Gallery Deck Arrangement, 1 sheet.
6. LECONTE Upper Deck Arrangement, 1 sheet.

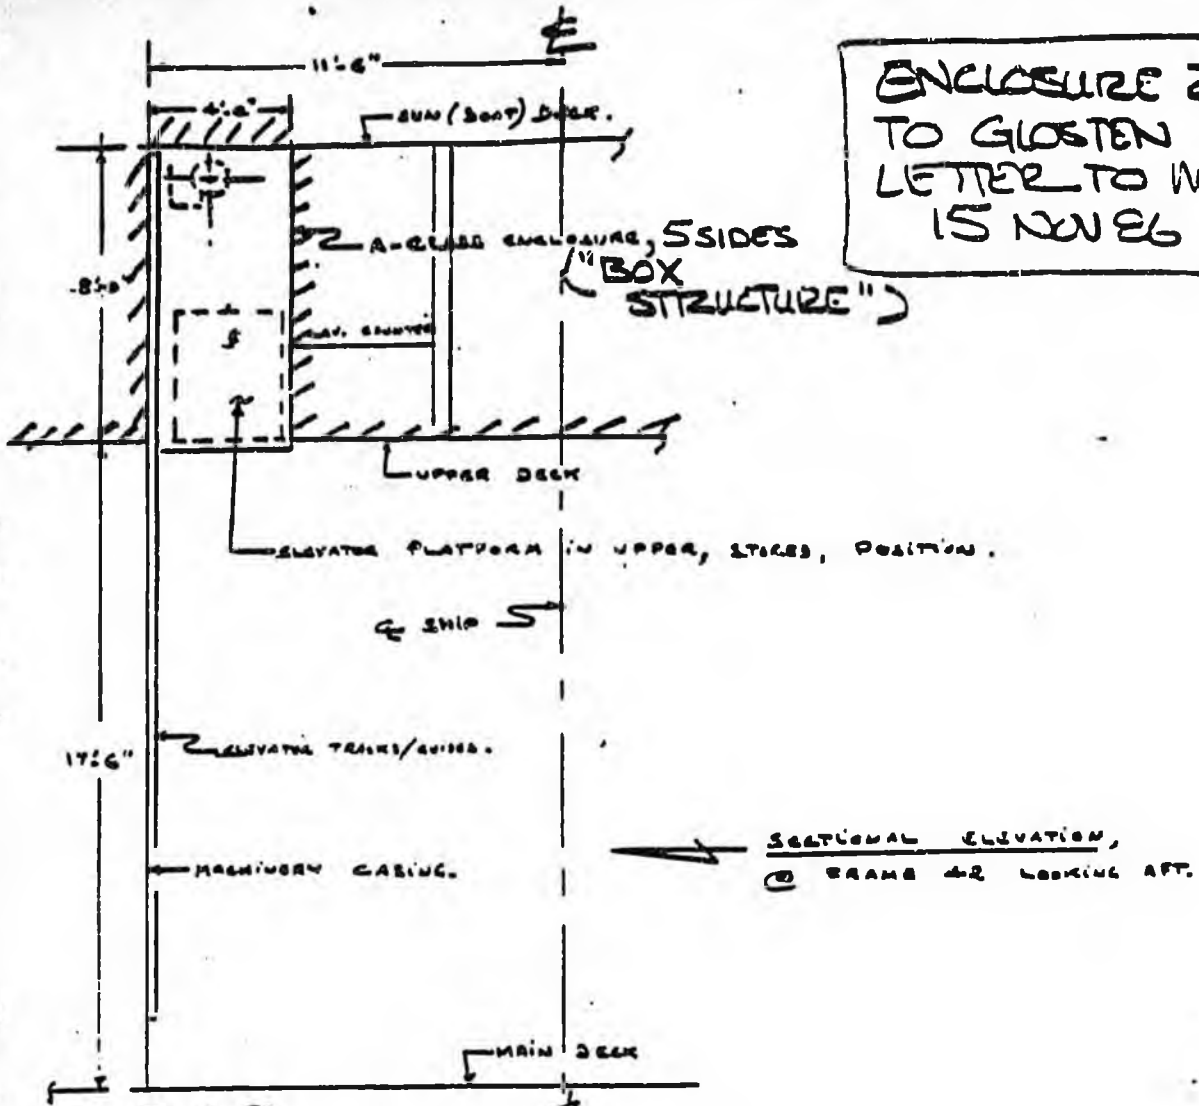
ENCLOSURE 2
 TO GLOSTEN
 LETTER TO WSC,
 15 NOV 86

LE CONTE/AURORA,
 PROPOSED ELEVATOR LOCATION (2)
 JUNE 86 - AUG. 86.
