## Current Conditions

## Standing Buildings

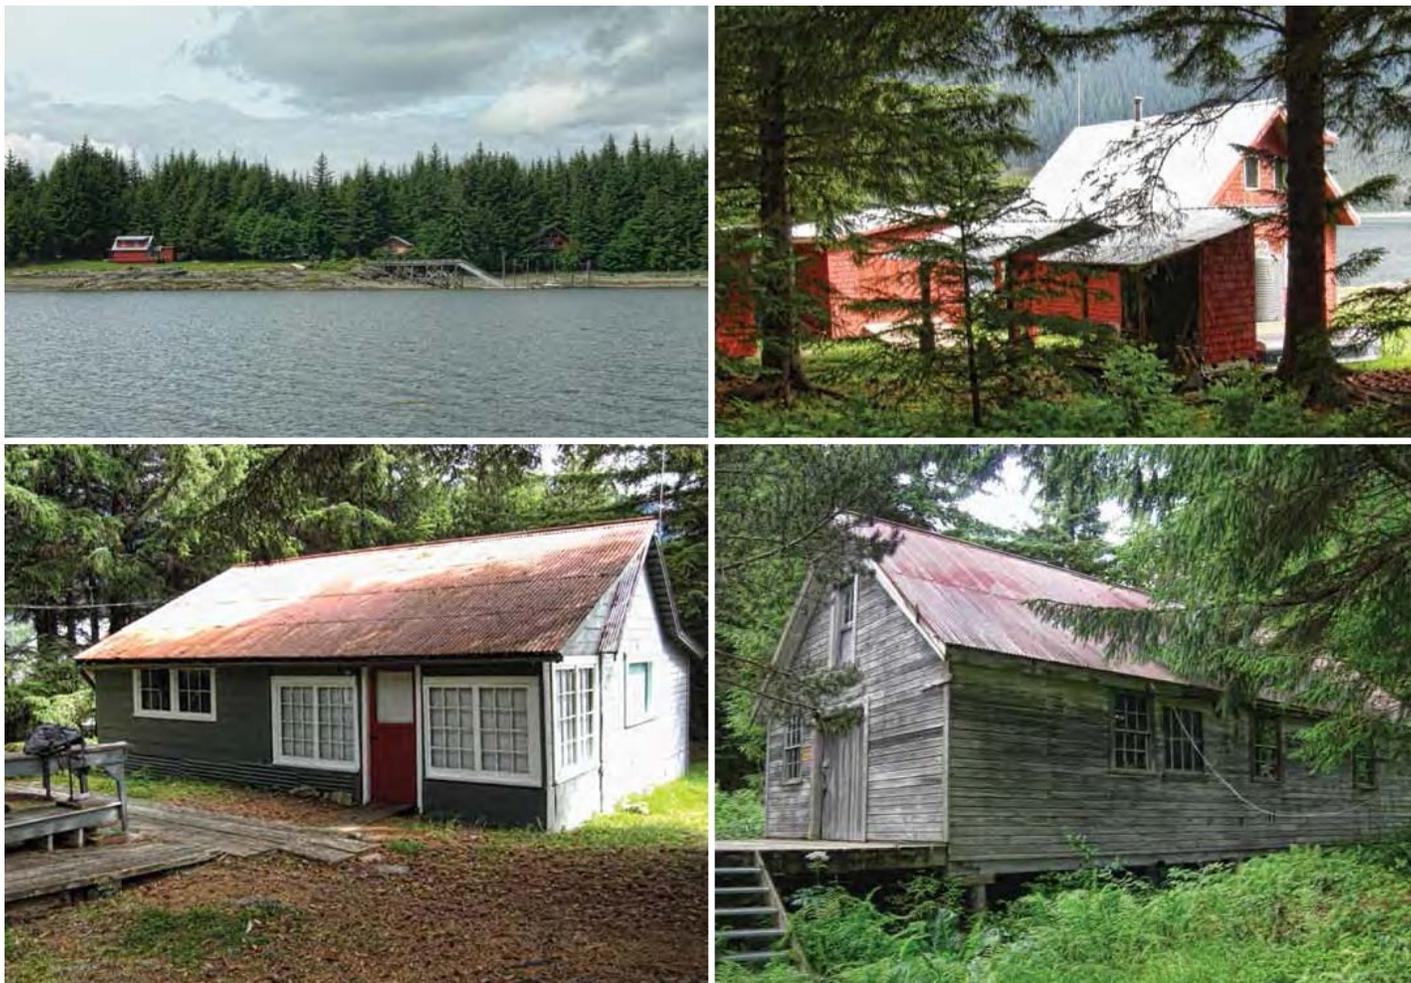
Figures 29-32. the Funter Bay cannery site is now occupied by four dwellings, three modern: Gordon Harrison's cabin with a shed-roofed dormer built in the late 1990s where the power house used to be, the 1990 cabin built by Reed Stoops where the mess once stood, Randall Gray's two-story log cabin.

to replace Harold Hargrave's original home that was destroyed by fire. One of the three dwellings on the former cannery property is Reed Stoops' one-story cabin built where the old mess hall used to be. A two-story cabin belonging to Randall Gray resides where the China House once stood (Figures 8, 29). And the cannery's former power house site is now occupied by Gordon Harrison's one-story frame cabin and several small sheds all painted a bright red (Figure 30). Whereas the two log cabins feature milled logs of obviously recent construction, the frame cabin is a gabled dwelling with a shed-roofed dormer facing the bay, a metal roof, and wood shingles, together giving the appearance of an older building (Figure 30).
