HOUSE COMMITTEE REPORT

SSHB 301

BAN SALE OF SOME STUDDED TIRES AND STUDS

Wheel Track Rutting Due to Studded Tires

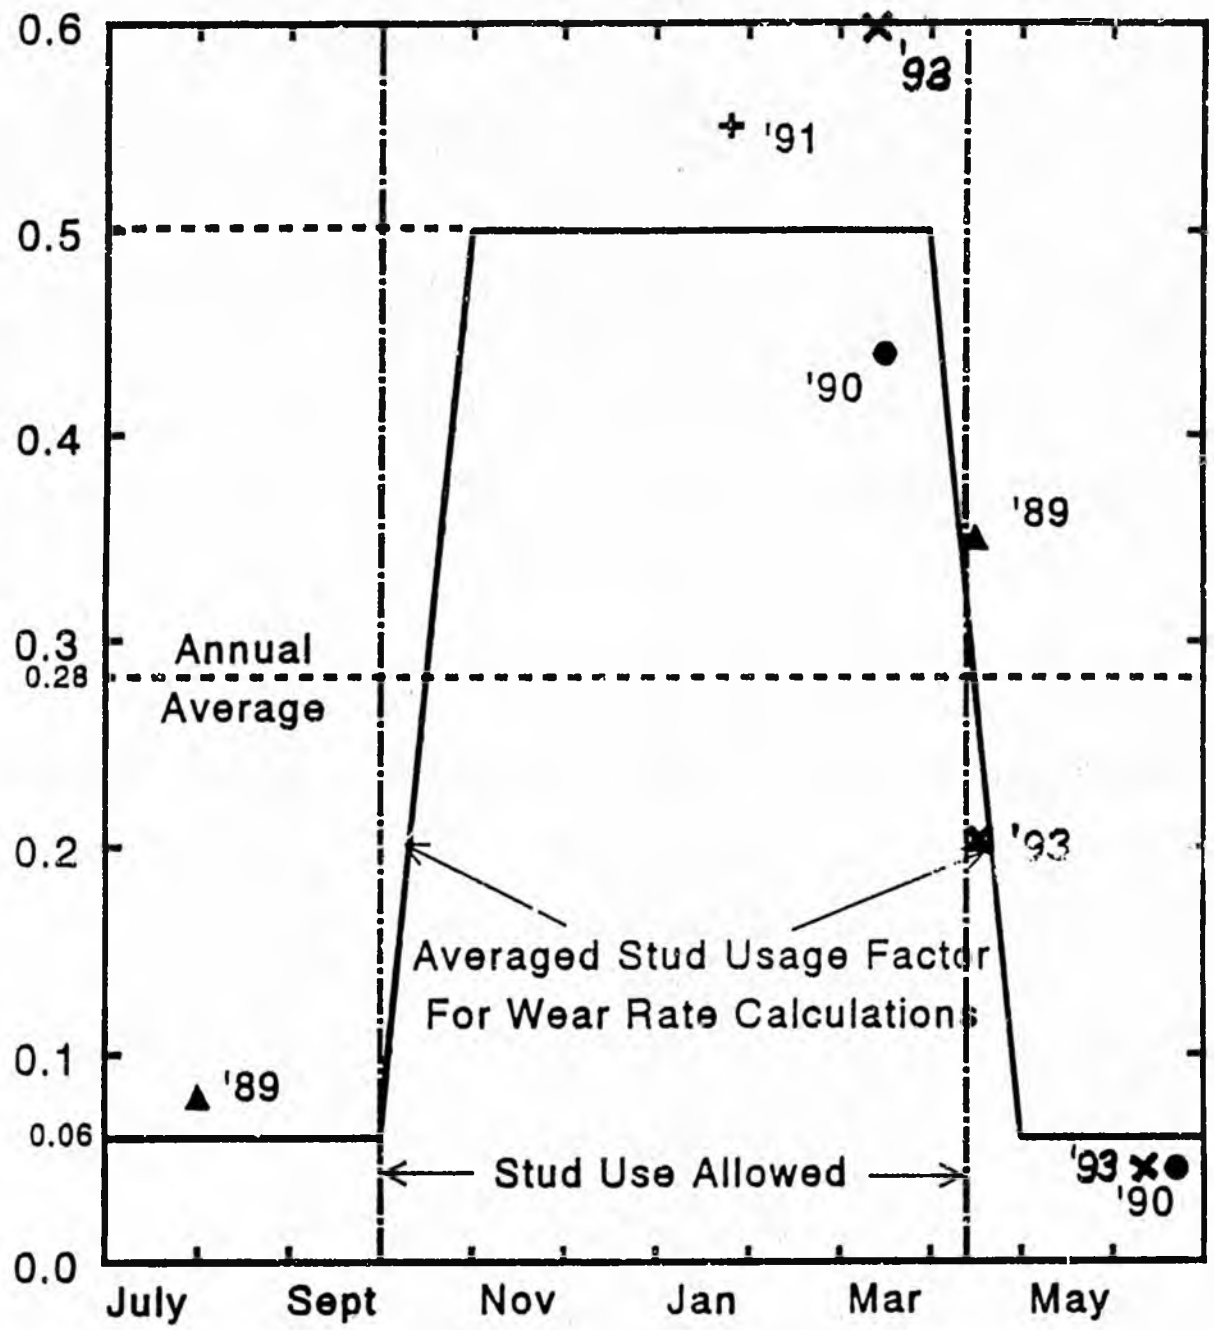
Seasonal Studded Tire Frequency Pattern
Juneau, Alaska

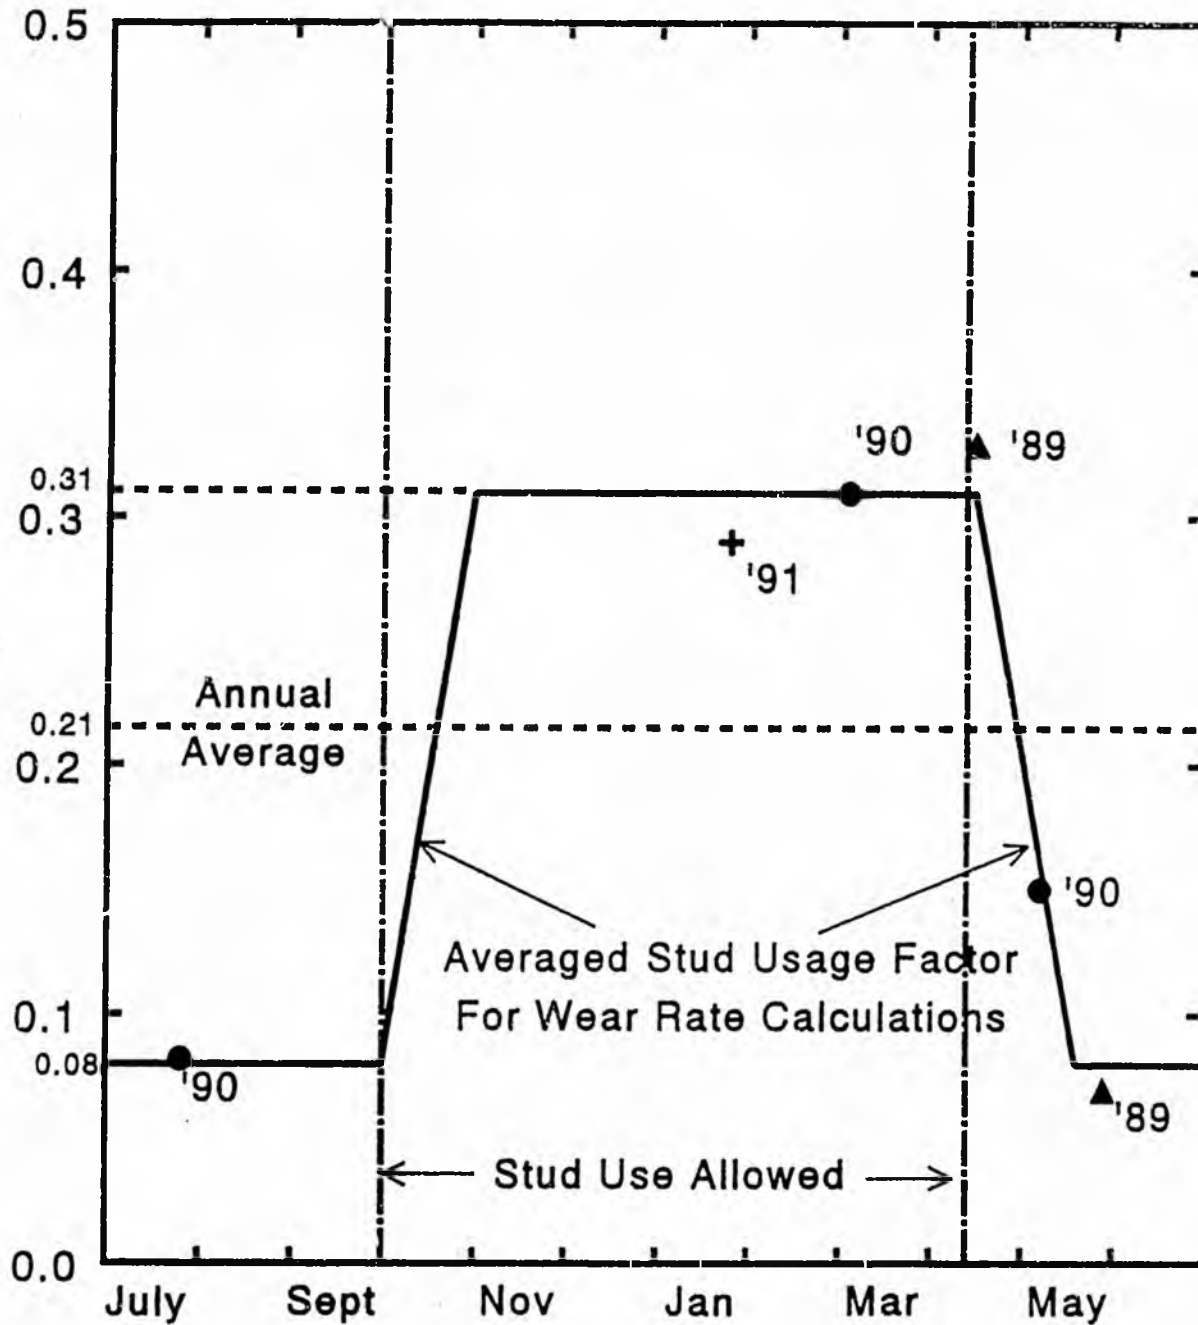
Seasonal Studded Tire Frequency Pattern
Fairbanks, Alaska

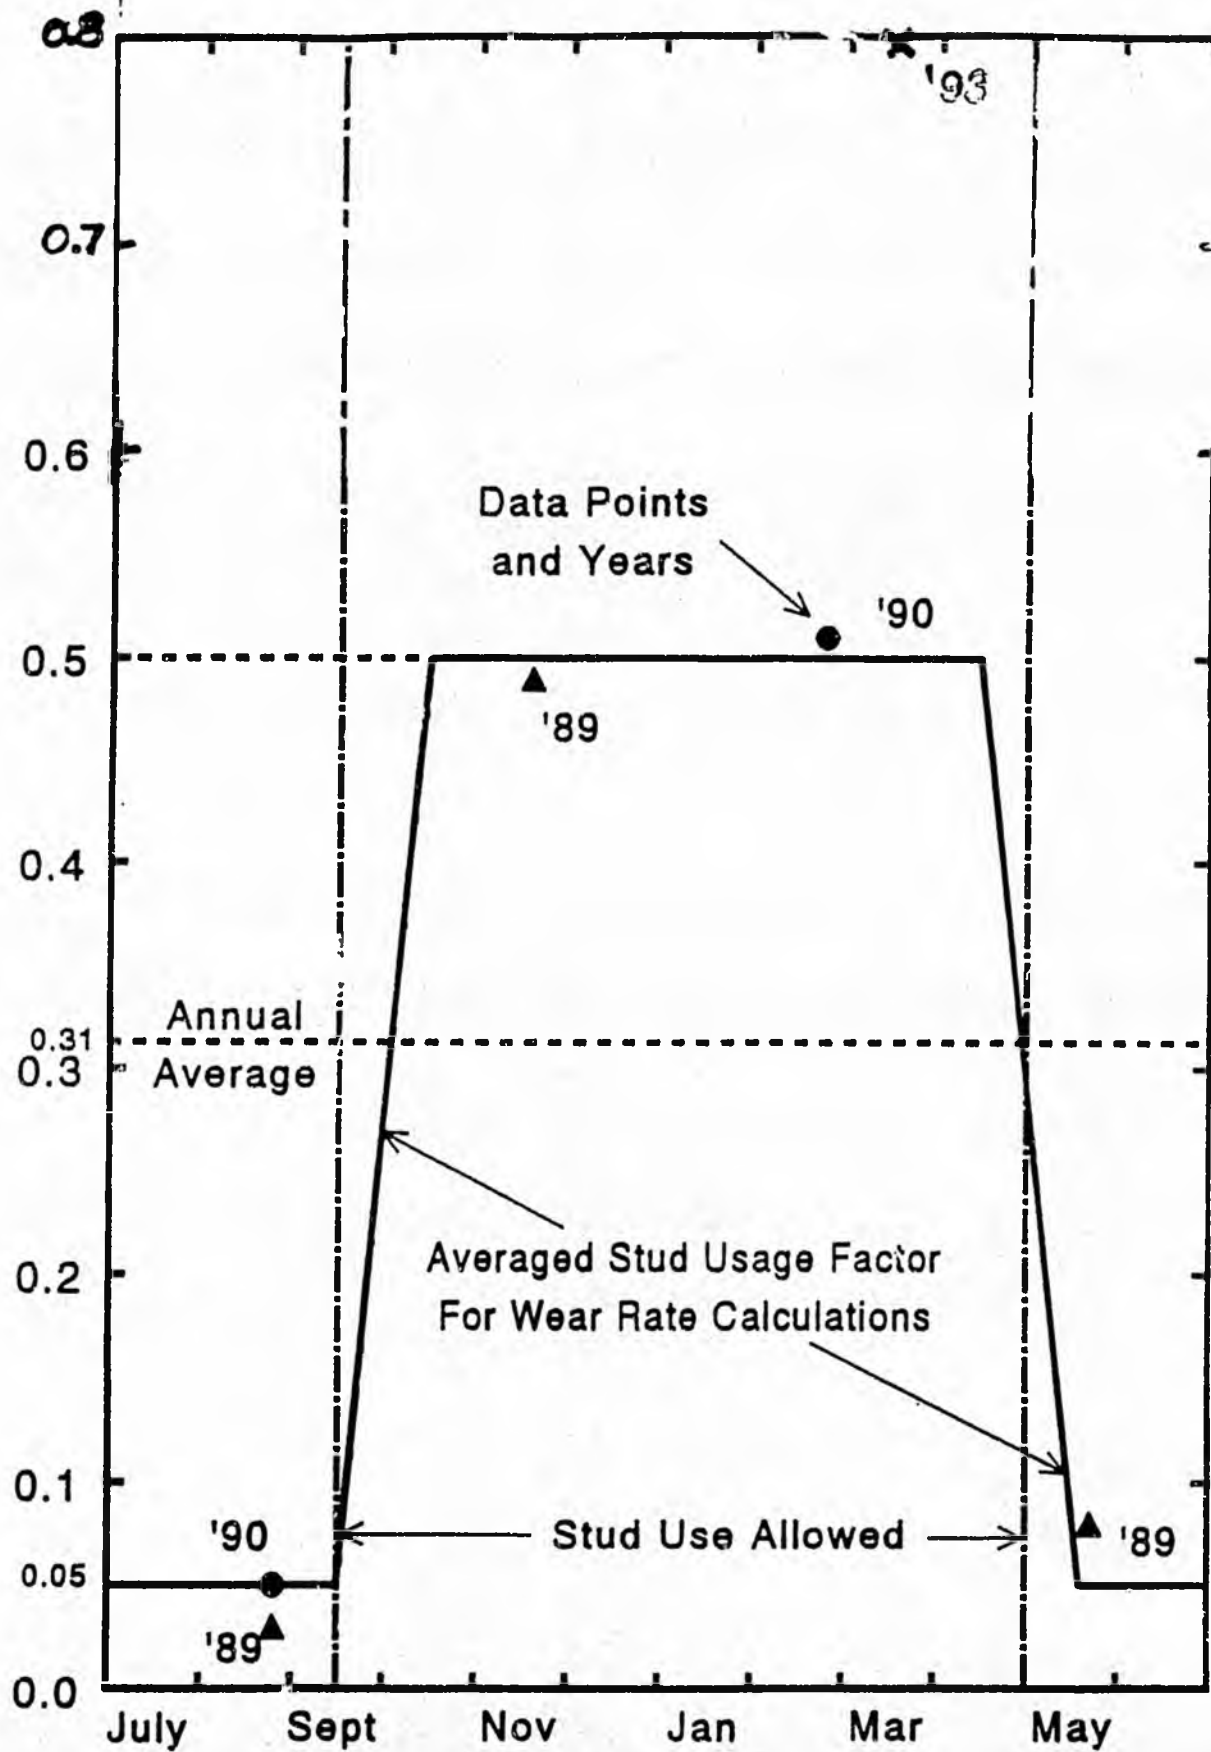
Seasonal Studded Tire Frequency Pattern
Anchorage, Alaska

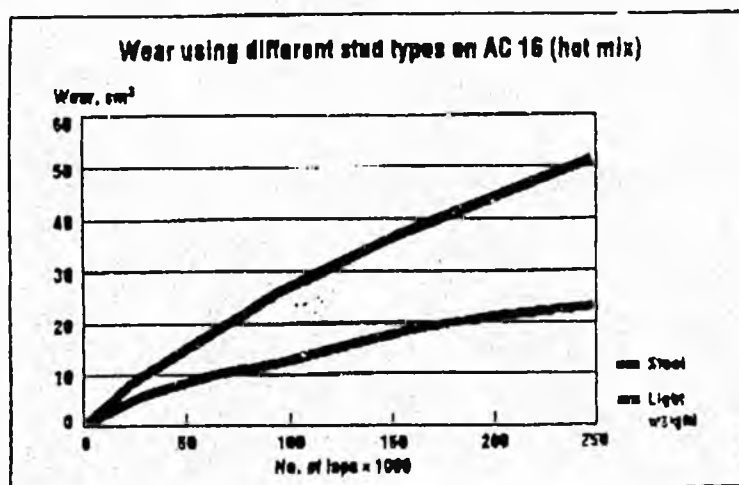
STUDED TYRE TESTS

The development of studs for car tyres has resulted in a steady reduction of stud mass. Among new studs on the market are types with plastic or alloy mantle surrounding a hard metal pin. Tests with these lightweight studs have been performed in the road simulator. The results show that the lightweight studs produce considerably less wear on the pavement than the heavier conventional steel studs.
