**PRUDHOE  
BAY  
CORROSION  
CRISIS,  
8/18/06  
(FILE 6)**

**BP Exploration Alaska  
Commitment to Corrosion Monitoring  
Annual Reports 2000 – 2005**

**Annual Report to Alaska Department of Environmental Conservation**

**Commitment to Corrosion Monitoring  
Year 2000**

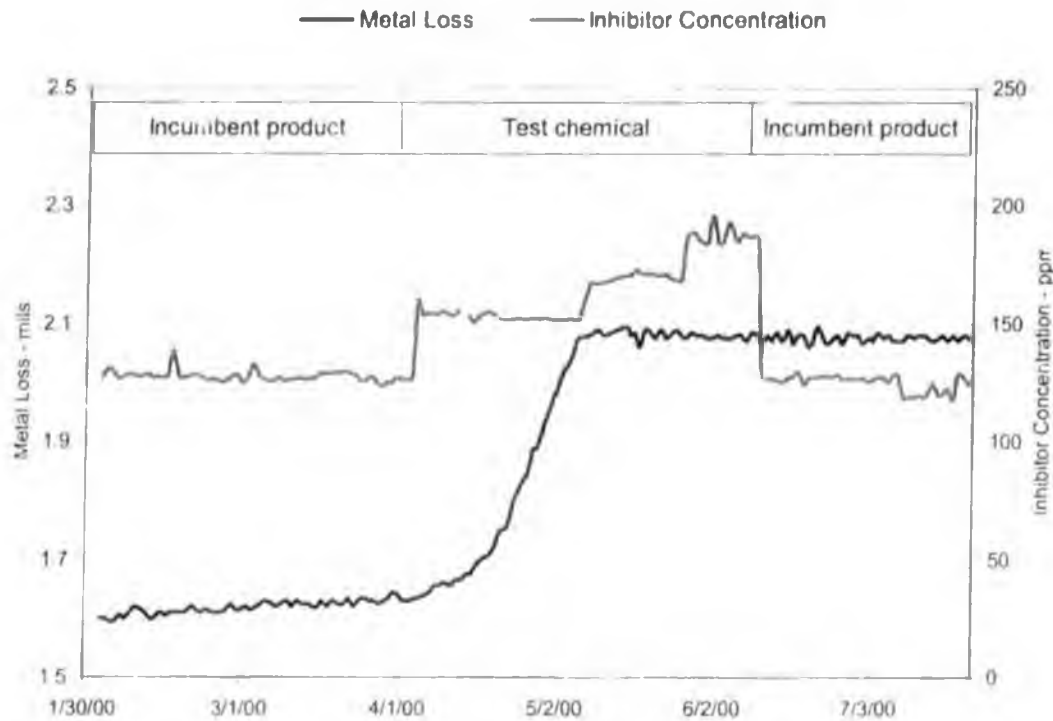
Figure 2: Chemical optimization in response to corrosion probe data

The metrics above deal with chemical usage at the field level but a lot of the chemical optimization activity concentrates on getting the correct amount of corrosion inhibitor to each piece of equipment. The inhibitor requirement is driven by factors such as water cut, water volume, flow regime, and condition of the equipment and varies over a wide range, from a few parts per million (ppm) to several hundred ppm. By way of example, Figure 2 shows corrosion probe data for a cross country pipeline during a chemical test. Soon after the test started, the corrosion rate increased and the concentration of inhibitor was increased to reduce the corrosion rate – see highlighted area. The required

increase in dose rate made the test chemical uneconomic and therefore the test was halted and the incumbent chemical was re-used at the original target dose rate. This type of optimization is done in response to probe, coupon, and inspection data, while testing new chemicals, as well as during normal operations as the amount of corrosion inhibitor required changes due to production variables such as water cut, water volume, or flow rates.

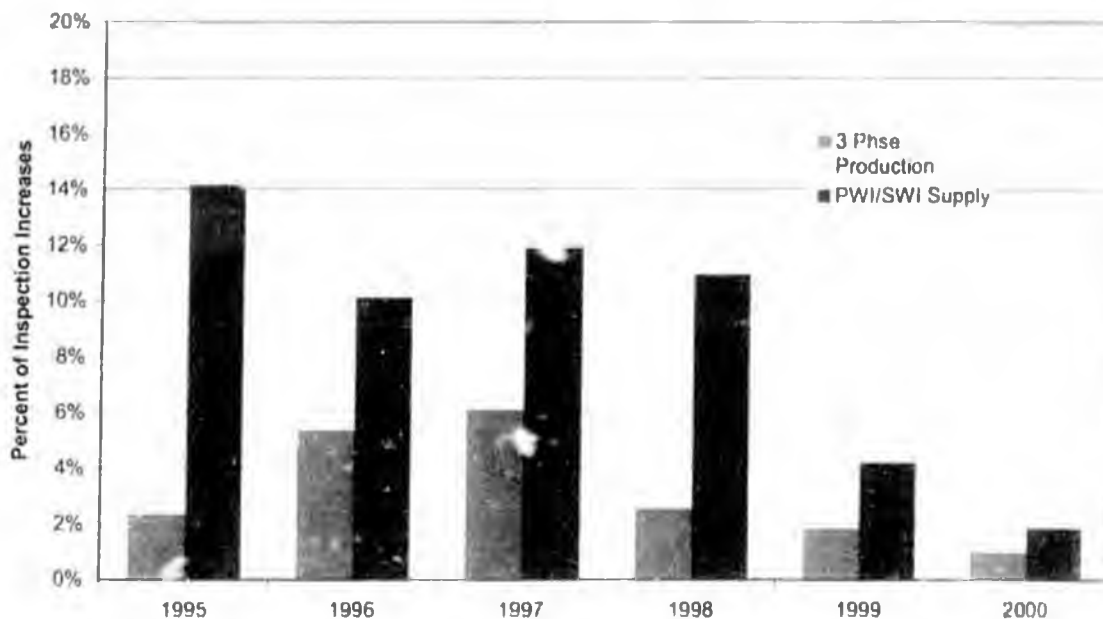
**Figure 5: Detection of internal corrosion of cross country pipelines by inspection**

Figure 5 shows similar data to Figure 4, but for cross country pipelines. Similar trends can be observed to those seen for well lines but with the improving trend continuing through 2000.

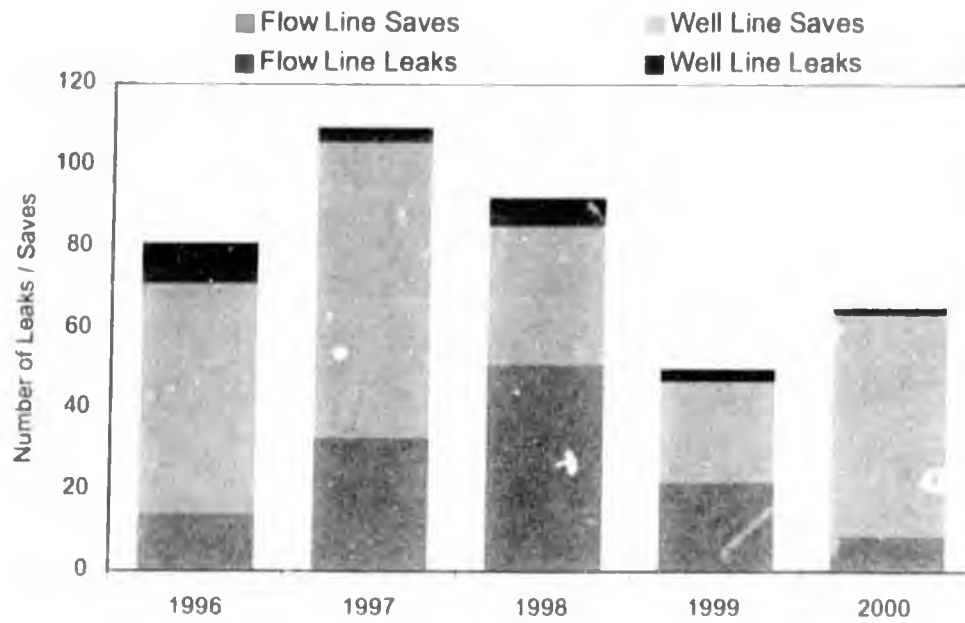
Figure 6: Leaks and Saves of well lines and cross country lines

inspection program at locating severe corrosion damage. The reasons for the increase in corrosion rate are discussed in Section E.2.

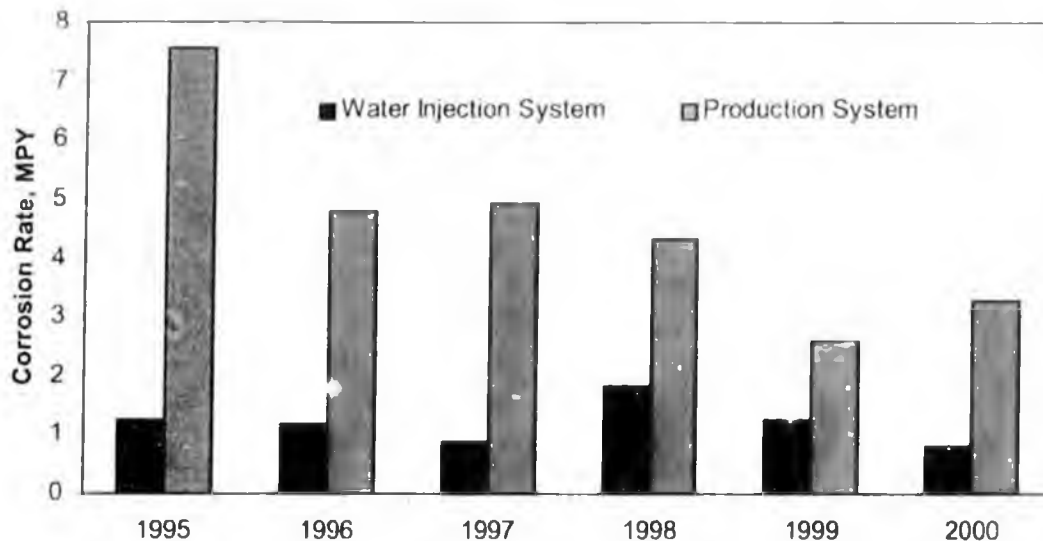
**Figure A1: Corrosion coupon data from Endicott 1995-2000**

System	Number of Locations with Access Fittings	% Coupons < 2MPY Corrosion Rate
Water Injection - Pads	15	100%
Water Injection – x-country	1	100%
Oil Production – Pads	81	64%

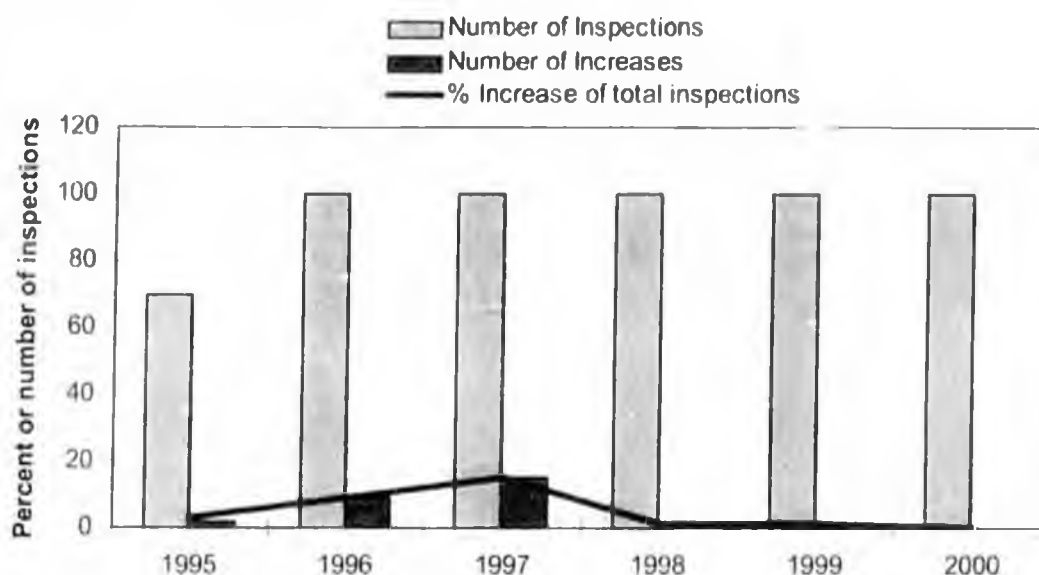
Figure A3: Endicott IWL Quarterly UT Readings

Chemical optimization at Endicott has concentrated on a three-pronged approach of maintenance pigging for line cleanliness, biociding to control bacterial activity and continuous injection of a corrosion inhibitor for corrosion control. As noted earlier, the primary monitoring tool for effectiveness is the UT inspection of 25 locations along the IWL. These inspections indicate there is very little corrosion activity in the IWL. Figure A3 shows an historical perspective of the IWL inspection activity. The last corrosion activity was noted to be in July 1999.

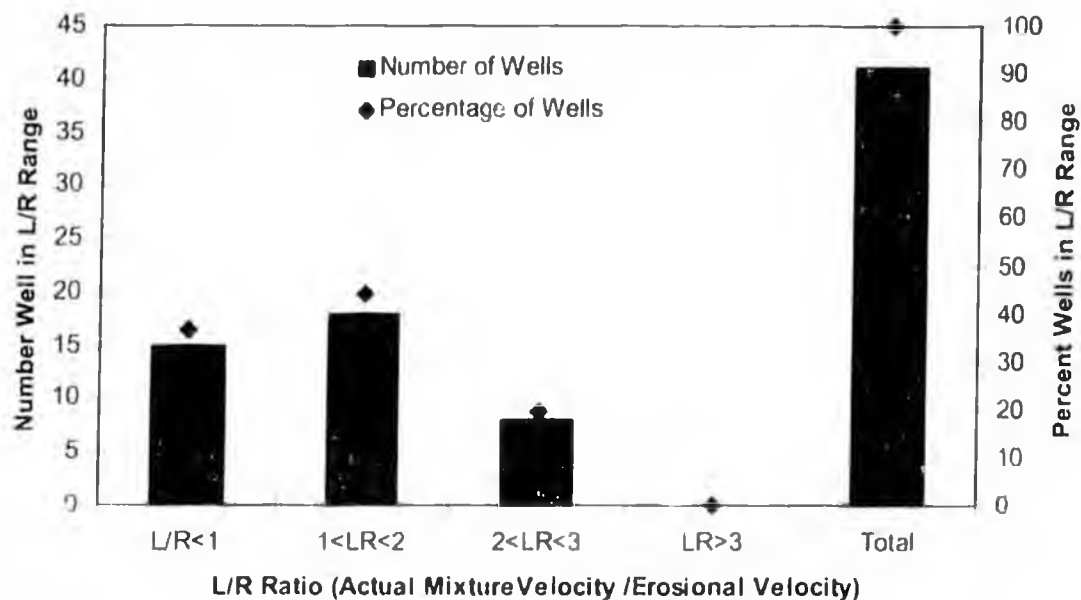
Figure A4: Endicott Velocity Monitoring

where corrosion and erosion resistant materials are used. Actual velocities are expressed as a ratio of the allowable velocity as defined by API RP 14E, with the aim being to limit velocities to less than 3 times the allowable velocity. This factor of 3 reflects BPX(A)'s experience that production fluids with minimal amounts of entrained solids may exceed the API RP 14E erosional velocity through stainless steel pipelines by this amount with minimal risk of erosion.

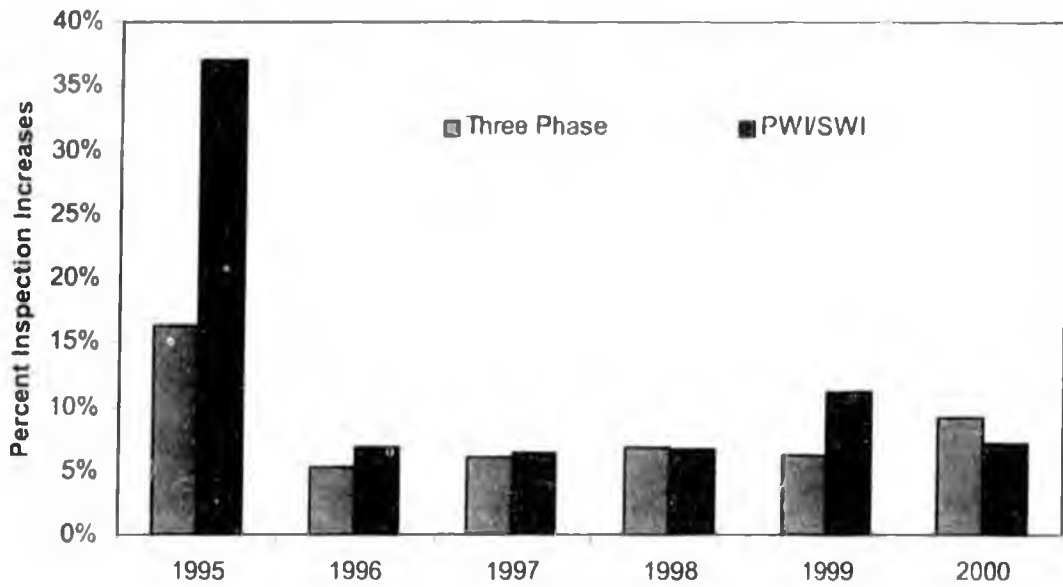
Figure A5: Detection of internal corrosion of well lines by inspection at Endicott

Figure A5 shows corrosion activity in the well lines by inspection for both the production and water injection systems at Endicott. These trends have remained relatively constant since 1996. The production system inspection data is used to alert operations of potential replacements of the carbon steel "C spools" at the wellheads. The inspection increases in the water injection system well lines have been consistently low since 1996 and reflects the improvements to the chemical mitigation program undertaken at Endicott.

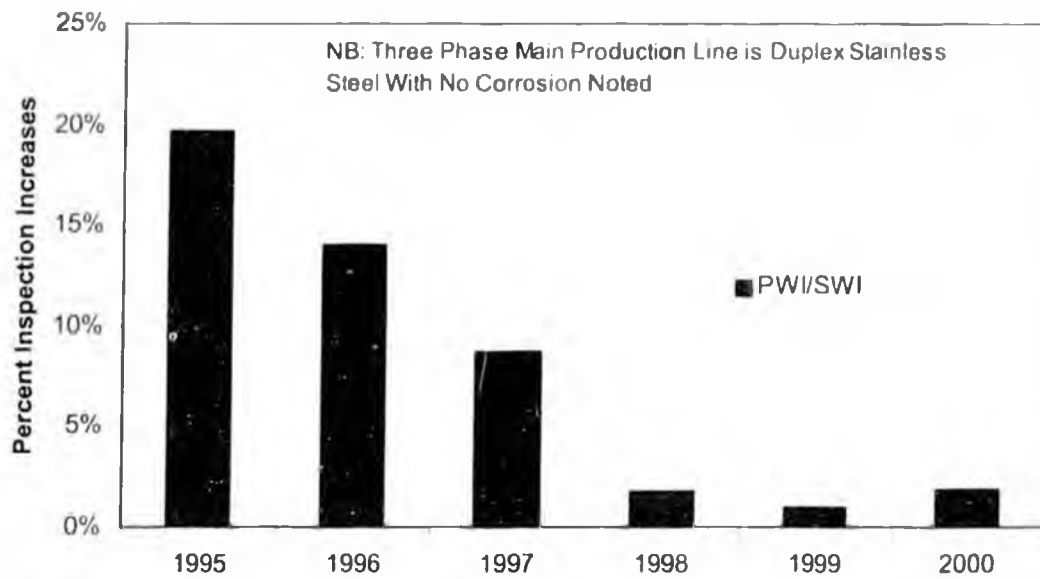
Figure A6: Detection of internal corrosion of cross country pipelines by inspection at Endicott

Figure A6 shows a trend of declining inspection increases since 1995 for the Inter-Island Water line at Endicott. This trend is indicative of the improvements made to the water injection mitigation program.

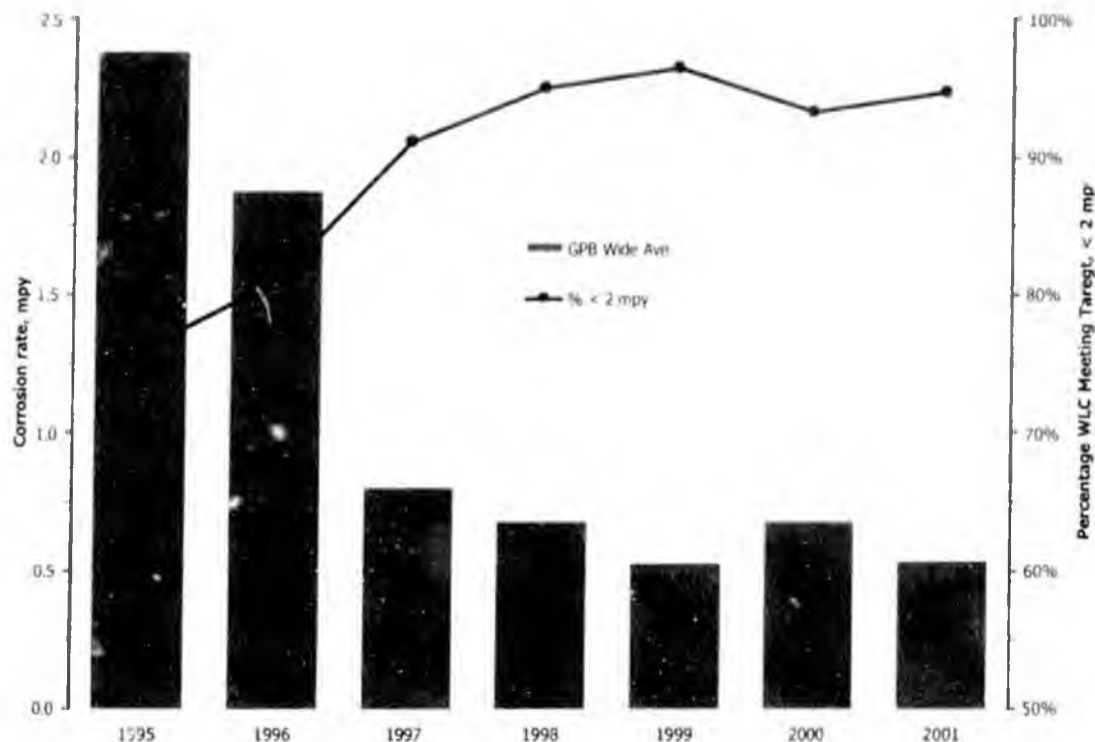
Figure C.9 GPB Aggregate Performance

It should be noted that the majority of the pipelines are in 3-phase (OIL) service and hence the majority of the corrosion monitoring is also in 3-phase service. As a consequence, the aggregate data shown above is dominated by the performance of the 3-phase system.

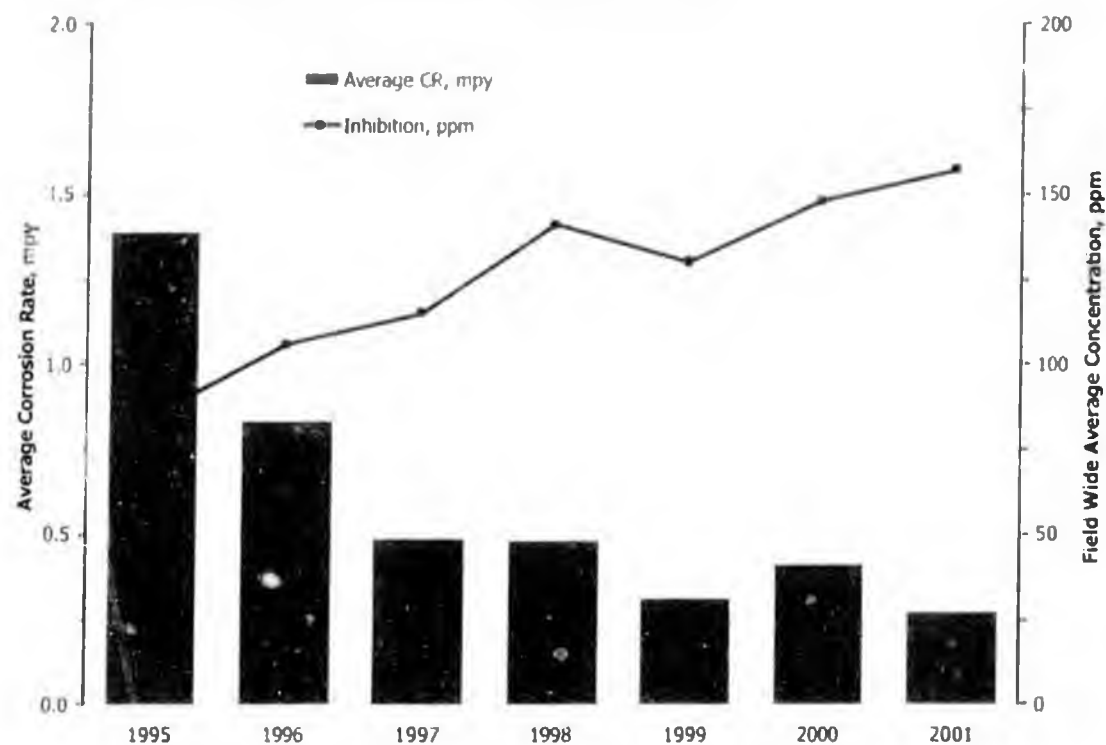
Figure D.8 shows the correlation between the increased level of corrosion inhibitor and the reduction in average corrosion rate from 1995. As might be expected, the decline in average corrosion rate correlates with the increase in corrosion inhibition levels over time. The inhibition levels have increased approximately 80% from 1995 to 2001, with a field-wide average concentration of 85 ppm to 157 ppm, respectively. As a result the corrosion rates have fallen by ~80% from 1.4 mpy in 1995 to 0.3 mpy in 2001.

Description	1995	1996	1997	1998	1999	2000	2001
FL OIL Ave CR, mpy	1.4	0.8	0.5	0.5	0.3	0.4	0.3
Inhibitor Conc., ppm	85	106	115	141	130	148	157

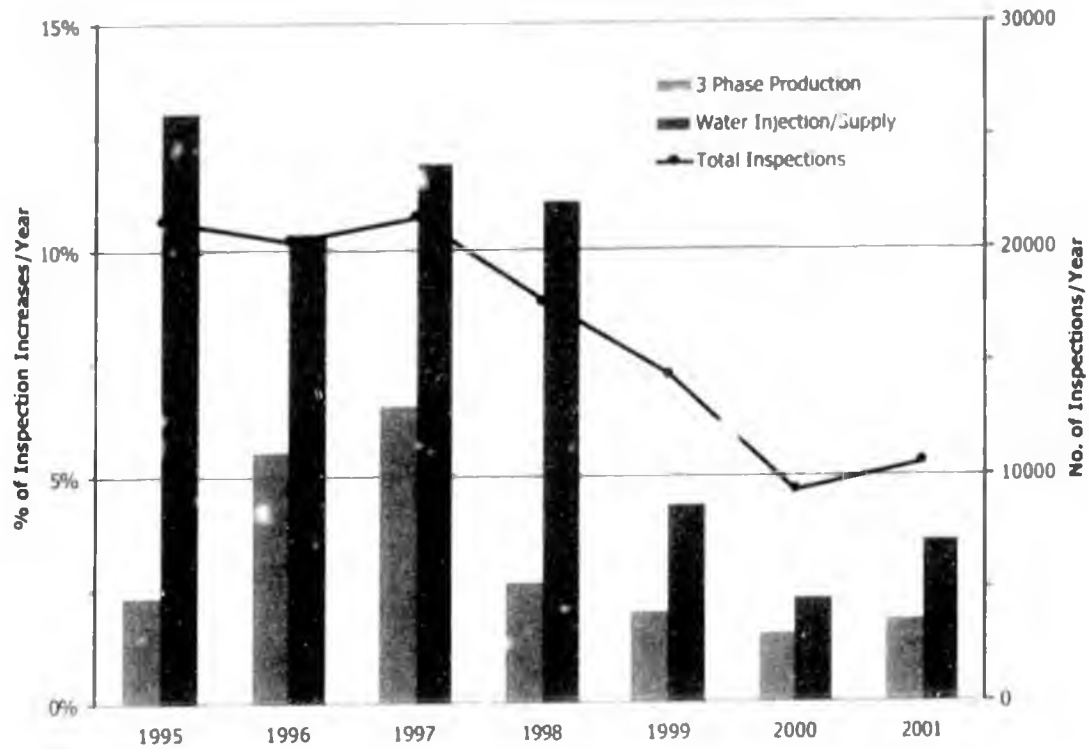
Figure E.7 Flow Line Internal Inspection Increase by Service

For the water system, corrosion activity is seen to be declining over the last 5 years; however, the increase in activity seen in the flow lines has not yet translated to activity in the well line data.
