11938 SENATE RESOURCES

BP SPILL

C. HISTORY OF THE GC-2 OIL TRANSMISSION LINE

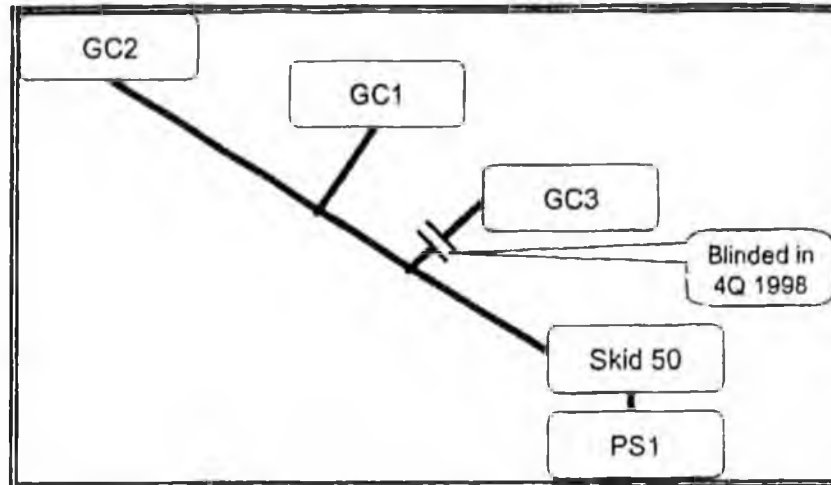
The GC-2 Oil Transit Line runs from GC-2 to Skid 50 as shown in the following schematic:

The pipeline is continuous but is divided into three segments as follows:

GC-2 to GC-1	~16,573 feet (OT-21)
GC-1 to GC-3	~11,420 feet (OT-13)
GC-3 to Skid 50	~13,881 feet (OT-31)
Total:	~41,874 feet (7.9 miles)

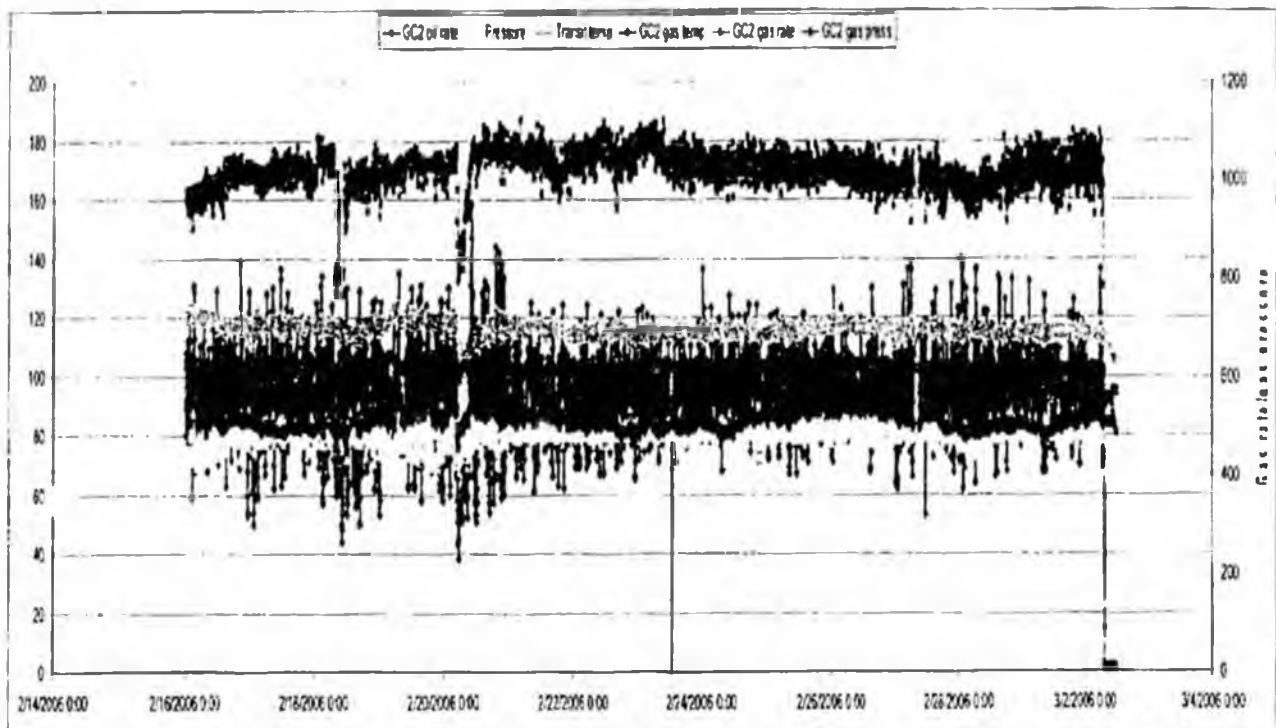
Chart data ranges

Electronic data retrieved from the Production Control computer system and graphed below indicates that normal operating parameters were present prior to the leak discovery. The only item of note recorded from February 16th thru March 2nd occurred during the shut-in process when pipeline pressure increased from normal operating pressure (approx. 80 PSI) to 209 PS.

Pipeline Pressure	Fluid Temperature	Flow Rate
63-91 PSI	104-126F	38-158 MBPD

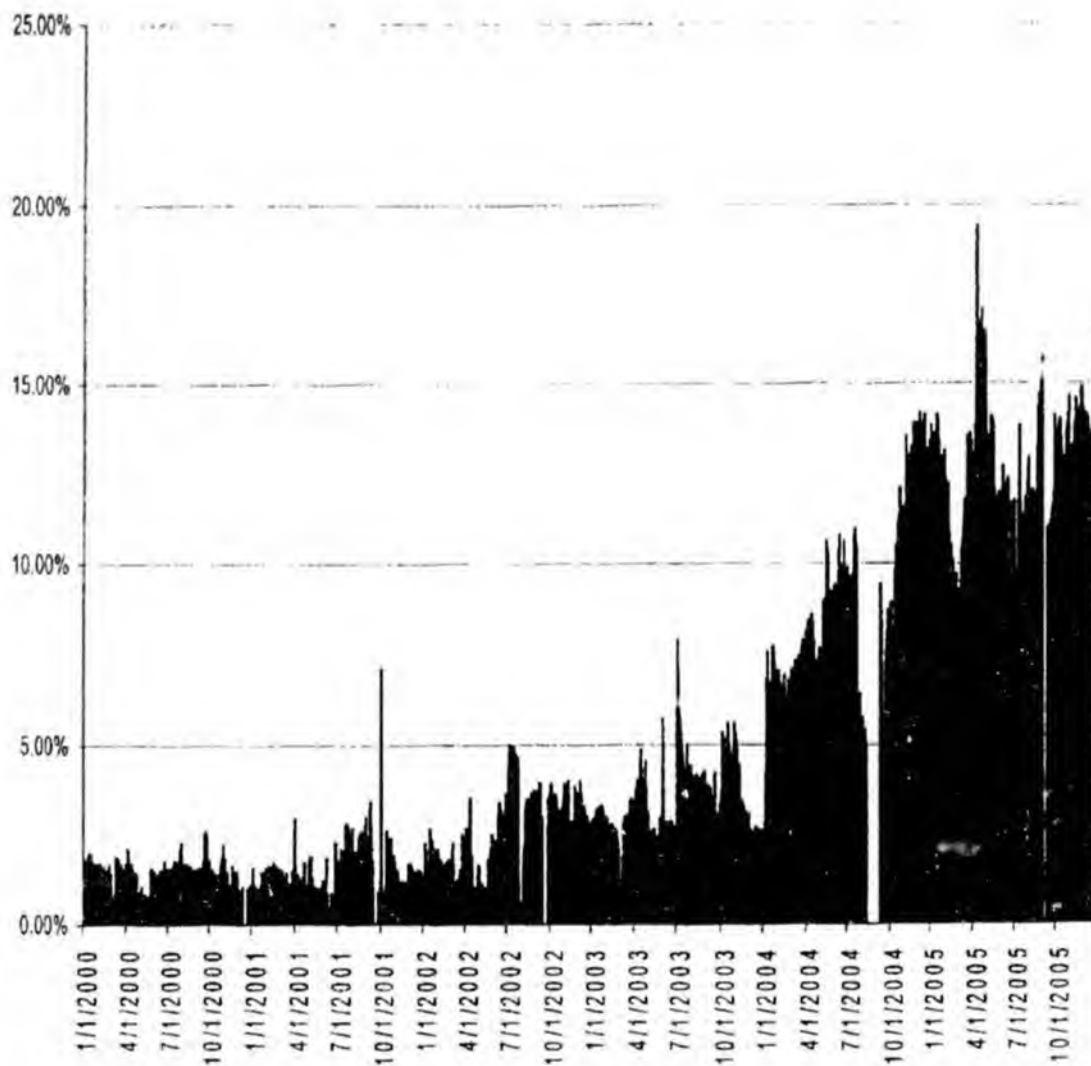
Percent of Viscous Oil of Total Production

The increase in viscous oil production at GC-2 has, however, resulted in an increase in Basic Sediment and Water (BS&W) entrained in the production fluids as they leave the GC-2 facility and are carried through the OT-21 line.

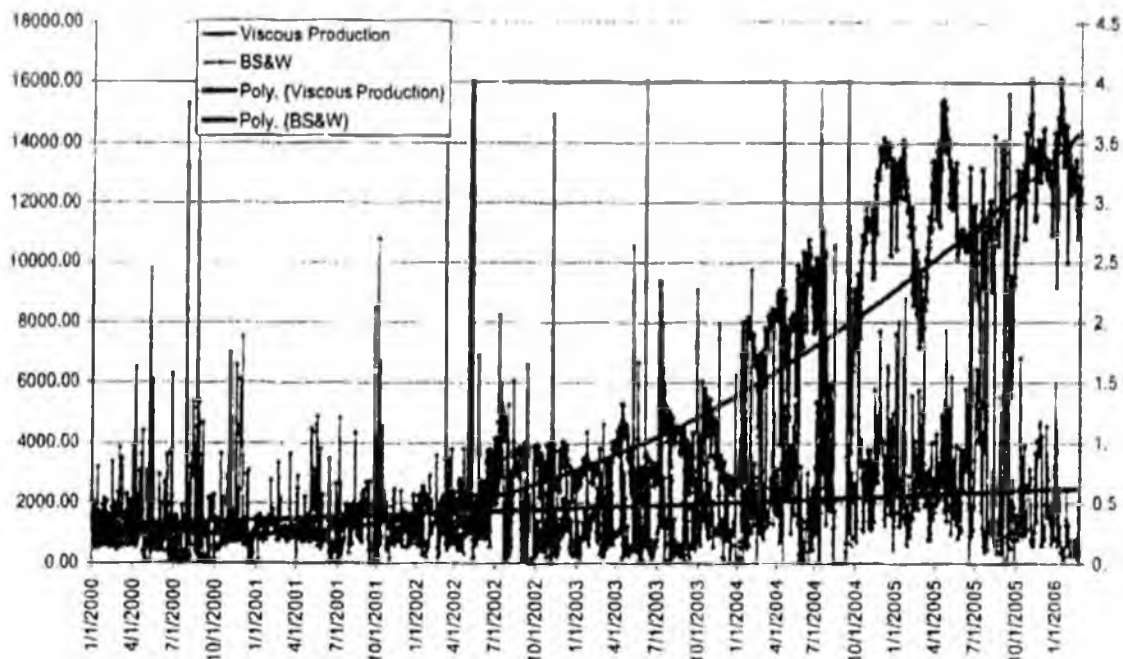
Viscous Production vs. BS&W

The electronic BS&W statistical data collected between 1/1/2000 through 2/28/2006 is graphed below and indicates a steady increase in mean BS&W as viscous oil production rates increased through GC-2.

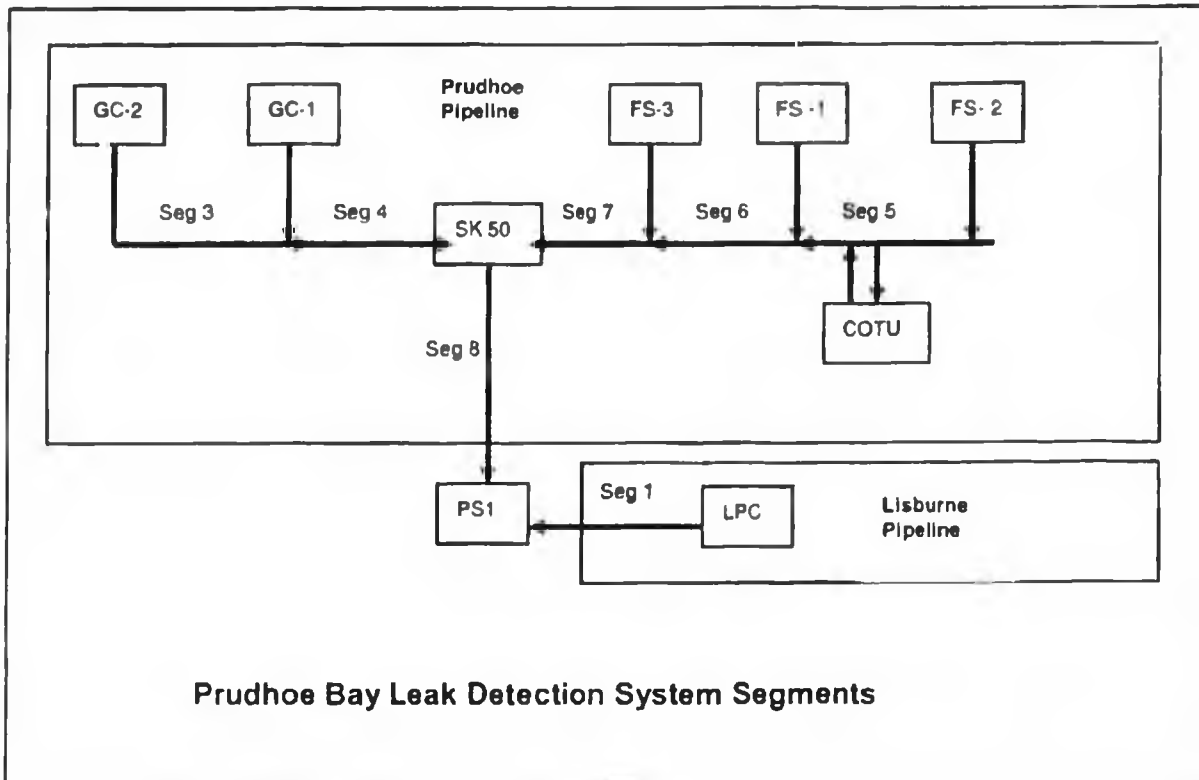
The Prudhoe Bay leak detection system covers oil transit lines from all of the production facilities at Prudhoe Bay and Lisburne to PS-1. As described below, the system is divided into individual segments for purpose of leak detection. The OT-21 line from GC-2 to GC-1 is termed segment 3 and the line from GC-1 to Skid 50 is termed segment 4.

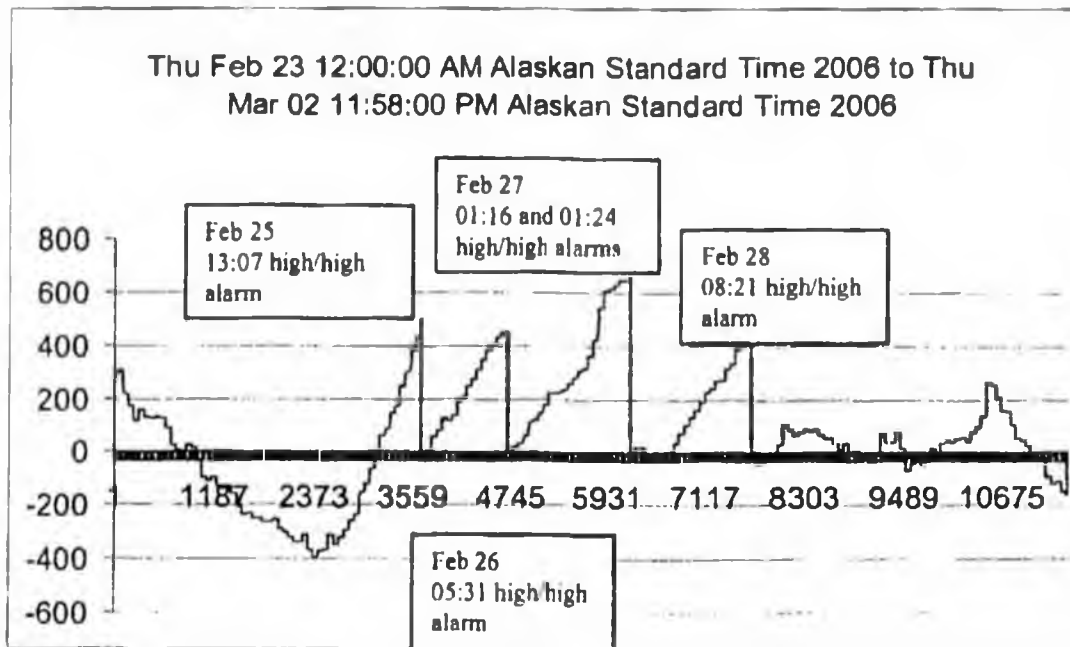
The leak detection system works by using a daily mathematical accumulator to measure positive and negative volumes between the meters at the beginning and end of each segment. For segment 3, the daily accumulator looks at the daily volume measured at the GC-2 sonic meter minus the daily volume as measured at the GC-1 sonic meter. For each segment, four alarm points are set: high/high, high, low and low/low. The high/high alarm set point for the system is set at approximately 0.5% of the average flow rate over a 24 hours period. For segment 3, the high/high alarm point is 440 bopd. Following is a graph of the daily accumulator rates for segment 3 for the week preceding March 2, 2006.

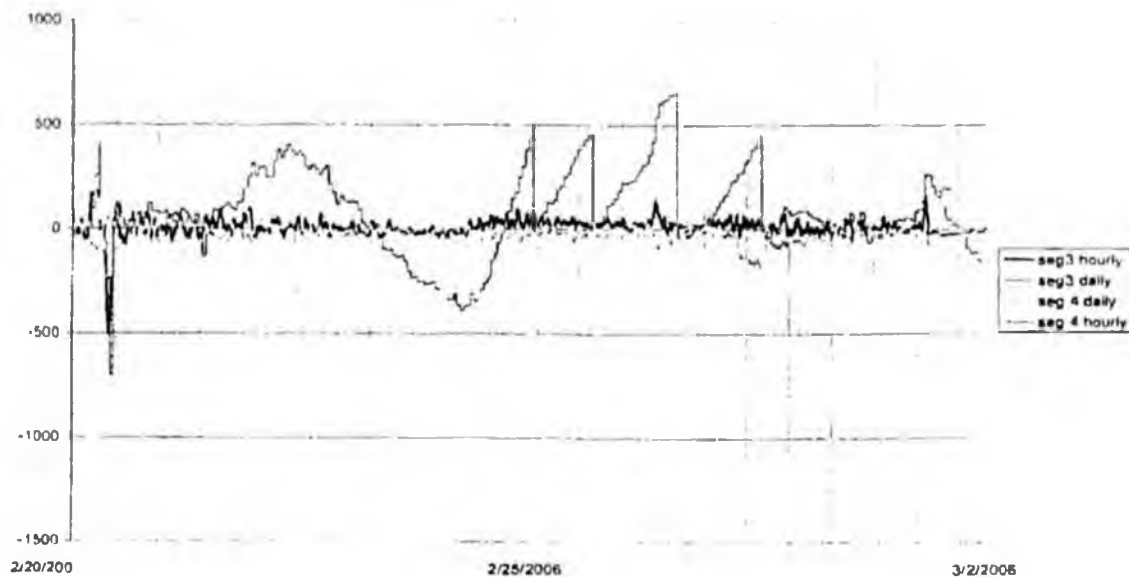
GC2 Segment 3 and 4 Leak Detection Data

High/high alarms were noted by the automation engineer in their Leak Monitoring Tuning Log on February 25 through February 28. The Eastern Operating Center (EOC) Specialists, who monitor the alarms, also keep an event message log which confirms the high/high alarm readings on the times noted above. As shown in the preceding graph, the magnitude of the high/high alarms ranged from 440 bopd to 600 bopd. Starting on February 25, the notes in the Leak Monitoring Tuning Log note that GC-2 had been producing water on a regular basis and that segment 4 was mirroring negative readings as shown in the following graph.

Based on the known GC-2 BS&W upsets that were occurring and the fact that line 4 was mirroring segment 3, the Leak Monitoring Tuning Log system states that the readings were interpreted as an error in the meters and both segment 3 and 4 were reset on each of these days (13:07 on the 25th; 06:49 on the 26th; 07:45 on the 27th; and 08:24 on the 28th). Our conversations with the automation engineers and the EOC Specialists who monitor the leak detection system confirm this statement. During this timeframe a tuning adjustment was also made to the leak detection system at 08:12 on February 28th. There was no high/high alarm detected on March 1 or March 2.

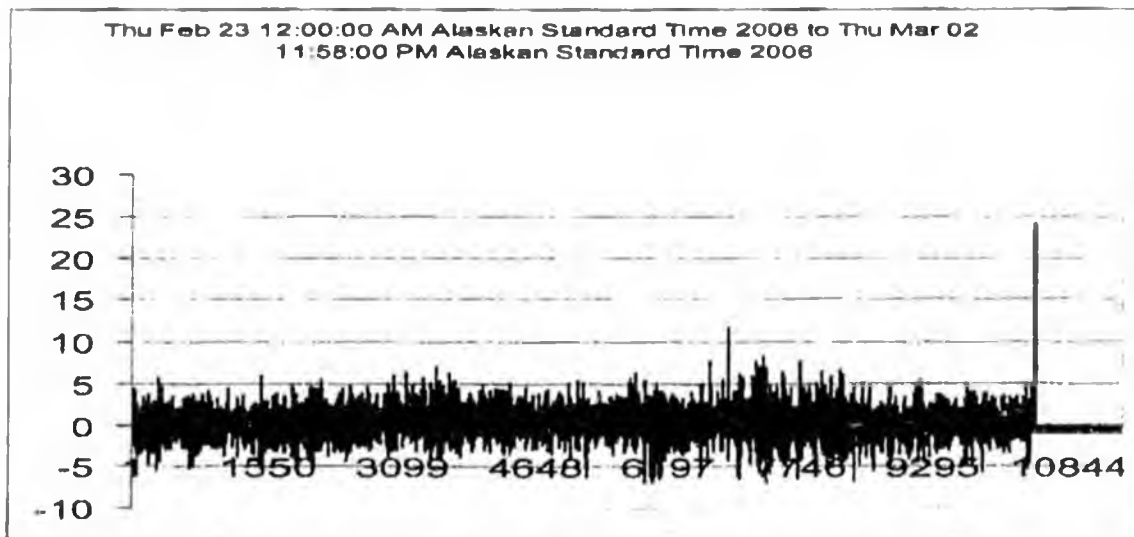
Theoretically, with no process fluctuations at GC-2 and no leaks in the pipeline, the measured flow rate at the sonic meter at GC-1 should be identical to that of the rate at the sonic meter measured at GC-2. Practically this is not the case. Due to process upsets (BS&W) and the non-steady state nature of the process, leak rates of less than 1% may not be detected by the system. As a result, it is designed to identify a 1% leak over 24 hours by use of a mathematical accumulator that adds up the delta of measured flow rates (GC-2 minus GC-1). It is also worth noting that the high-high alarm is set at a leak rate of approximately 0.5% to add a level of insurance to try and act on an event more quickly than if set at 1%. How the system works is that a positive accumulator number would indicate less oil coming out of GC-1 than what is going in at GC-2 and conversely, a negative accumulator number would suggest more oil exiting GC-1 than what is entering at GC-2. The graph below shows a week long history of minute by minute readings of GC-2 minus GC-1 for the week prior to the spill.

The graph illustrates a continual swing of positive and negative readings, with the absolute swings being in the 4 barrel per minute range. At 4 barrels per minute, this is the equivalent of 5760 bopd or just under 6% of a 100,000 bopd nominal flow rate.

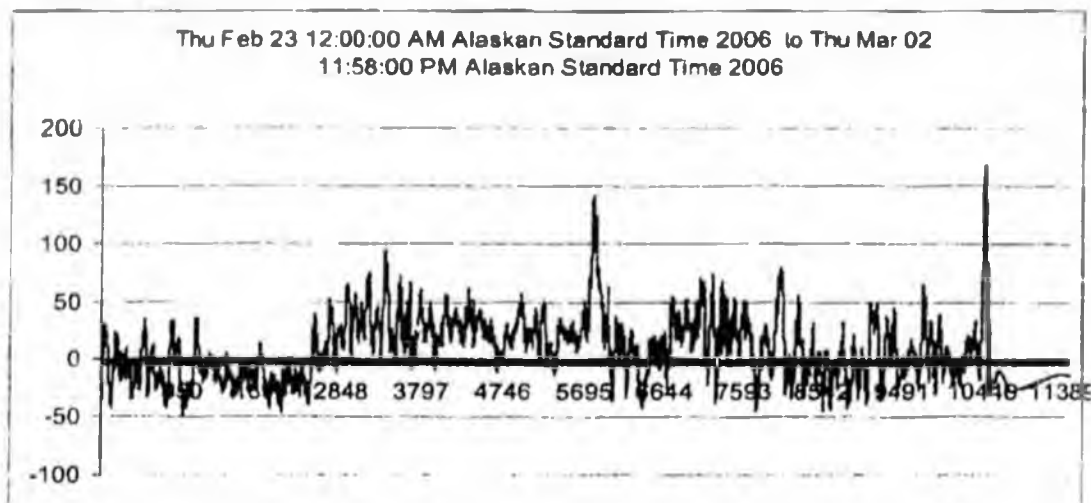
To compensate for these dynamics, the ups and downs are smoothed using the accumulator and are looked at on an hourly basis as shown below over the same timeframe.

This graph still shows quite a variation in both negative and positive swings in the system on an hourly basis. As a result, it takes one further smoothing over a 12-24 hour period of the accumulated data to detect a small leak.

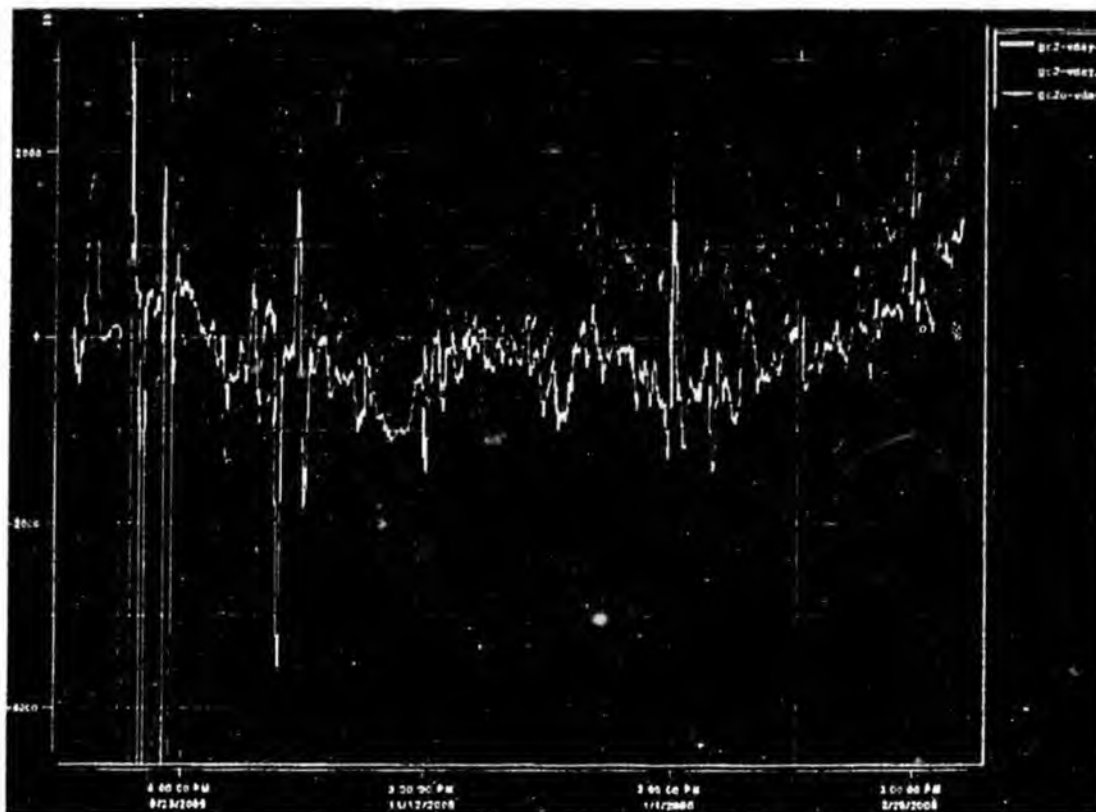
The graph below illustrates the uncorrected delta in daily meter readings from September 2005 to March 2, 2006.

This graph shows that there are three meters at GC-2: orifice plate meters and two sonic meters. All measure the meter readings at GC-2 minus the readings at GC-1. The blue curve is the delta between the summation of the orifice plate meters and the sonic meter at GC-1; the white curve is the delta between the first sonic meter at GC-2 and the sonic meter at GC-1; and the red curve is the delta between the

second (newer) sonic meter at GC-2 and the sonic meter at GC-1. Note the magnitude of the differences between the three sets of meters is in the 1000 to 2000 bopd range. The spikes are usually associated with some sort of process upset. When this happens the EOC Specialists follow the Leak Detection Monitoring and Response Procedure and the systems and procedures outlines in the GPB Leak Detection System Overview, both of which are attached in Appendix C, to evaluate what is happening in the plant and the line. As described in those documents and discussed below, they must continually reset the accumulator and work to re-tune the meter factors for improved accuracy.

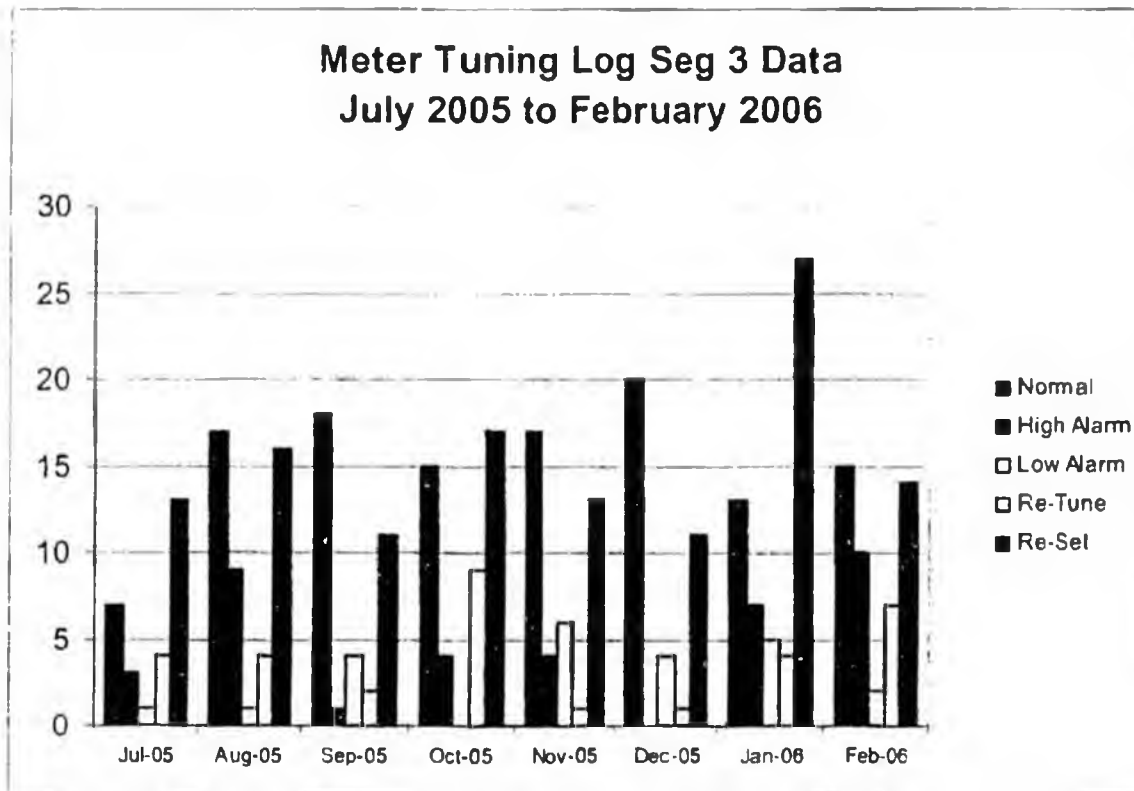
In 2005, BPXA evaluated the Prudhoe leak detection system to see if it could meet a 0.5 % leak detection threshold being considered by ADEC in a proposed rulemaking. The analysis concluded that meeting a 0.5 % leak detection threshold is not feasible. Nonetheless, as stated above, prior to the leak the system was set to alarm at approximately 0.5%. The 2005 analysis also determined that segment 3 has a high number of false alarms and a lot of unsteady state conditions – more than any other segment. Most of the false alarms are ruled out as process upsets due to high water content in the exported crude and the mirroring of a neighboring segment of pipe with negative readings. In the absence of these two facts, a request is made for the pipe to be either driven or flown over. According to the Leak Detection Monitoring and Response Procedure, it is the responsibility of the EOC Specialist to make this call, in consultation with the automation engineer, the Leak Detection Technical Authority, and other available resources. Below is a summary of the high and low alarms and number of resets and retuning that occurred from July 2005 through February 2006.

In summary, based on the minute by minute flow rate fluctuations, known process upsets and fluid composition changes, it is a challenge, if not next to impossible to detect instantaneous leaks of less than 1%. As a result, in order to detect a 1% leak, it will require 12 to 24 hours at a minimum to confirm the trend. Even then, because of the false alarms associated with the system in general and long term process upsets in particular, leak detection at the 1% threshold would be challenged.

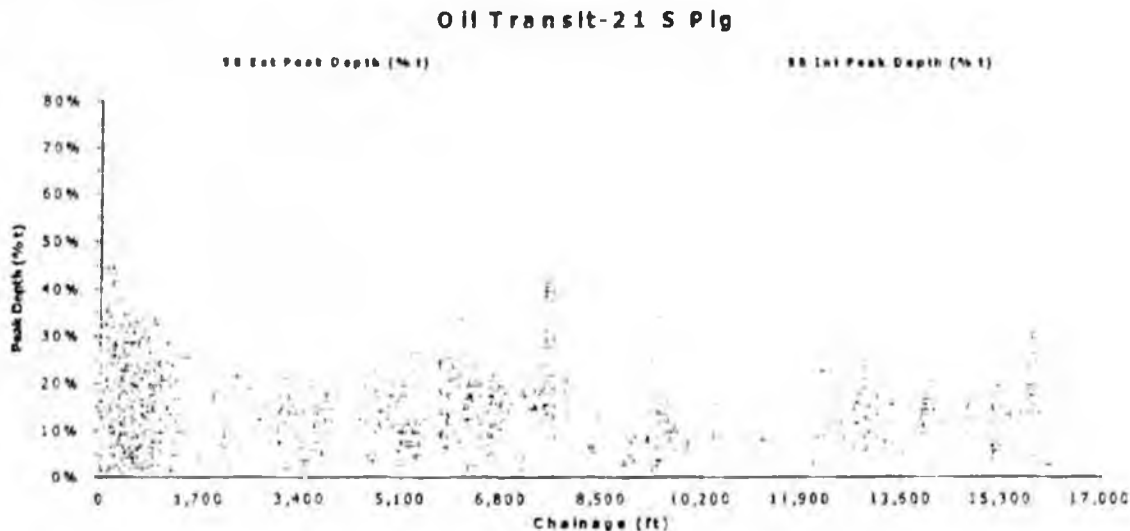
- 1998 Smart Pig Inspection: OT-21 was again inspected using a Pipetronics smart pig (Generation 2) in 1998. As can be seen from the following figure, the 1998 smart pig run found quite a few more corrosion indications than were found in the 1990 smart pig run.

According to the 1998 smart pig run, the maximum internal corrosion loss was approximately 50% of the wall (corresponding to 0.187 inches wall remaining). As in 1990, the 1998 smart pig run was followed up with manual UT measurements. Unlike 1990, however, these follow-up manual UT measurements largely confirmed the results of the smart pig. The results of both the smart pig and UT inspection indicated that there had been continuing internal corrosion damage between 1990 and 1998. However, while experiencing some corrosion, OT-21 was well within the BPXA "fit for service" criterion. The basic fitness-for-service criterion used by BPXA is ANSI/ASME B31G – 0.100 inch wall thickness or a thickness required for 105% MAOP (the specifics of the fit-for-service definition are discussed in greater detail in the above referenced Appendix 3 at section 3.3.5 to the 2004 Annual Update included in Appendix C).

The amount of wall loss at this particular caribou crossing at the site of the leak was reported to be 9% in the 1998 survey.

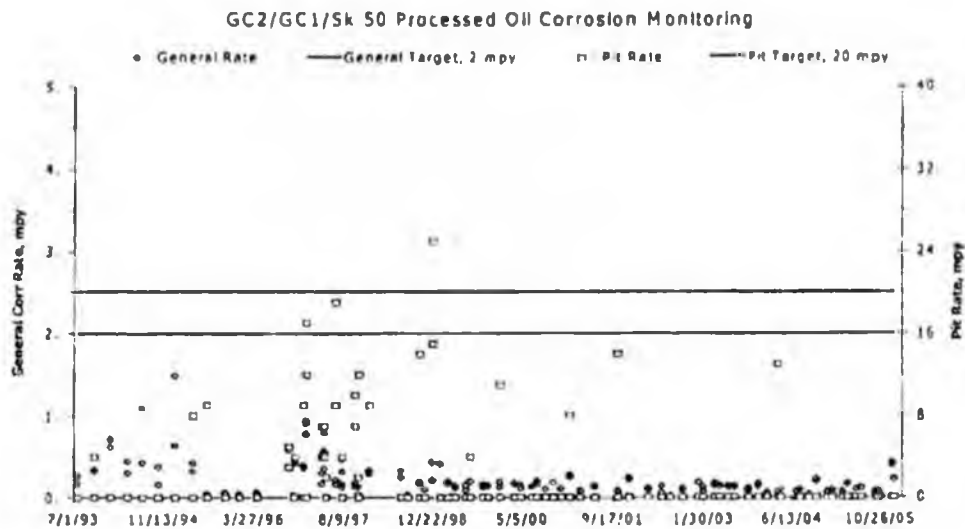
The graph below shows data from corrosion coupons installed in the oil transit line between GC-2 and Skid50.

As can be seen from the graph, the coupon data are all well below the target corrosion rate of 2 MPY. Some slight pitting has been observed over the years, but nothing excessive. The coupon data does not show any evidence of increasing corrosion trend. This may be explained by the fact that the coupons are in the flow stream and the corrosion damage appears to be primarily located on the bottom of the line on certain uphill runs.

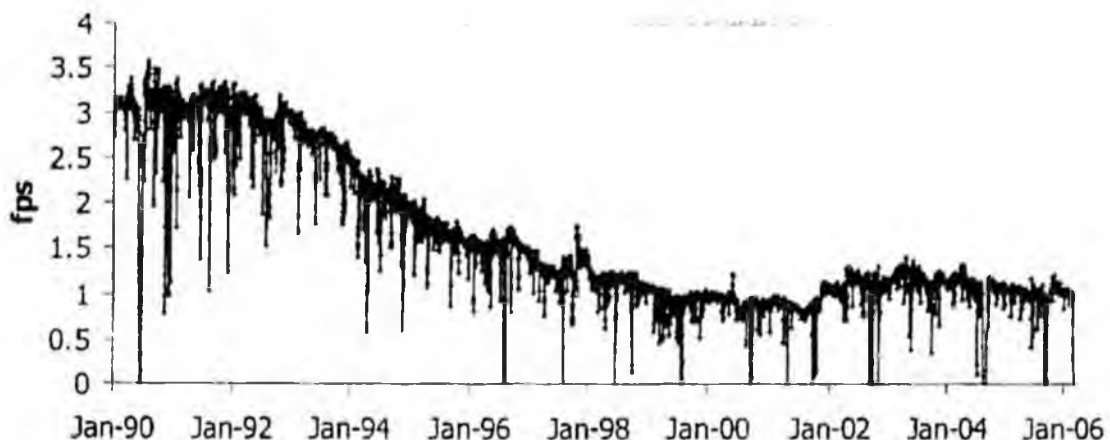
OT-21 Historical Velocities - fps

To help with the analysis, we calculated the flow velocity of fluids through the OT-21 based on production rates from 1990 forward. Those historical rates are shown below in feet per second.

Next, we modeled the OT-21 pipeline and determined that a velocity of about 8 ft/sec would be required to sweep residual water from the line. This would be true even at various inclinations like that at the caribou crossing. Based on these two data points, we can conclude that with a velocity of 4 ft/sec or less, water has likely been present in the OT-21 line since at least 1990 and probably long before that given the fact that corrosion was found in the 1990 smart pig. Therefore, although Section D of this report shows the relationship between the increase in Viscous Oil production at GC-2 and the resultant increase in BS&W carryover into OT-21, water was present long before Viscous Oil although likely in lesser amounts.

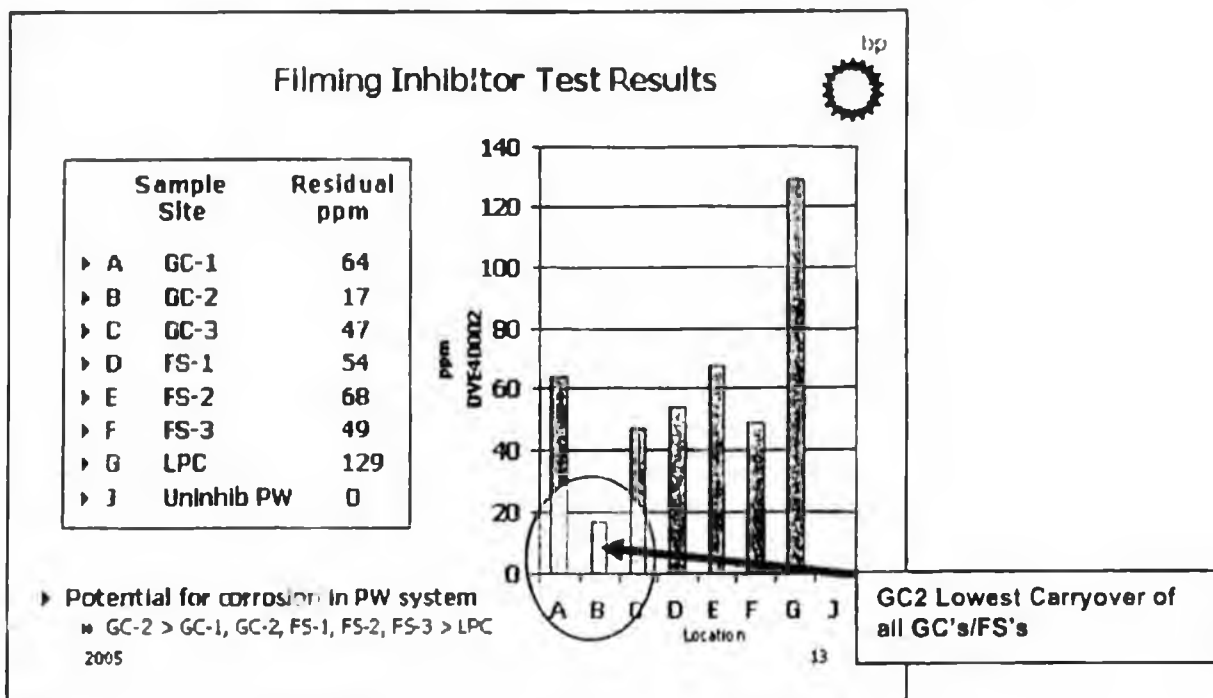
Inhibitor carryover was tested by Nalco on samples of produced water from GC 1, 2 and 3 and FS 1, 2 and 3 in February 2005. As shown below, this data shows GC-2 had the least carryover of corrosion inhibitor of the six facilities. At 17 ppm the amount was 30% of the average of the other GC's or FS's. Upstream inhibitor injection appeared normal at this time. This low level of corrosion inhibitor carried over into the OT-21 pipeline system could contribute to an increase in corrosivity of the GC-2 water in the line. The reason for this low level of corrosion inhibitor carryover is not totally known. However, facts suggest it could be the result of the additional solids brought in by Viscous Oil production into GC-2. Increased solids provide sites for adsorption of the corrosion inhibitor, which would then reduce the level of residual corrosion inhibitor in the water. Because of the increase in Viscous Oil production and the resultant increase in BS&W, GC-2 has had to experiment with various emulsion breakers to try and address the BS&W upsets. Because of the various chemical interfaces this too could have contributed to the reduction of corrosion inhibitor carryover.

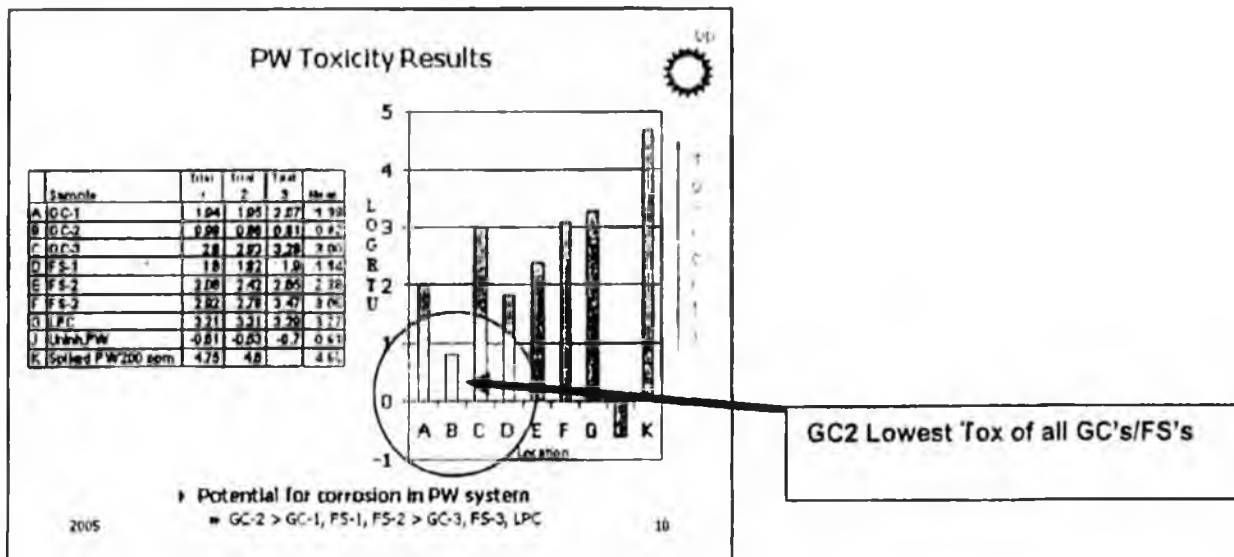
In addition to the inhibitor residuals mentioned above, Nalco conducted tests on GC-2 produced water on samples taken in February 2005 that showed GC-2 inhibitor carryover had the least affect on SRB growth of any of the production facilities tested. This is graphed below. The importance of this fact is that corrosion inhibitor, although not a biocide, is toxic to SRB's. As a result, a reduction in corrosion inhibitor carryover into the GC-21 line could have led to an increase in SRB activity in the line.

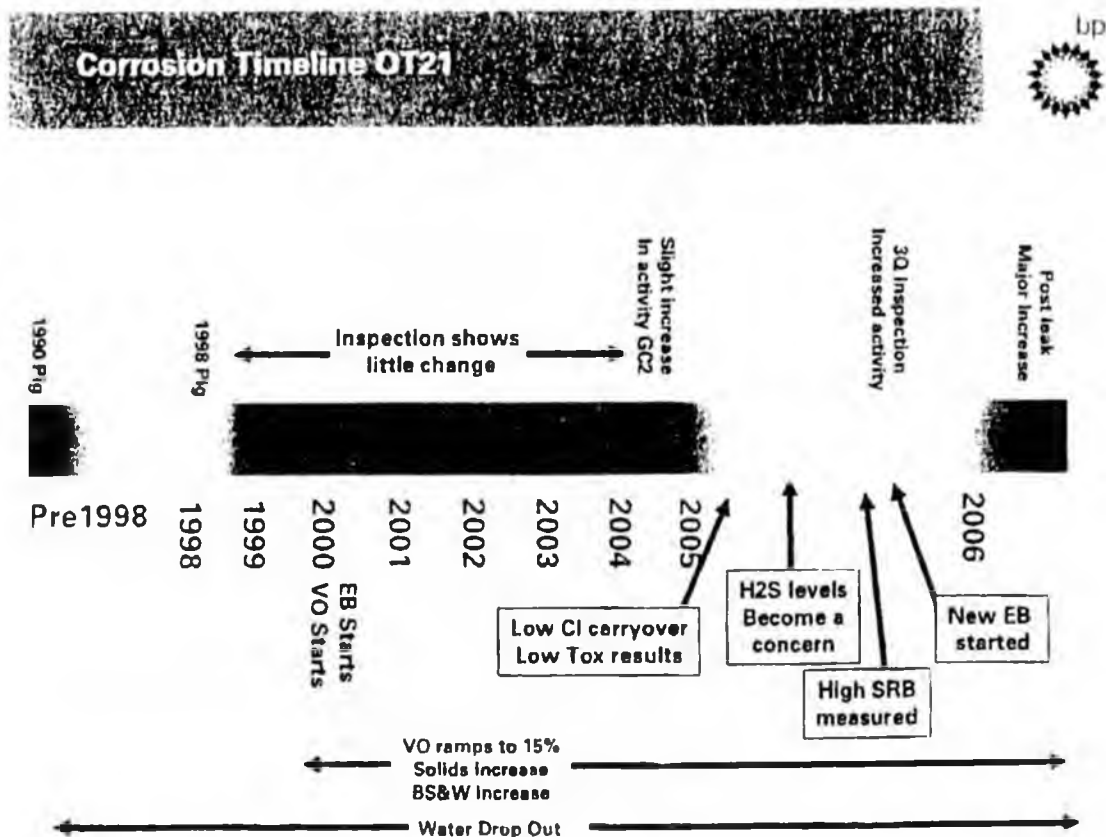
Some of the more pertinent facts from above are shown in the following timeline.

Much of the data collected in hindsight after the leak points towards an increase in SRB activity in GC-2 and the pipeline as a likely factor in the recent and sudden increase in corrosion activity. Data shows that SRB are present in GC2 as shown by the elevated H2S levels and the bacterial test results. The presence of bacteria combined with the demonstrated low carryover of corrosion inhibitor in GC-2 and the low toxicity test results increases the likelihood of this occurrence.

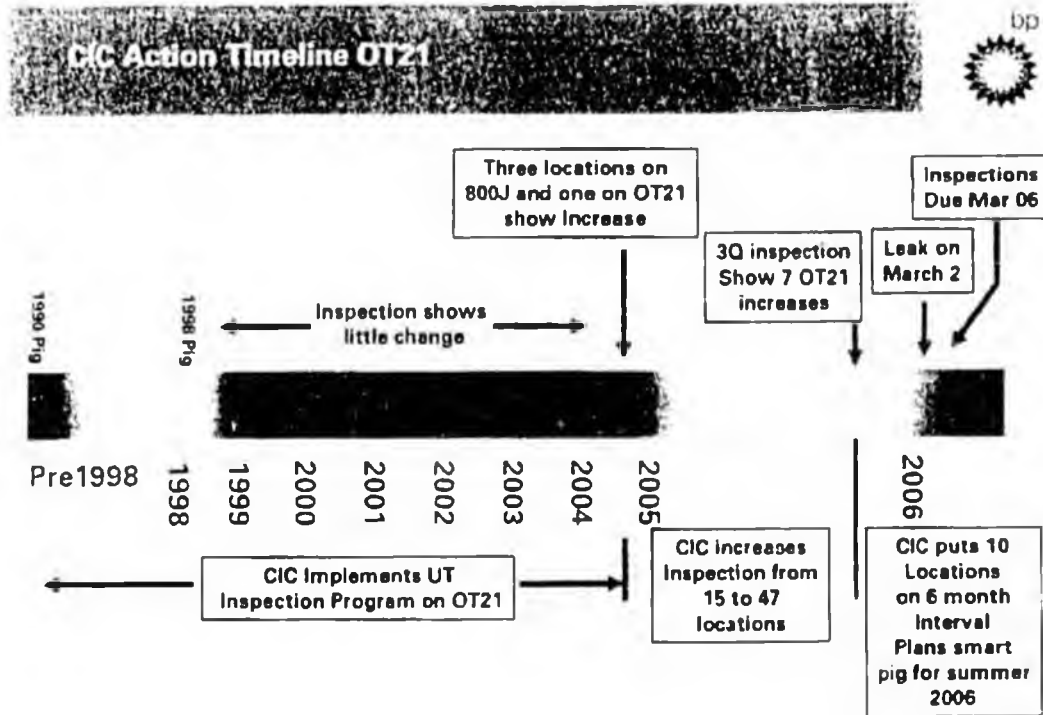
The following Action Timeline attempts to document actions taken with facts known about the corrosion on the OT-21 line.

As discussed in detail above, there was very little change in the corrosion rates on the OT-21 line segment until the 2004 program data was reported in 3Q04. At that time, three locations in the 800j 24" line, the line that feeds into the OT-21 line at GC2 increased along with one location on OT21. None of these increases gave rise to concern about the fitness for service of 800J or OT-21. Based on these results, however, BPXA increased the number of inspections on the OT-21 segment from 15 to 47 for the year 2005 program. The results of that program in 3Q05 showed seven locations on the OT-21 line had increased corrosion rates. As a result, ten OT-21 locations were placed on a six-month inspection interval, as opposed to the previous 12 month interval, and the smart pig was confirmed for 2006. None of the data in either 2004 or 2005 indicated a concern for the "fitness for service" of OT-21.

The leak occurred March 2, 2006. The next round of bi-annual UT inspections for the ten locations was scheduled for March 2006. The smart pig was scheduled for 2006 as well. Since the leak, BPXA has conducted in excess of 2,500 UT inspections including over 1,800 on this line. This post leak inspection data clearly shows sudden and unexpected increases in corrosion activity since the last set of data was gathered in fall of 2005. Had the leak not occurred, either the next round of bi-annual UT inspections or the smart pig run would likely have detected this increase and actions would have been taken.

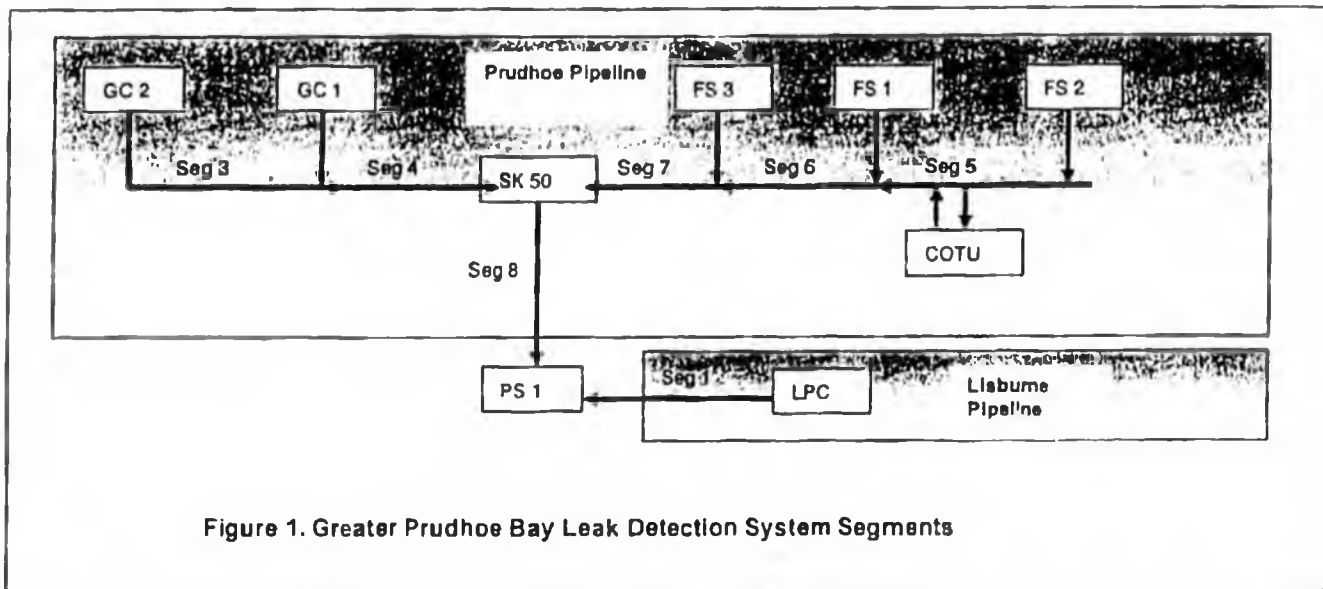
Figure 1. Greater Prudhoe Bay Leak Detection System Segments

Figure 1 shows the general layout of the segments. Figure 2 shows all the meters (and their SetCim tags) used in the leak detection system.
