## DEFERRED MAINTENANCE TASK FORCE

Public Hearing

October 14, 1997

# **FAIRBANKS COURTHOUSE FEASIBILITY STUDY**

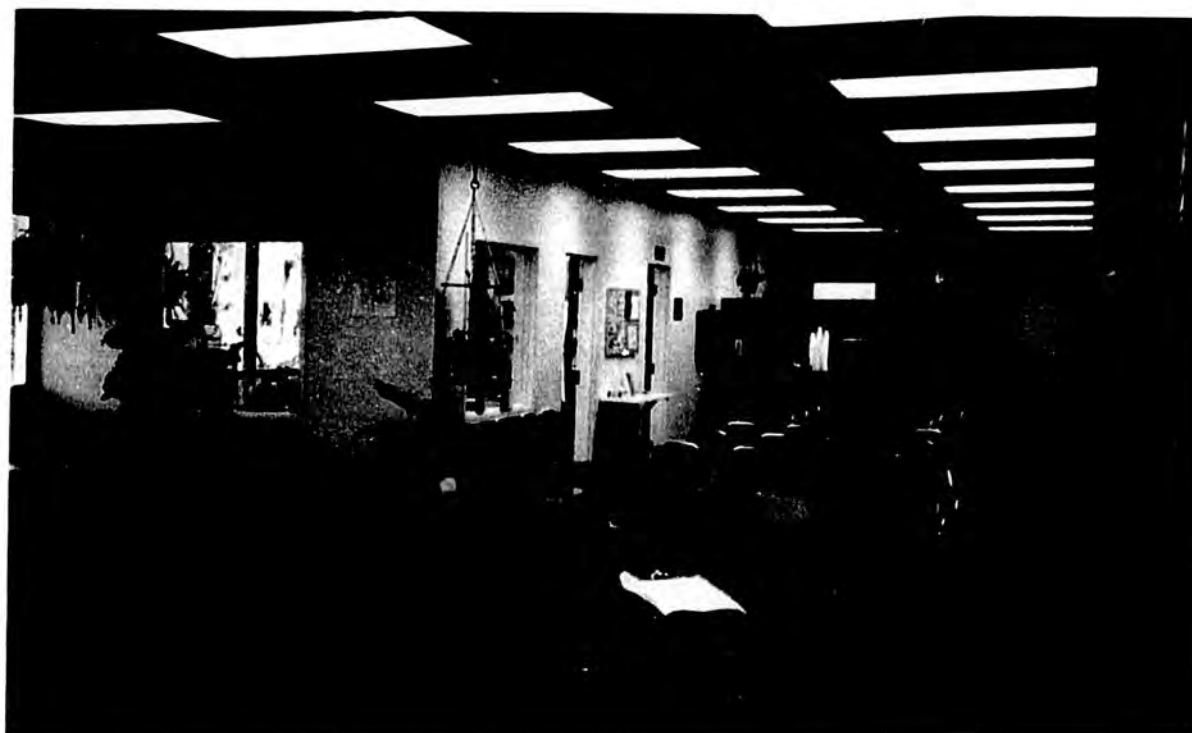
Photo #14

Jury Assembly (A3)

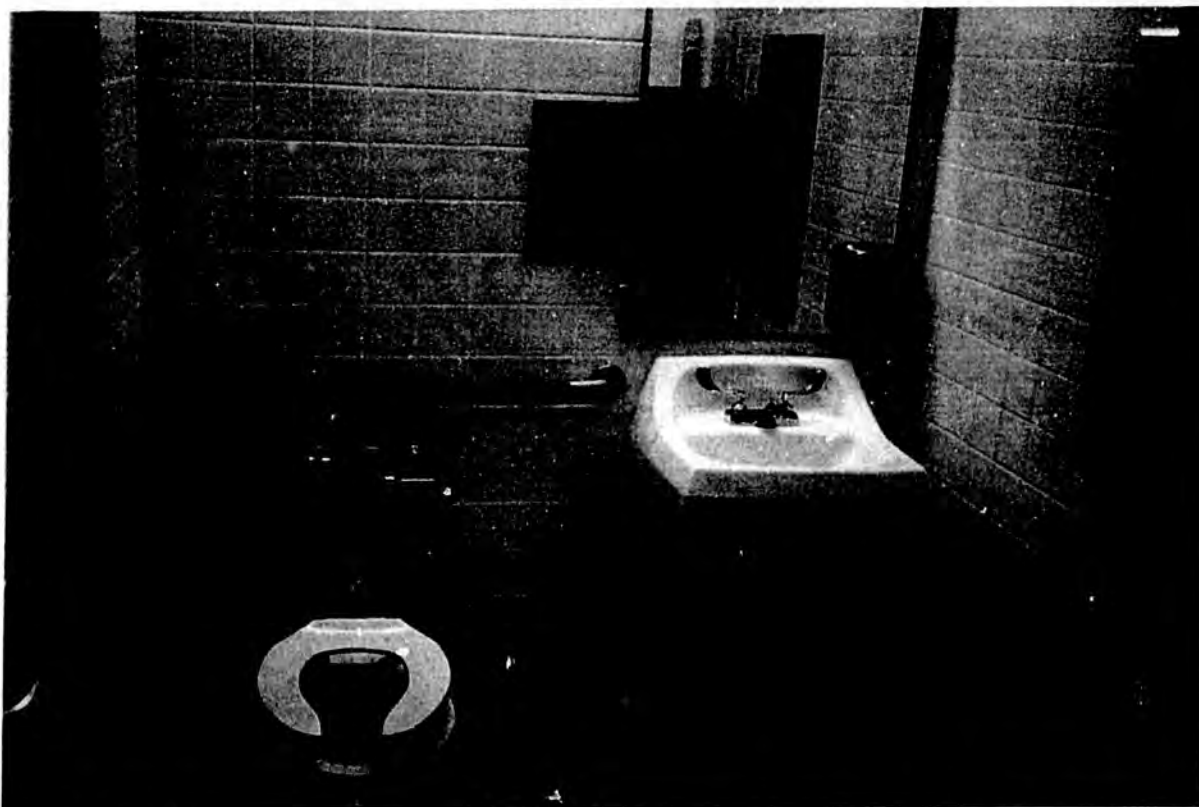
Photo #29

Typical ADA Toilet Room

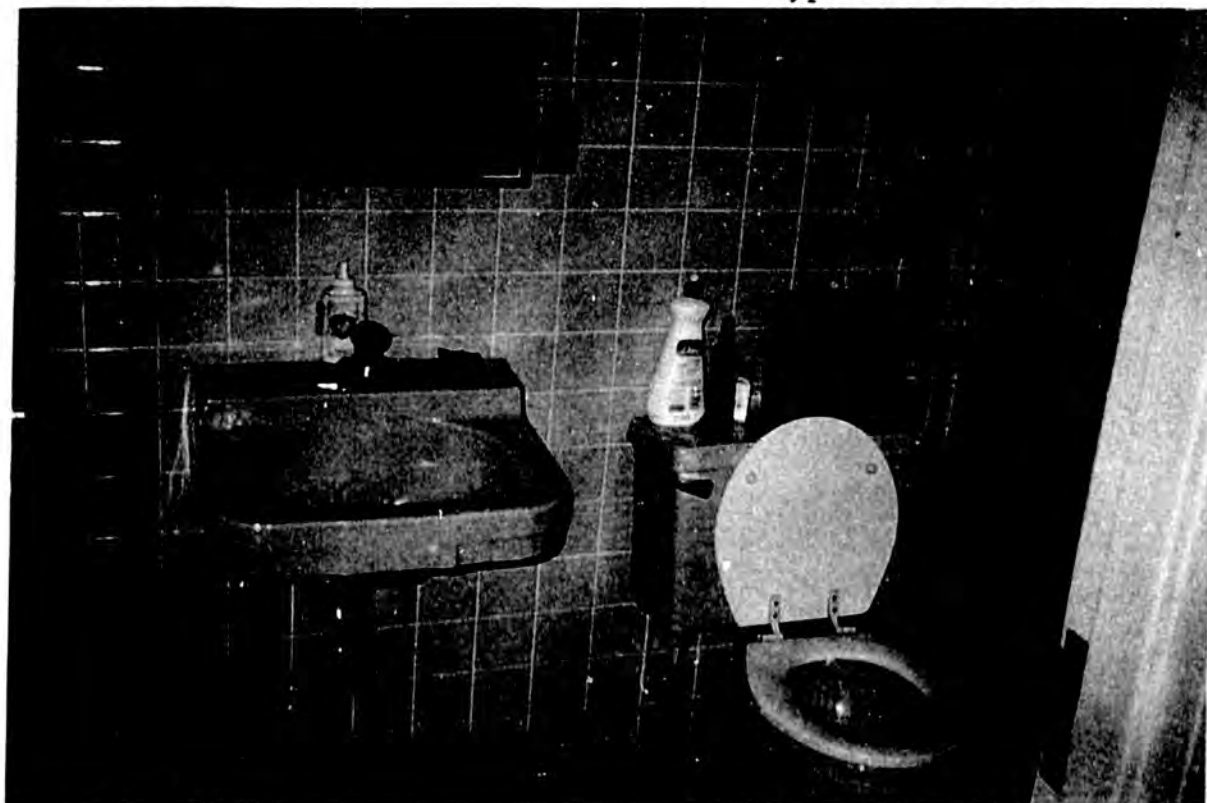
Photo #30

Typical Non-ADA Toilet Room
